Technical Service Bulletin

REAR CONSOLE LID DOES NOT SLIDE SMOOTHLY

Bulletin No.: 09-016/22

2020 CX-30

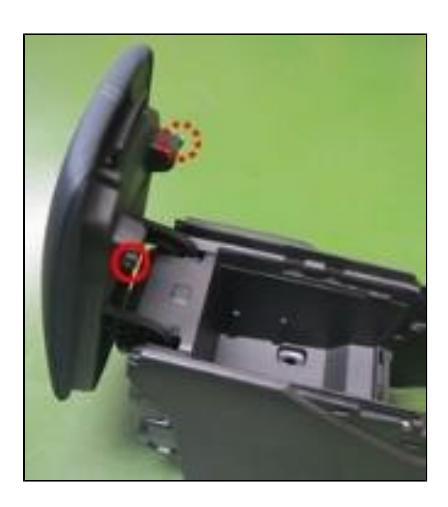
Some customers may complain that the rear console lid does not slide smoothly. This may be caused by improperly positioned felt pads attached to the rear console lid lock, which may have moved out of position after repetitive use. The exposed adhesive residue may stick to the rail and disrupt smooth sliding operation.

To eliminate this concern, the felt pad positions have been changed.
