Service Bulletin

Bulletin No.: 18-NA-073

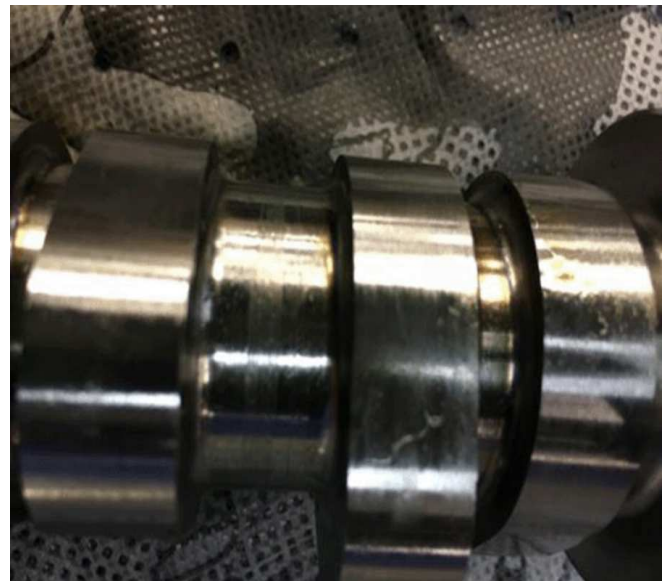
Review the following:

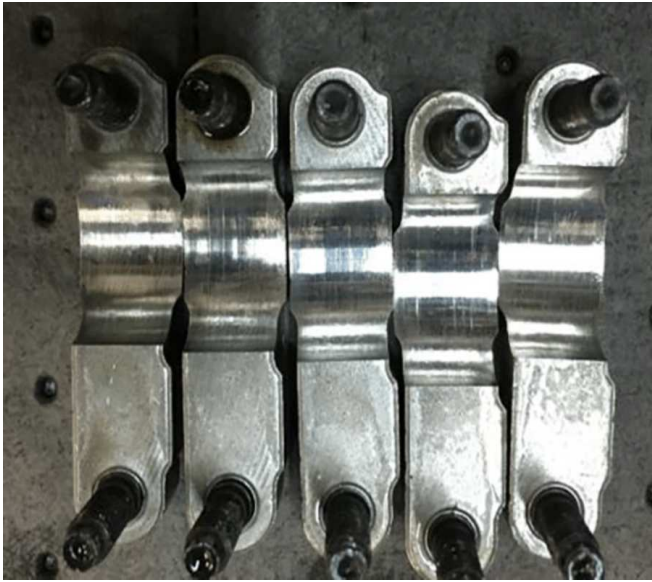
Review the following:
