RS19-004B

NTB19-071B

April 26, 2022

DTC B00A0-00 STORED

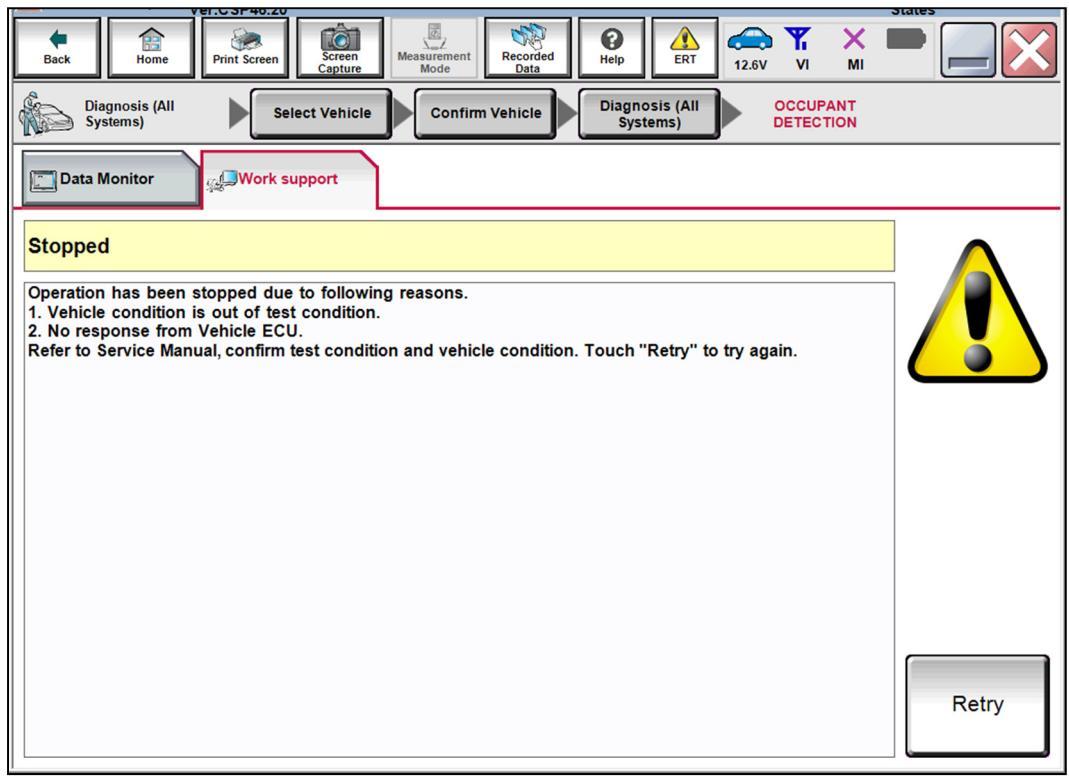
DTC B00A0-00 (OCCUPANT DETECTION SENSOR UNIT) is stored,

OCS zero point reset cannot be performed (continued on the next page),

The following screen displays:

- 1. Check the Occupant Classification System (OCS) control unit using the ODS Analysis tool software.
 - Refer to **SERVICE PROCEDURE** on page 3.

2. Perform "75-Zero RESET".

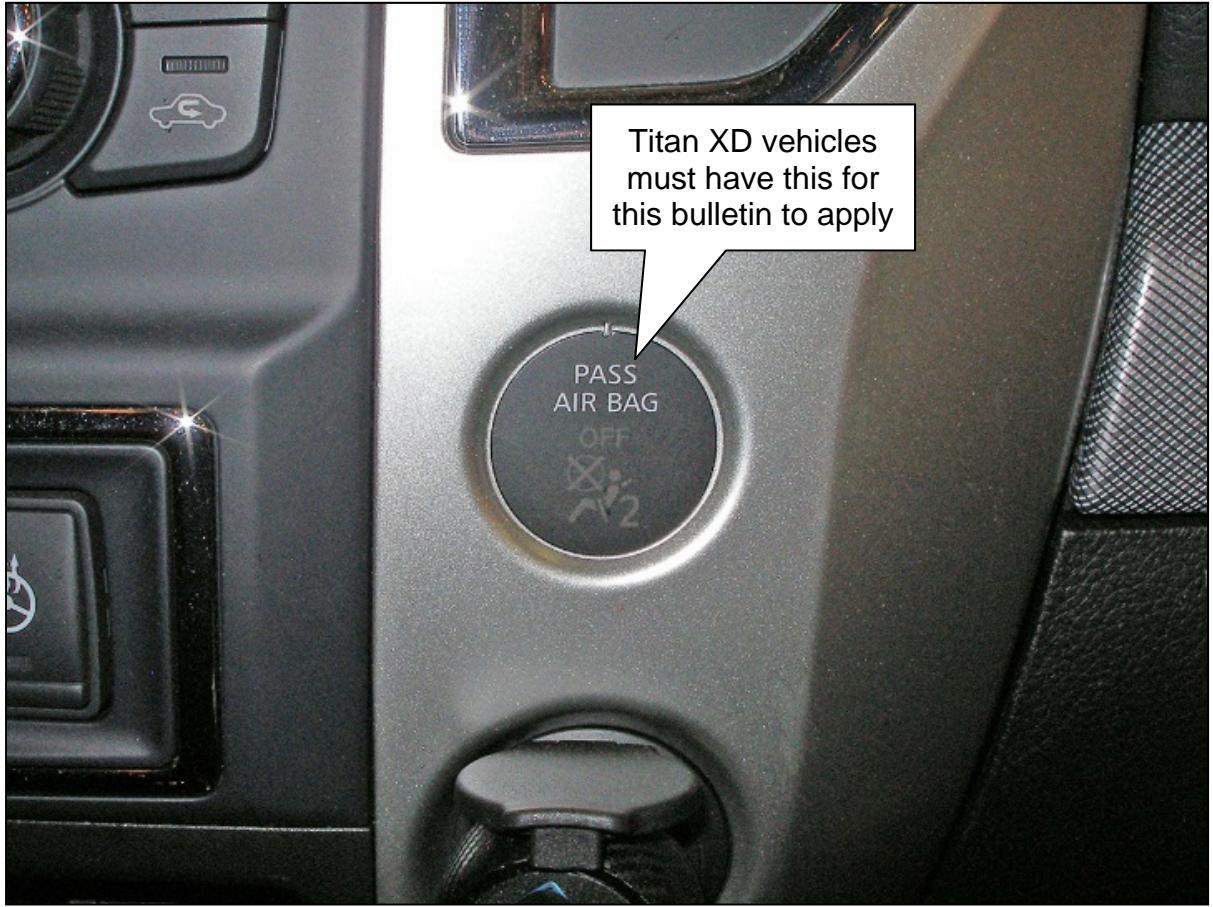
Figure 3

- ASIST on the CONSULT PC has been synchronized (updated) to the current date.
- All CONSULT-III plus (C-III plus) software updates (if any) have been installed.
- The CONSULT PC is connected to the Internet (Wi-Fi or cable).
- Titan vehicles: This bulletin applies to ALL Titan vehicles.
- Titan XD vehicles: This bulletin does NOT apply to all Titan XD vehicles. This bulletin applies to Titan XD vehicles equipped with OCS, as indicated by the presence of a front passenger air bag status light (see Figure 3).
