## **Service Bulletin**

- Subject: Information for Identifying Non-GM ECM Calibration Use and Power-Up Hardware Detection in Duramax<sup>™</sup> Diesel Engines Photograph Tech 2® Calibration IDs, Calibration Verification Numbers (CVNs) and Transmission Data Screen

- Models: 2006-2013 Chevrolet Express, Kodiak, Silverado 2006-2013 GMC Savana, Sierra, TopKick Equipped With Duramax<sup>™</sup> Turbocharged Diesel Engine RPO LB7, LBZ, LLY, LML, LMM, or LGH

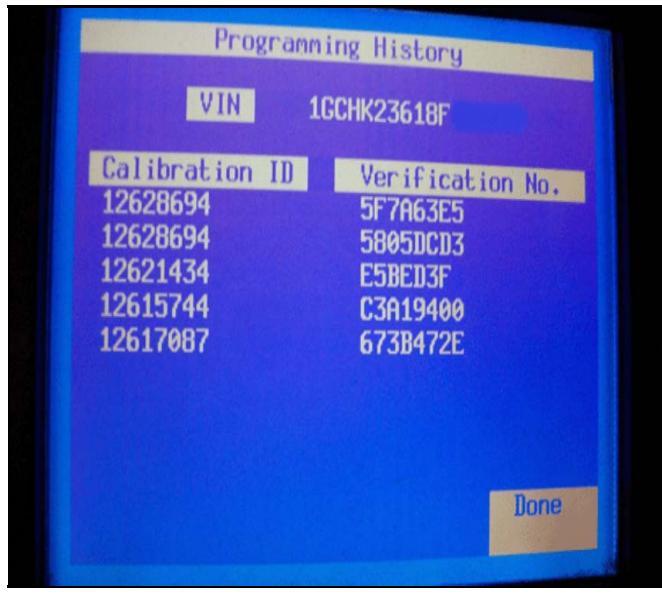
### **Programming History Screen**

Record the Calibration ID Numbers and Calibration Verification Numbers from the Tech 2® Programming History Screen. If the list of Calibration Part Numbers is less than 10, the first Calibration ID Number (bottom of the list) will not be in SPS CVN database. In this case, the first Calibration ID Number is programmed at the ECM production factory and is reprogrammed at the vehicle assembly plant.

- 8. From SPS, record the Calibration Part Number into the CVN Database. Get the CVN.
  - ⇒ If the CVN DOES NOT MATCH the CVN database, an unauthorized engine calibration part WAS PROGRAMMED into the ECM.
  - ⇒ If the CVN MATCHES the CVN database, the calibration/s are GM issued and an unauthorized engine calibration part WAS NOT used.

9. Take a clear digital picture of the Tech 2® Programming History screen showing the complete VIN, Calibration IDs and the CVNs. Retain the printout information and the Tech 2® screen photograph with the repair order.

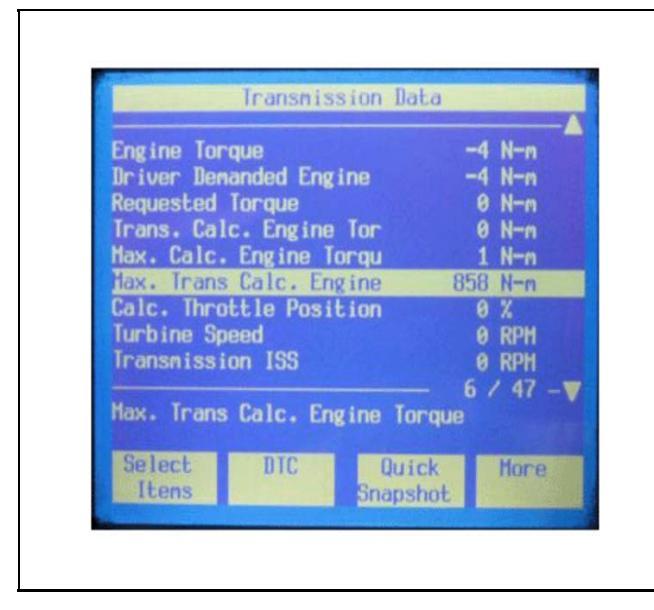
### Transmission Data Screen (Max. Transmission Calc. Engine Torque Parameter)

A transmission control module (TCM) algorithm has been implemented that records a maximum calculated input torque. This information is available via the Tech 2<sup>®</sup>.

- Take a clear digital picture in the .jpg file format of the Tech 2<sup>®</sup> screen showing the Transmission Data and the Max. Transmission Calc. Engine Torque parameter.
- 7. Retain the Tech 2<sup>®</sup> Transmission Data screen photograph with the repair order.
