20 Fuel level is implausible and/or vehicle judders, DTCs P008700, P046100, P014800, or P310B00 may be stored in the ECM

20 22 45 2063377/1 June 9, 2022.

Model(s)	Year	VIN Range	Vehicle-Specific Equipment	
A6, and A7	2019 – 2021			
A6 allroad, S6, and S7	2020 – 2021	All	Not applicable	
RS 6 Avant, A7 e quattro, and RS 7	2021

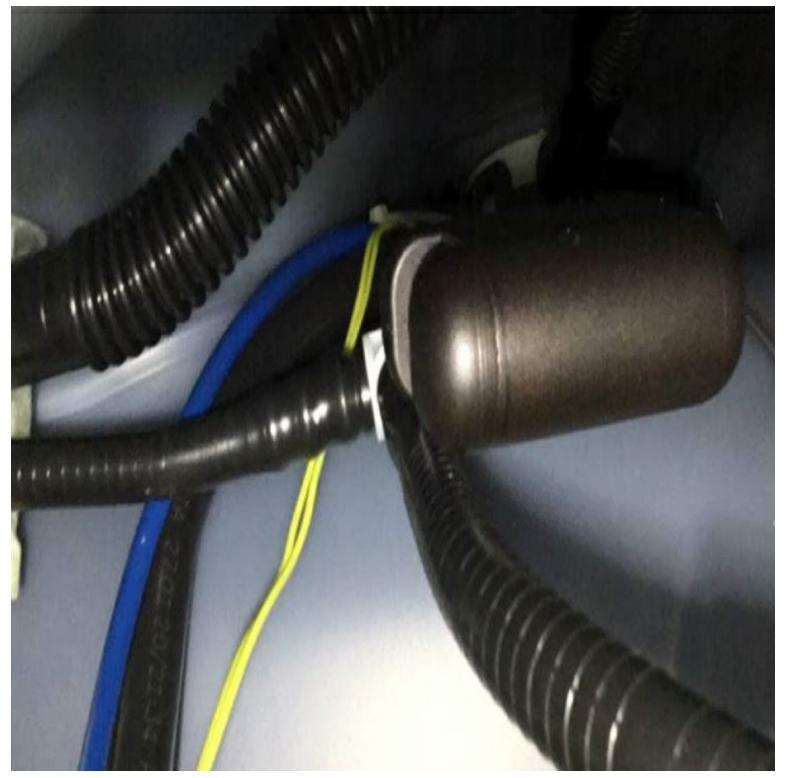
The fuel level sender can get caught on internal lines inside the fuel tank causing an inaccurate fuel level to be displayed in the cluster (Figure 1).

Figure 1. Checking the fuel gauge sender.

An improved fuel level sender has been implemented in production.

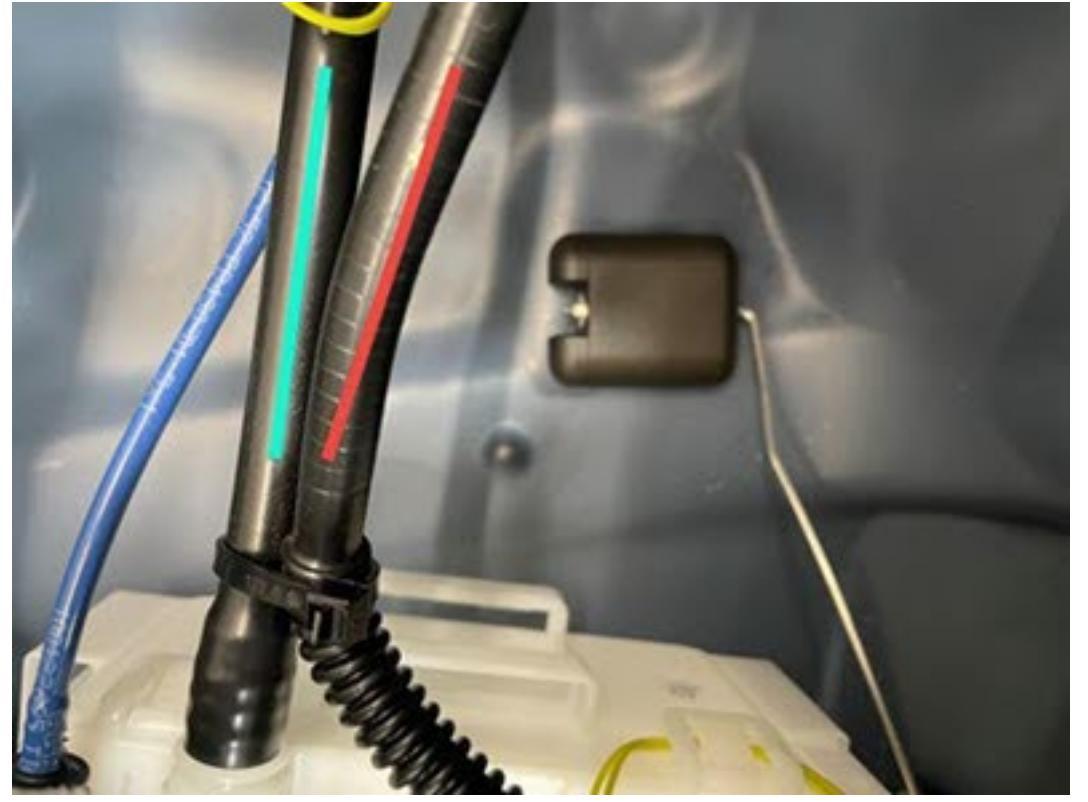
Figure 2. Suction jet supply and vent lines.

- 1. Remove the fuel pump flange and inspect the inside of the fuel tank for fuel. If no fuel is present, please continue with the procedure outlined below.
- 2. Install a fuel-resistant cable tie around the suction jet pump supply (green) and the vent (red) lines. When the cable tie is installed, there should be a gap of no more than 5mm between the two internal lines (Figure 2).

$\checkmark$  Note: DO NOT bundle the blue line into the cable tie with the suction jet pump supply and vent lines.

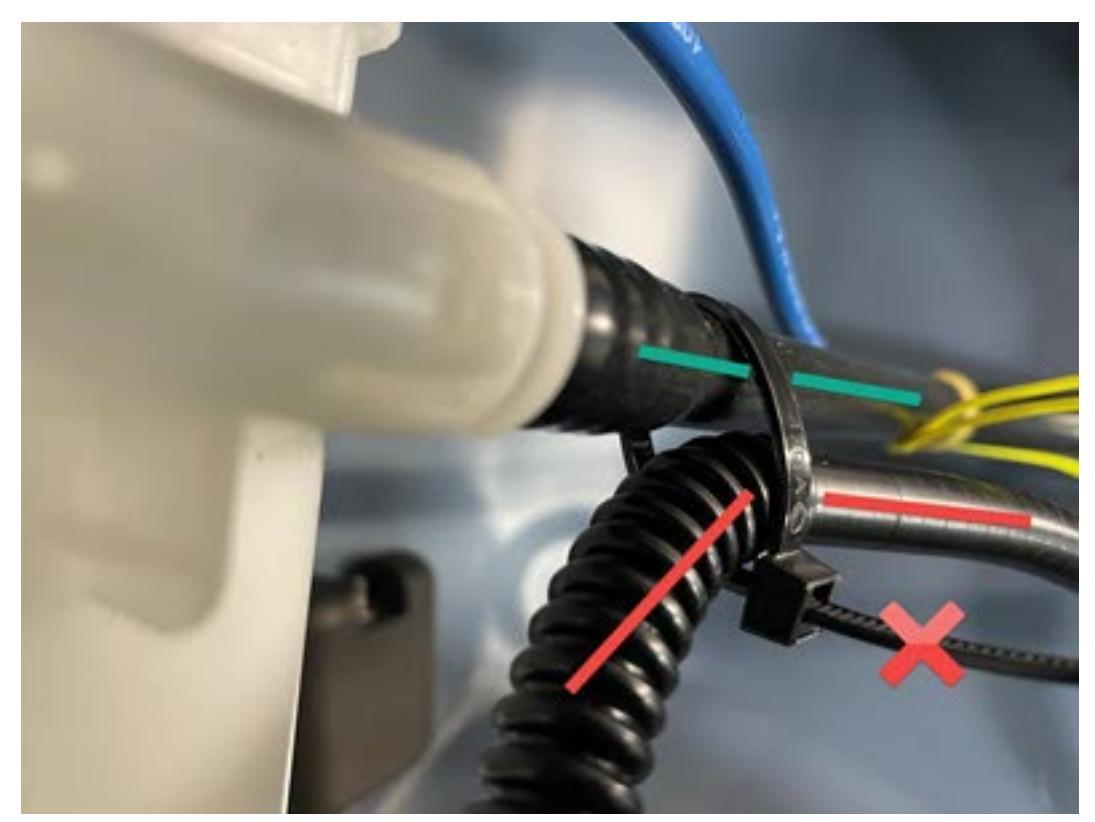
Figure 3. Lines with sufficient gap to prevent rubbing. Please ensure you remove the tail of the cable tie carefully.

3. Remove the tail of the cable tie, being careful to ensure the tail does not drop into the tank (Figure 3).
