Release date:

Transaction No:

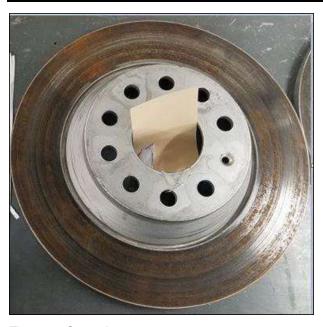
Figure 5: Corrosion.

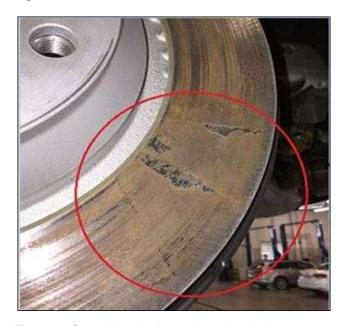
Figure 7: Corrosion, brake pad stuck to brake rotor.

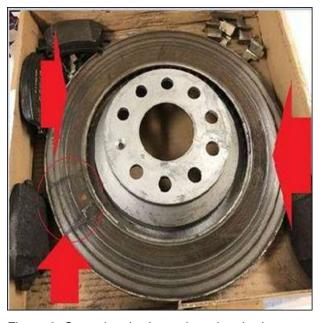
Figure 6: Corrosion, brake pad stuck to brake rotor.

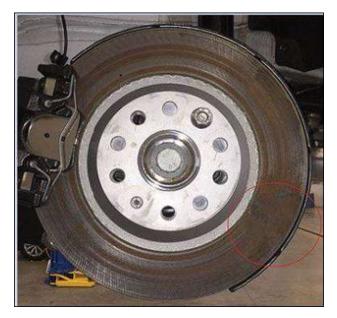
Figure 8: Corrosion, brake pad stuck to brake rotor.

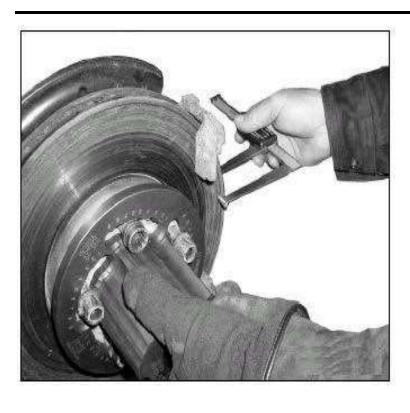
Disc Thickness Measuring

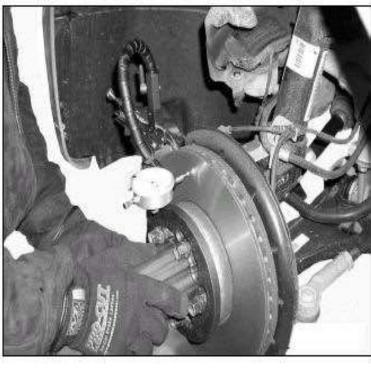
- Measure brake rotor lateral run out using a caliper and dial gauge set.
- Run out must not exceed 0.1mm after machining.
- If brake rotor exceed the 0.1mm specification after machining replace the applicable brake rotors.
