40 Creaking noises from front of the vehicle when driving - Q7, Q8, A8, etron

40 22 44 2058489/6 July 12, 2022. Supersedes Technical Service Bulletin Group 40 number 22-41 dated June 8, 2022, for reasons listed below.

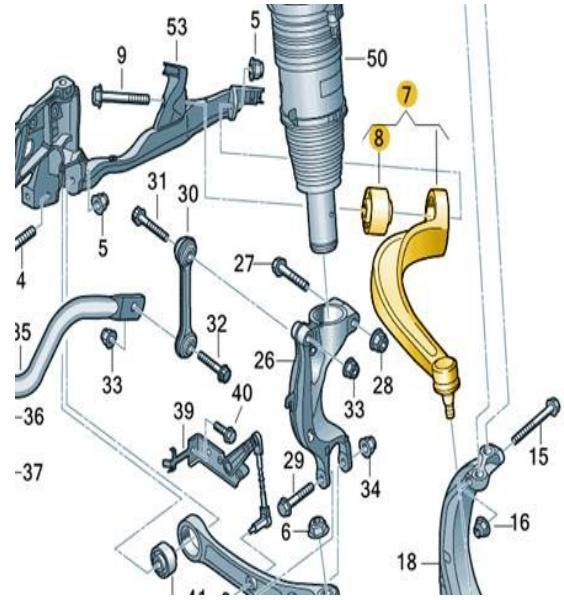
Figure 1. Hydro-bush.

The noises can be generated on the lower-left guide in the area of the hydro-bushing. (Figure 1, Positions 7 and 8).

- 1. Replace the hydro-bushing on the guide link in pairs (Figure 1, Position 8) according to the instructions in the ELSA Repair Manual at *Chassis >> Suspension >> Wheels, Steering >> 40 Front Axles >> Lower Control Arm and Ball Joint >> Guide link bonder rubber bushing, Removing and Installing.*
- If repeat repairs are necessary and the hydro-bushing has already been replaced (pressed out/in), the complete guide link has to be replaced (Figure 1, Position 7). Refer to the instructions in the ELSA Repair Manual at *Chassis >> Suspension >> Wheels, Steering >> 40 Front Axles >> Lower Control Arm and Ball Joint >> Guide link, Removing and Installing.*

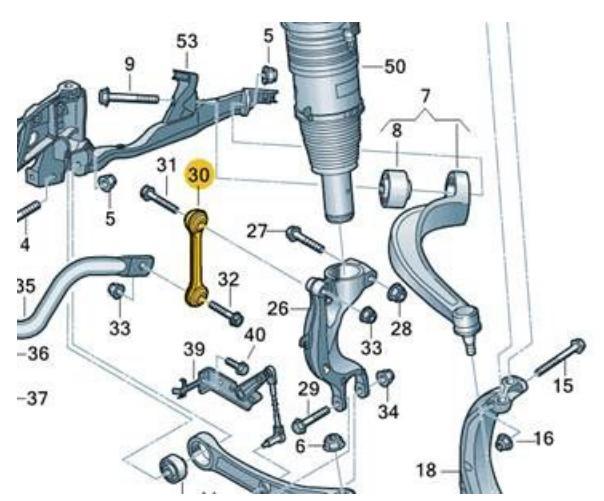
Figure 2. Coupling rod.

Parts such as the coupling rod (Figure 2, Position 30) are usually replaced by mistake, presenting no problems.
