## **Mack Particulate Matter (PM) Sensor Troubleshooting Guide - US14+OBD16 And Newer Emissions**

# SCR Fittings, One Box, Replacement

# Exhaust Particulate Sensor, Repair

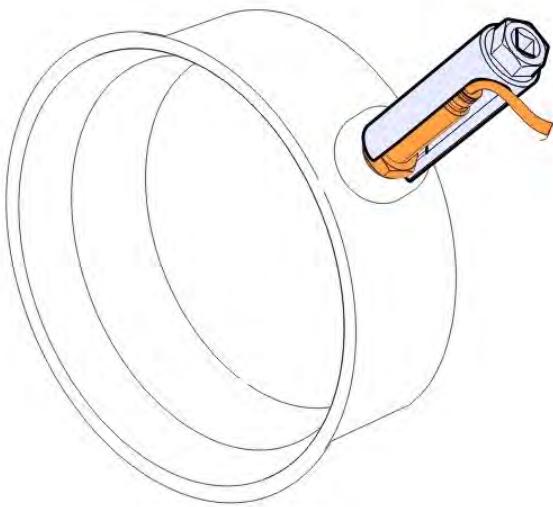
- Replacement instructions can be found under the Service tab in [Impact](#).
- DO NOT CUT THE HARNESS** when initially attempting to remove the sensor. A 22 mm Oxygen Sensor socket will keep the harness intact.

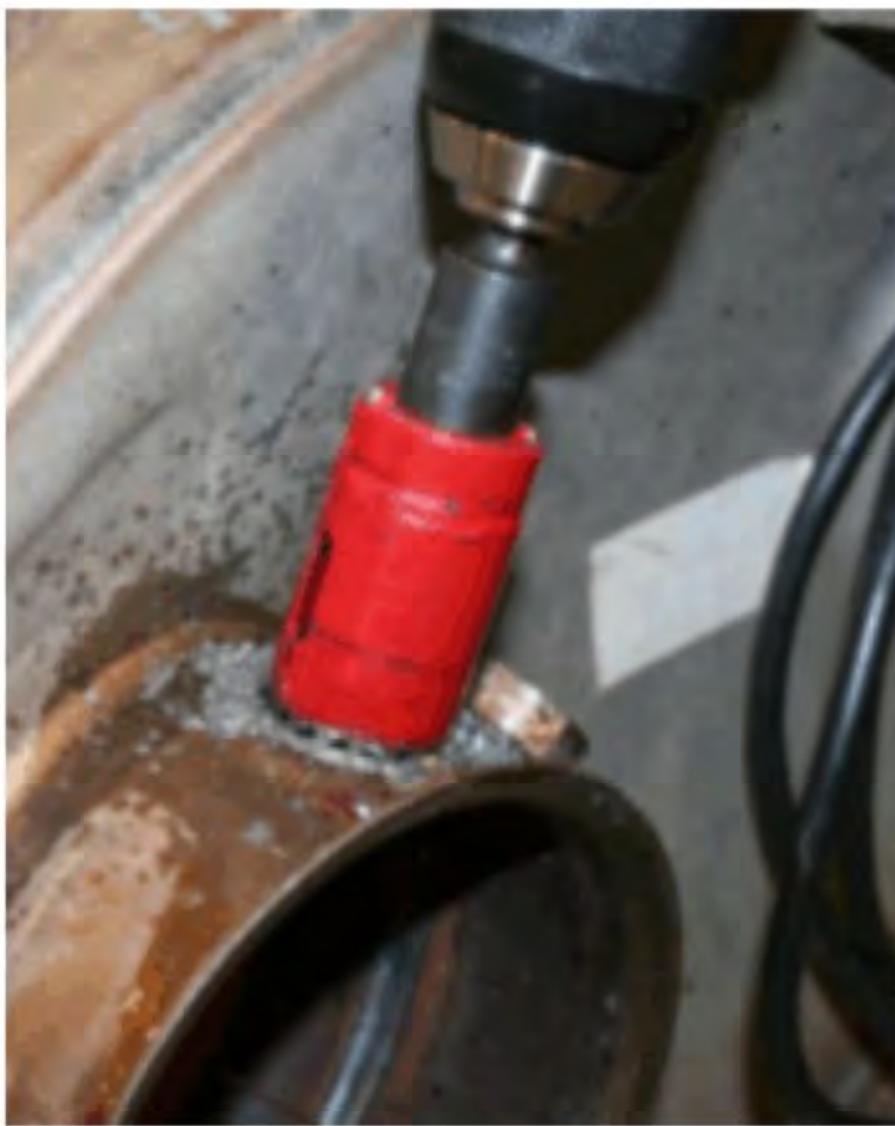
**Note:** If the PM sensor boss is damaged as shown in the illustration mark the position of sensor boss notch before removing the boss welding. The notch of PM sensor boss is always set in the 3'o clock position.

**Note:** When removing the sensor boss weld, check the depth frequently to prevent the damaged sensor boss from falling inside the aftertreatment muffler. Also ensure that the notch mark is not removed.

1. Remove the damaged boss welding.
