### **Volvo DEF Level (UQLS) Sensor Troubleshooting Guide - US17+OBD16 Emissions and Newer**

# Aftertreatment Diesel Exhaust Fluid (DEF) Tank, Level Sensor, Replacement

M-258-040

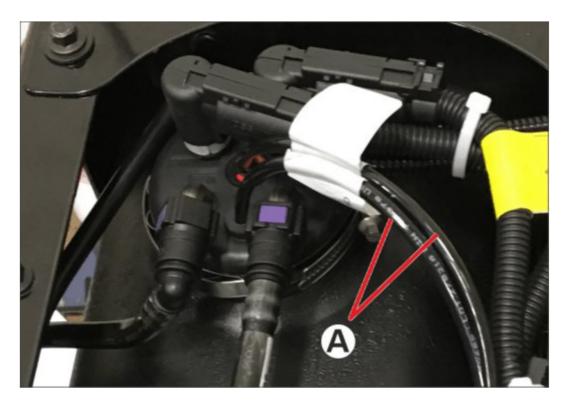
. Maintain minimum 40 mm bend radius of UQLS (Urea Quality and Level Sensor) control module routing (A) at sensor head.

Note: Do not kink the UQLS control module routing.

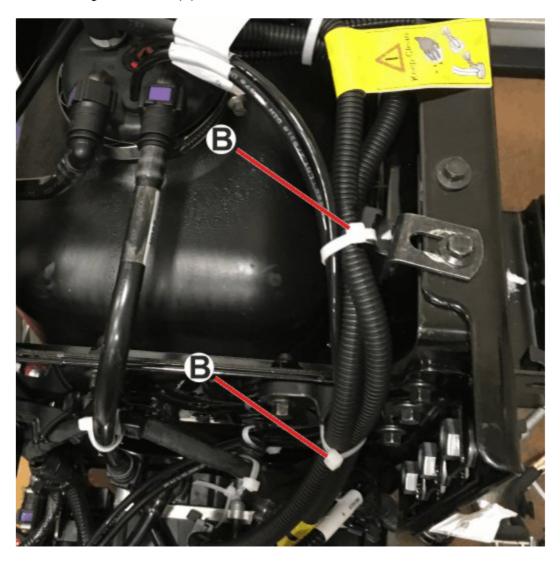
. Route and tie the UQLS control module routing with the urea harness.

Note: Use regular cable tie (B).

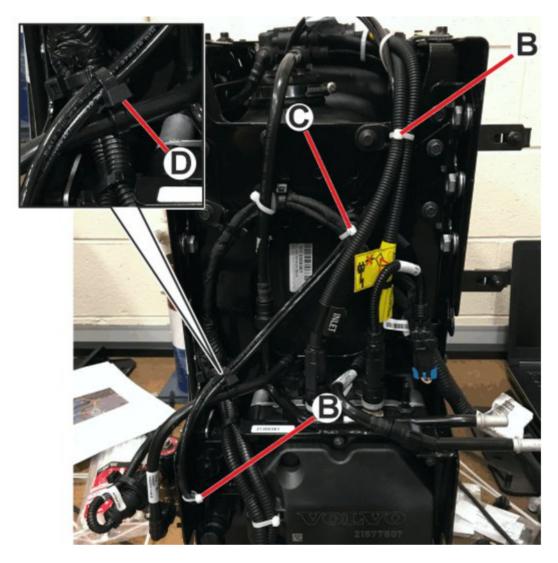
. Route and tie the UQLS control module routing with the electrical harness.

Note: Use helicopter cable tie (C).

. Route and tie UQLS control module routing with the coolant lines.

Note: Use double head cable tie (D).

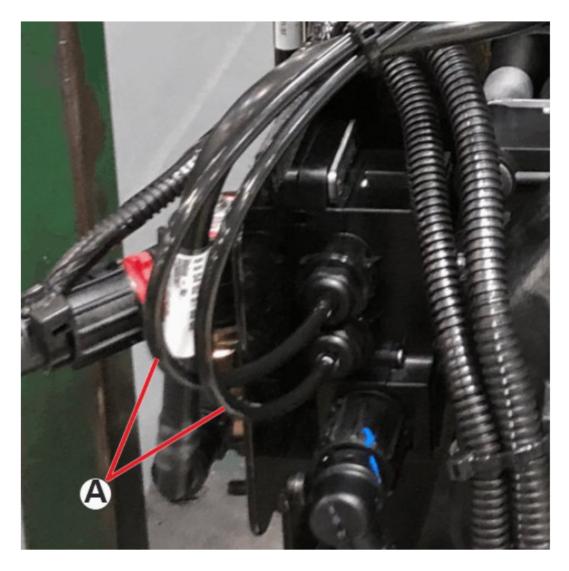
. Maintain minimum 40 mm bend radius of UQLS control module routing(A) at electrical junction box.

Note: Do not kink the UQLS control module routing.

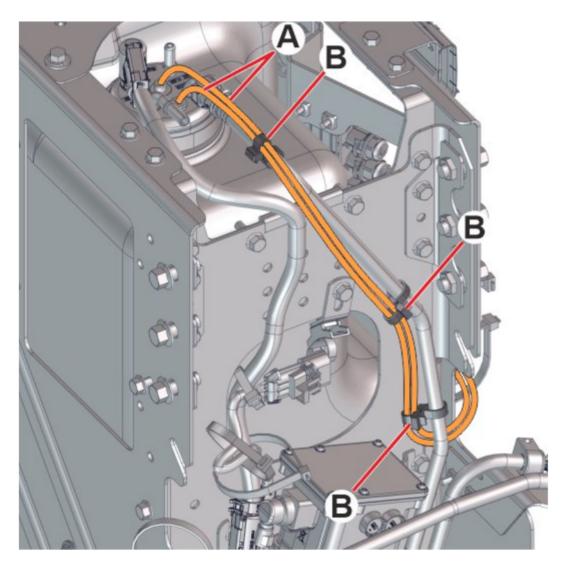
. Maintain minimum 40 mm bend radius of UQLS (Urea Quality and Level Sensor) control module routing (A) at sensor head.

Note: Do not kink the UQLS control module routing.

. Route and tie the UQLS (Urea Quality and Level Sensor) control module routing with the coolant pipe.

Note: Use double head tie (B).

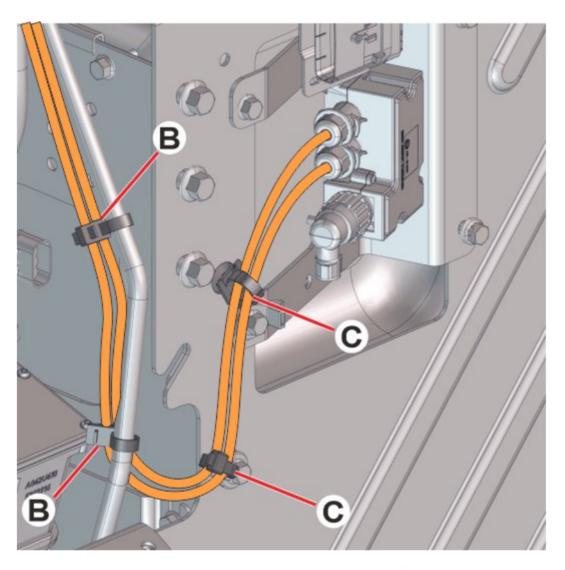
. Route and tie the UQLS control module routing with the bracket.

Note: Use cable tie (C).
