**Technical Service Bulletin**

GROUP	NUMBER
HYBRID SYSTEM	22-HC-002H
DATE	MODEL(S)
AUGUST 2022	Tucson Hybrid (NX4 HEV), Santa Fe Hybrid (TM HEV)

### SUBJECT: REFILL INVERTER COOLANT WARNING LIGHT ON

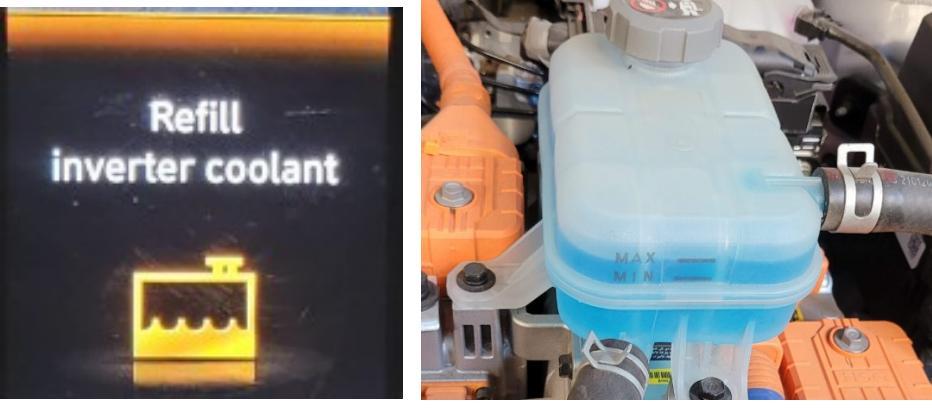
**Description:** This bulletin addresses a warning light "Refill Inverter Coolant" displayed on the instrument cluster, but inspection of the under hood blue coolant reservoir is found to be at normal level (not below "MIN" marking on the reservoir bottle).

This may be caused by poor flow of antifreeze inside the low-conductivity coolant pipe from internal debris, resulting in unusual high EWP operation being detected.

Follow the procedure outlined in this bulletin to flush/discharge debris from the cooling system and replace the blue coolant. To effectively resolve, the flushing must be performed section by section as instructed. After flushing of the cooling system is done, updated BSC-2 coolant will be installed.

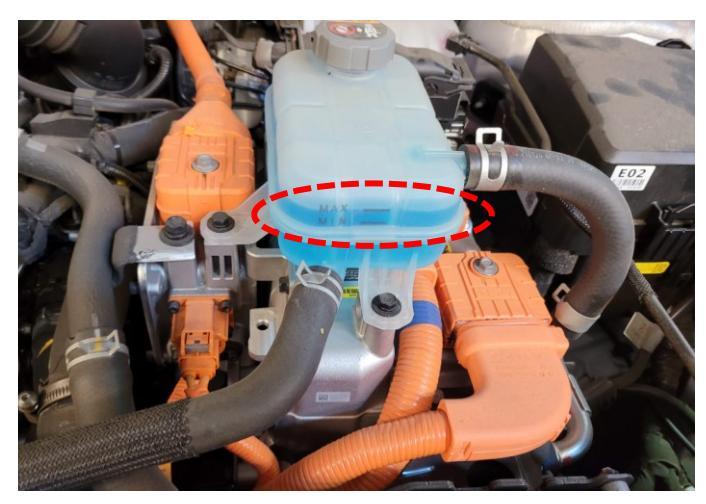
Open the hood, visually check the amount of blue coolant in the reservoir tank:

- **Coolant Level is Normal:** Proceed with this TSB.
- **Coolant Level is Low**: Fill coolant to "MAX" level and drive vehicle briefly to confirm if the "Refill Inverter Coolant" warning light disappears:
  - If the warning light still appears, then proceed with this TSB.
  - If the warning light no longer appears, this TSB does not apply.
