NUMBER: 23-006-22 REV. C

DATE: June 24, 2022

Heated Seat Calibration Update

Grand Wagoneer/Wagoneer

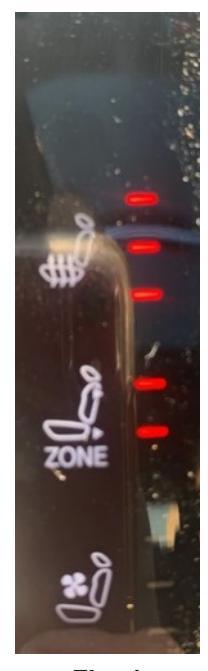
Fig. 1 Heated Seat Buttons With Red Indicators

- Turn on the cushion and back seat heat by pushing the heat seat logo until three red indicator bars (high setting) are shown (Fig. 1).
- 7. Ensure both cushion and back heat seat are both on by pushing the seat zone button until two red indicator bars are shown (Fig. 1).

- 9. Did all the red indicator bars on the heated seat buttons (Fig. 1) stay activated after 10 or 20 minutes?
 - YES>>> This bulletin has been completed. Use LOP (18-50-10-AH) or LOP (18-50-10-AG) depending on build dates, to close the active RSU.

- **NO>>> One or more red indicator bars turned off before 10 or 20 minutes proceed to Step 10.**

- 10. Replace the seat backs and side cushions for the affected seats based on the DTCs listed below:
 - B1E99-13 (Left Side Back Wagoneer) Front Left Heater Control 1-Circuit Open. Refer to the detailed service procedures available in DealerCONNECT/Service Library under: Service Info>23 - Body / Seats, Front / Panel, Seat Back / Removal and Installation.
