TECHNICAL SERVICE BULLETIN

TCM COMMUNICATION ERROR CAUSING A NO START CONDITION

NTB21-002A

APPLIED VEHICLES:	2020 Frontier (D40)
APPLIED TRANSMISSION:	9 Speed A/T (GE9R01A)

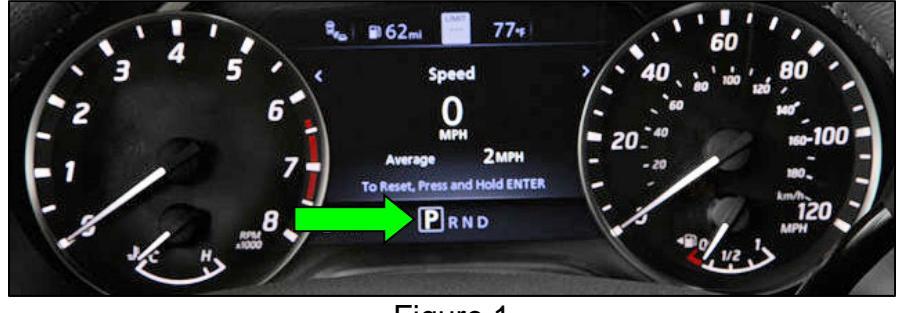
NOTE: If the Park indicator is not displayed in the Driver Information Center (Figure 1) and C-III plus does not display the current TCM part number after a 2 minute wait with the ignition ON, engine OFF, this TSB <u>does not apply</u>. Refer to the ESM for further diagnostic information.
