Service Bulletin

Subject: Stop/Start System Inhibited / IBS / Battery Monitor with Module Malfunction Indicator Light (MIL) Illuminated - DTC U152D, P15FF, P305D, P305E, U01B0 Set

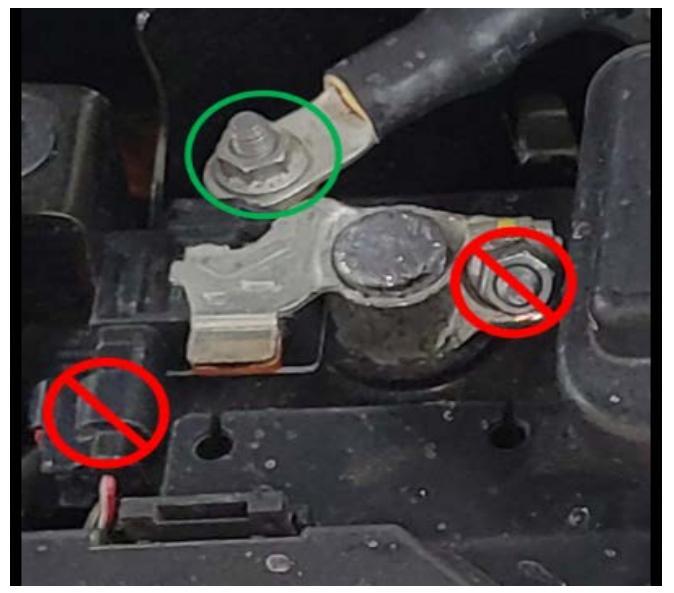
6164935

Preventing Sensor Reset

Unless the 12V battery or the sensor is being replaced, the Battery Sensor should stay attached to the negative stud with its connector attached at all times.

- OK to disconnect at Green circled point or any point further downstream towards chassis ground stud.
- DO NOT disconnect Battery Sensor Module from the negative battery post or the connector.
