Customer Satisfaction Program

N212354522 Heated Vented Seats Retrofit - Front and Rear Seats

Release Date: November 2022

Revision: 03

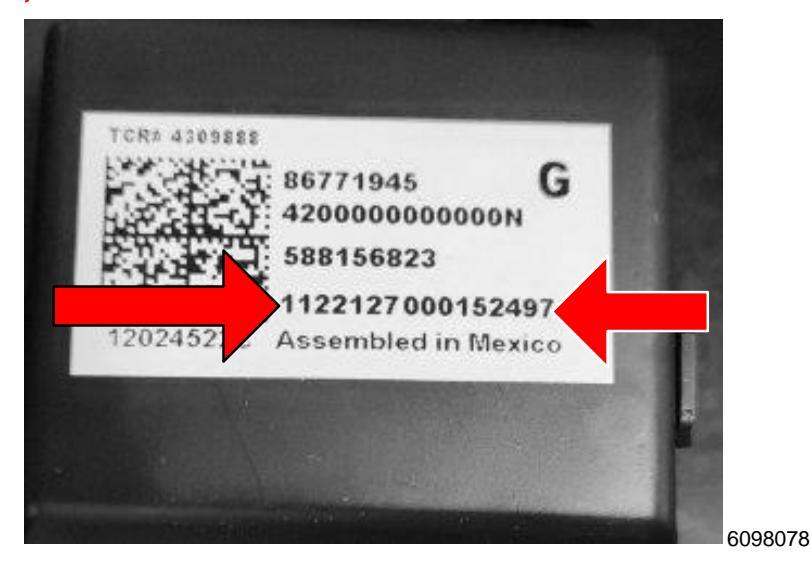
Record the serial number on the front and rear seat heater vent control module labels.
