34 Oil leak near the transmission cooler

34 22 61 2067365/2 November 15, 2022. Supersedes Technical Service Bulletin Group 34 number 22-58 dated July 11, 2022, for reasons listed below.

Model(s)	Year	VIN Range	Vehicle-Specific Equipment	
A3, A3 Cabriolet, and S3	2017 - 2023	All	With 0GC Transmission	
TT, TT Roadster, and TTS	2019 – 2023

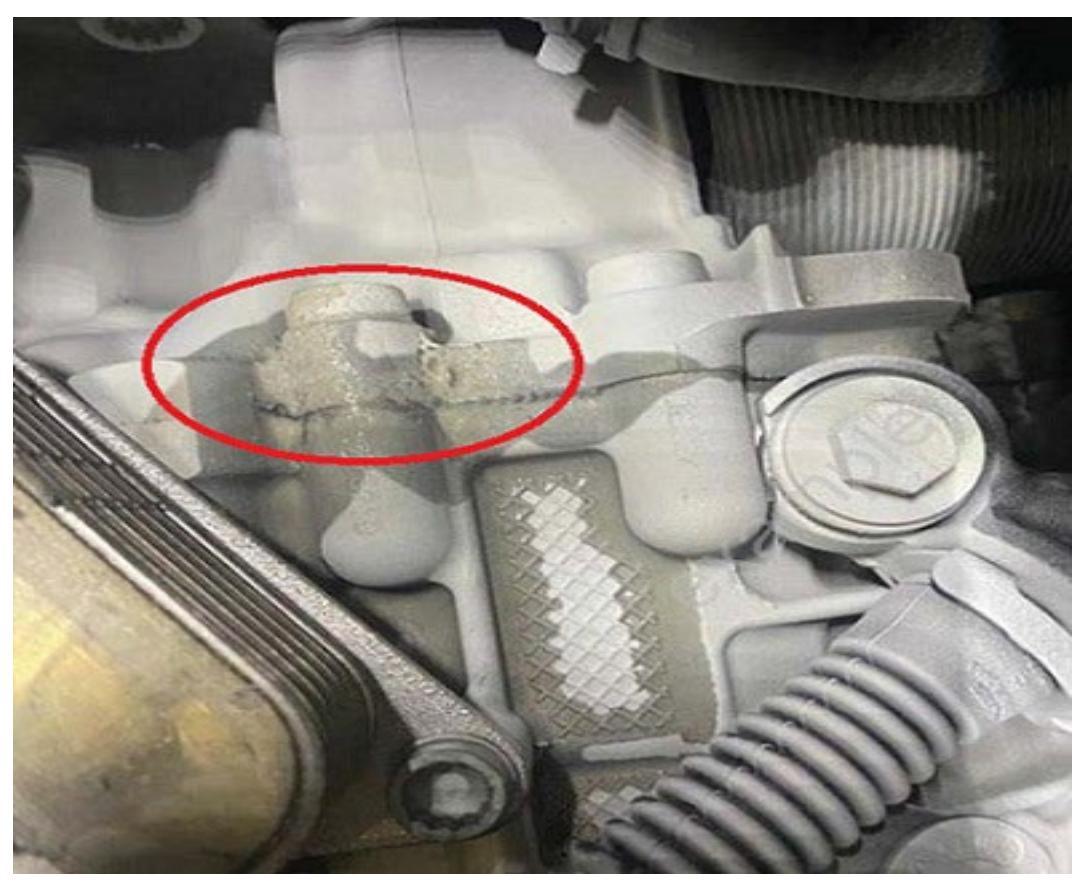
The oil leak traced to the area near the transmission oil cooler at the seam of the case (Figure 1).

Figure 1. Oil leak at transmission case seam.

- Clean the transmission and oil cooler area thoroughly in the affected area using suitable workshop materials.
- Dry the area of the leak with rags and/or compressed air.
- Using oil leak detection spray (part number: G 001 900 A1 or equivalent powder-based oil leak detector) on the affected area on gearbox housing.

- Perform a short road test to warm up the gearbox (engine oil temperature at least 80° C) and assess the leak again (refer to Figure 1, red oval).
- If the leak <u>cannot</u> be traced to the areas below the gear oil cooler/separating joint, this TSB does not apply. Continue diagnosis of the oil leak without claiming this TSB.
- If the leak can be clearly traced to the area below the gear oil cooler at the separating joint, you must document your findings with photos that clearly show the leak. Keep the documentation photos with the warranty records of the repair.

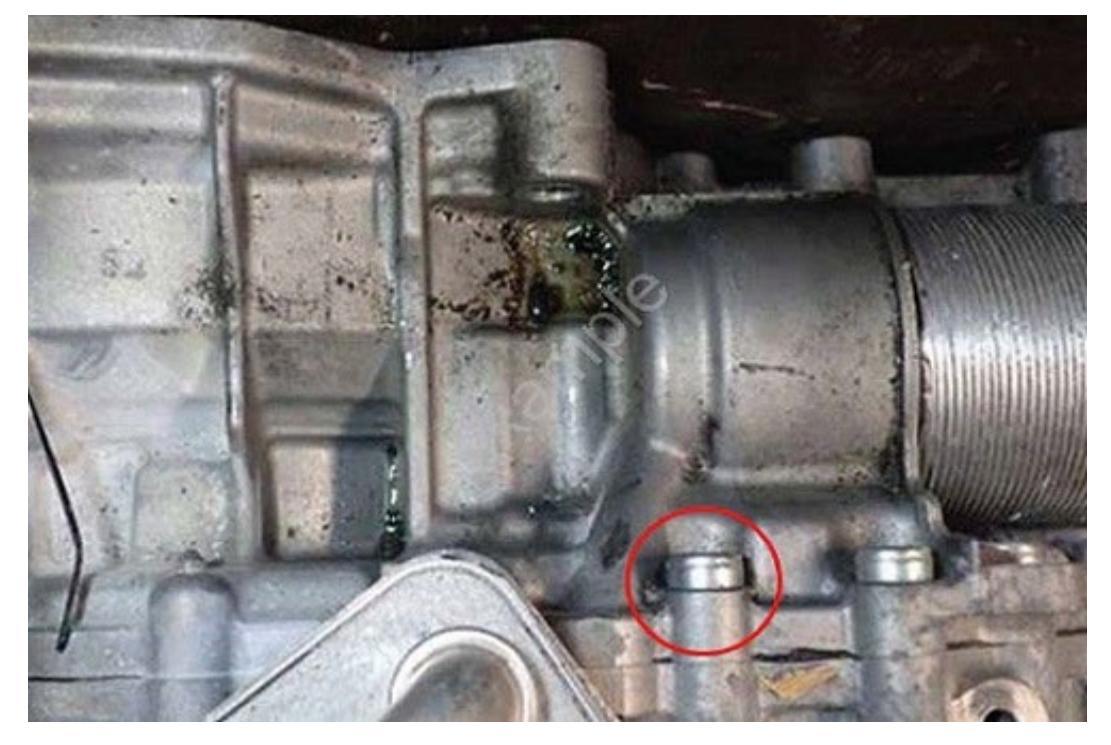
- Audi A3 vehicles: Remove the 12-volt volt battery and battery tray as specified in Workshop Manual. Audi TT models with a 12-volt volt battery mounted in the trunk do not need the battery removed.
- Remove bolt for housing (Figure 2, red circle). Then check if there is a film of oil in the hole (using a mirror and flashlight) and on the threads of the removed bolt.
- If there is <u>no</u> film of oil in the hole and/or on the bolt for housing, the gearbox must be replaced according to the repair manual (Repair option 2 in the Warranty table).

Figure 2. Housing bolt leak.

- If there is a film of oil in the hole and/or on the bolt for housing, replace the bolt with a new bolt for the housing (See Required Parts and Tools table below). Tighten bolt for housing (Figure 3) to a torque of 20 Nm + 90° (Repair option 1 in the Warranty table).
- If necessary: Install battery and battery tray (if previously removed) as specified in Workshop Manual.

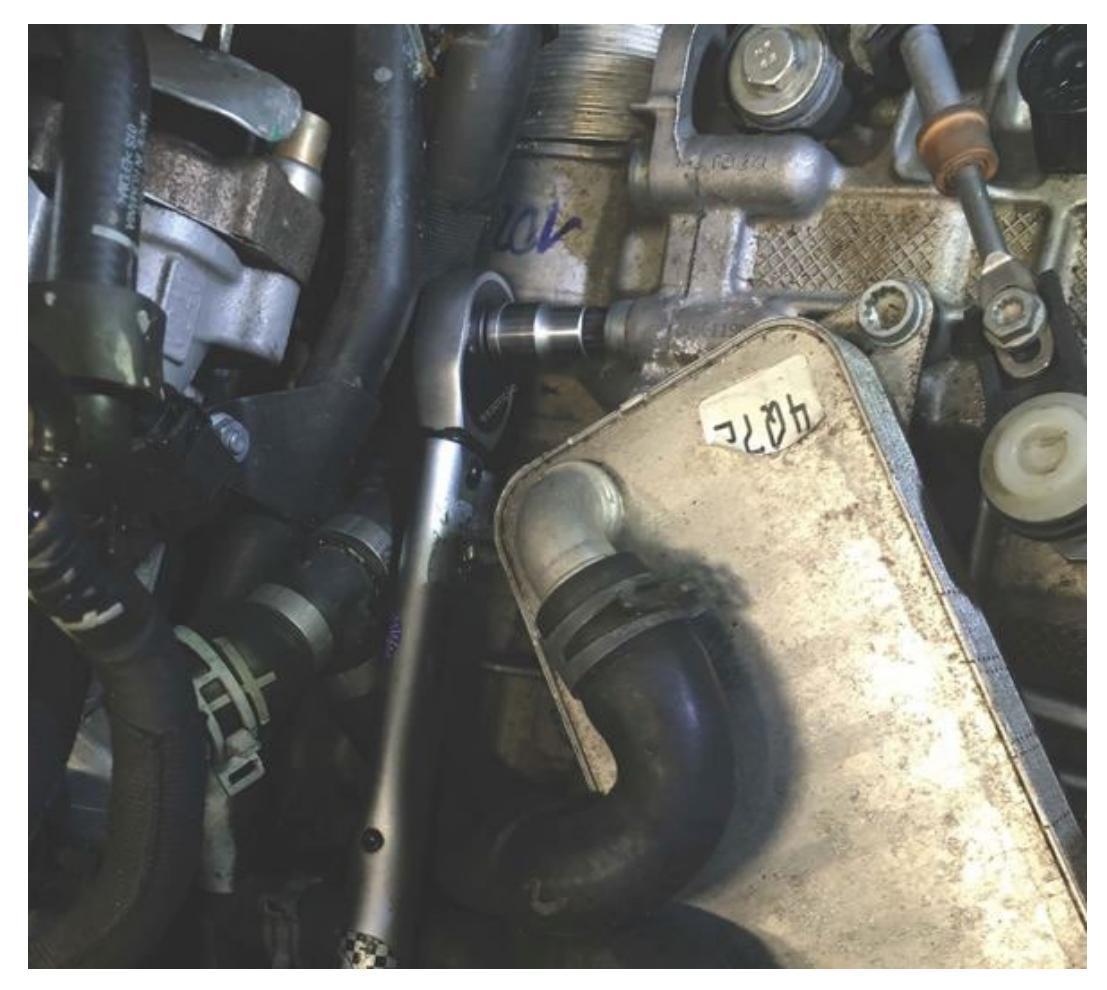
Figure 3. Tightening housing bolt to a torque of 20 Nm + 90°.
