CNG Cylinder Inspection Manual

DSM.0084 Ver. 2.0 October 18, 2022

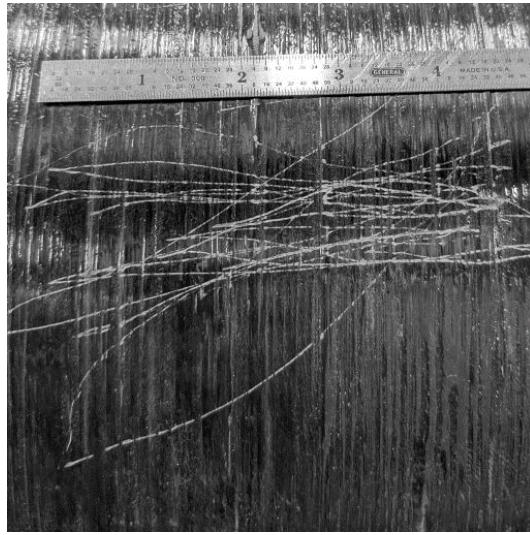
Damage Level	Abrasion Depth		Disposition
	inches	millimeters	
1	0.000 ≤ 0.010-in	0.00 ≤ 0.25 mm	field repair
2a	0.011 ≤ 0.035-in	0.26 ≤ 0.89 mm	field repair
2b	0.036 ≤ 0.050-in	0.90 ≤ 1.27 mm	contact CCTS
3	> 0.050-in	> 1.27 mm	decommission and dispose of cylinder

Figure 3. Surface scratches categorized as Level 1 abrasion damage.

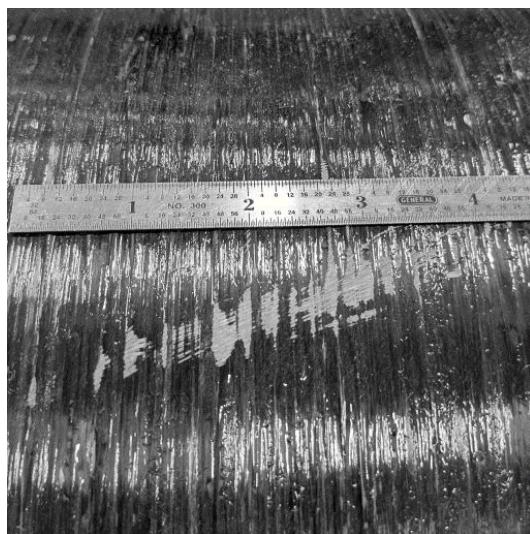
Figure 4. Matte surface texture from Level 2a abrasion damage.

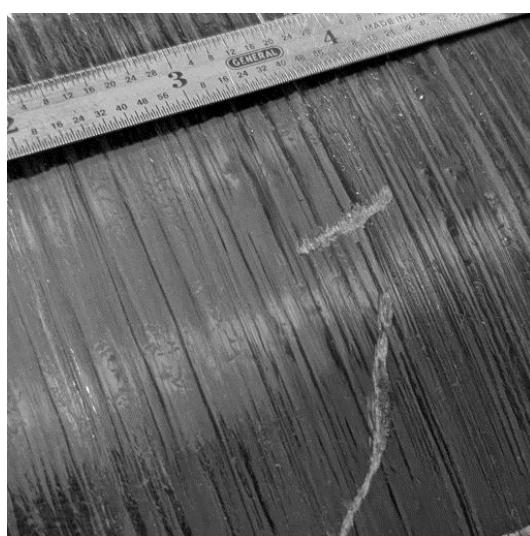
Figure 5. Gouge in the composite categorized as Level 2b abrasion damage.

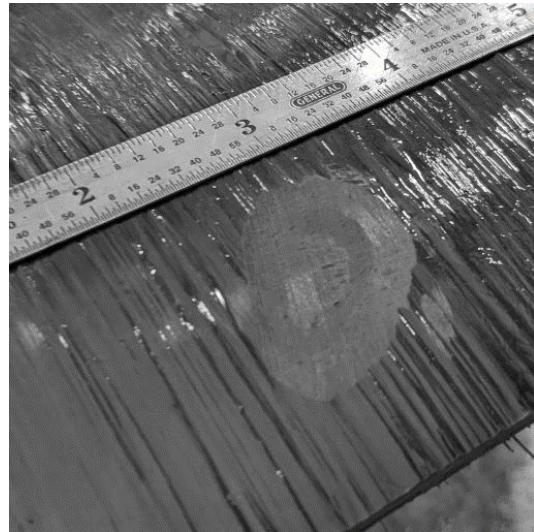
Figure 6. Level 3 abrasion damage where multiple layers of composite are visible.

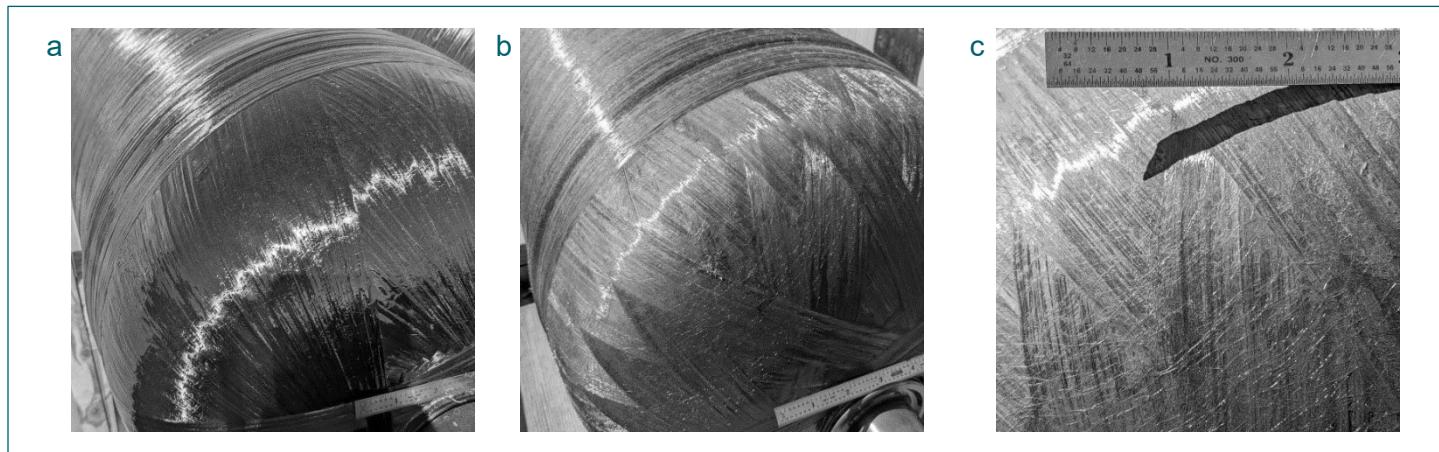
Weathering damage can occur when the cylinder has prolonged exposure to sunlight and weather. Weathering damage is evident by areas of resin degradation (chalking) and loose or broken fibers. **FIGURE 7**

FIGURE 7. a) cylinder not exposed to weathering, b) a weathered cylinder with yellowed resin and loose surface fibers, c) a macro of the weathered cylinder showing the visible fibers.

Contact Hexagon Agility for evaluation of weathering damage.

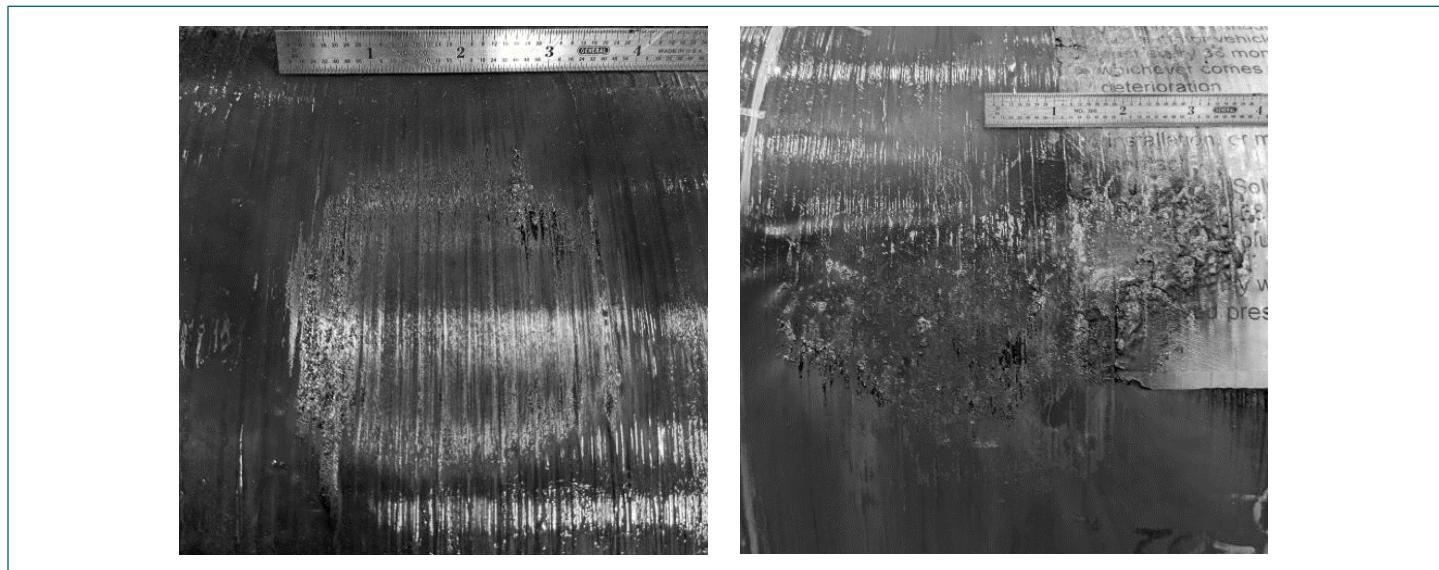
Heat damage may occur if the cylinder is involved in a fire or is near a heat source such as an exhaust system. Evidence of heat damage includes discoloration, charring, soot, melted resin, loose fibers, melted labels, or activation of a T-PRD. **FIGURE 8**

FIGURE 8. Cylinder exposed to excessive heat. *Left:* surface charring, melted resin; *right:* melted label and resin.

Cylinders exhibiting evidence of heat damage must be **decommissioned and disposed of**.

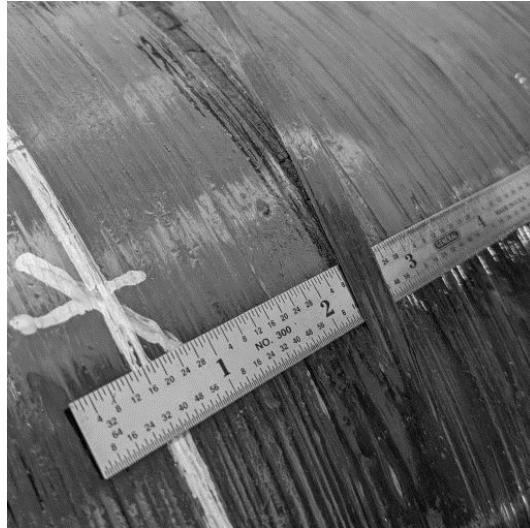
Damage to cylinders can lead to unravelling when broken fiber progressively delaminates from the composite surface. **FIGURE 9**

FIGURE 9. Fiber unraveling with a section of the composite lifted up

If fiber has begun to unravel, cylinder must be decommissioned and disposed of. Refer to [CNG Cylinder Decommissioning and Disposal Manual](#).

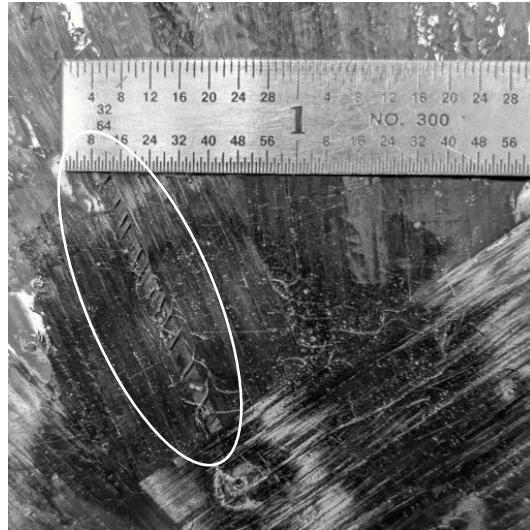
FIGURE 10. Resin crazing on the cylinder composite (circled).

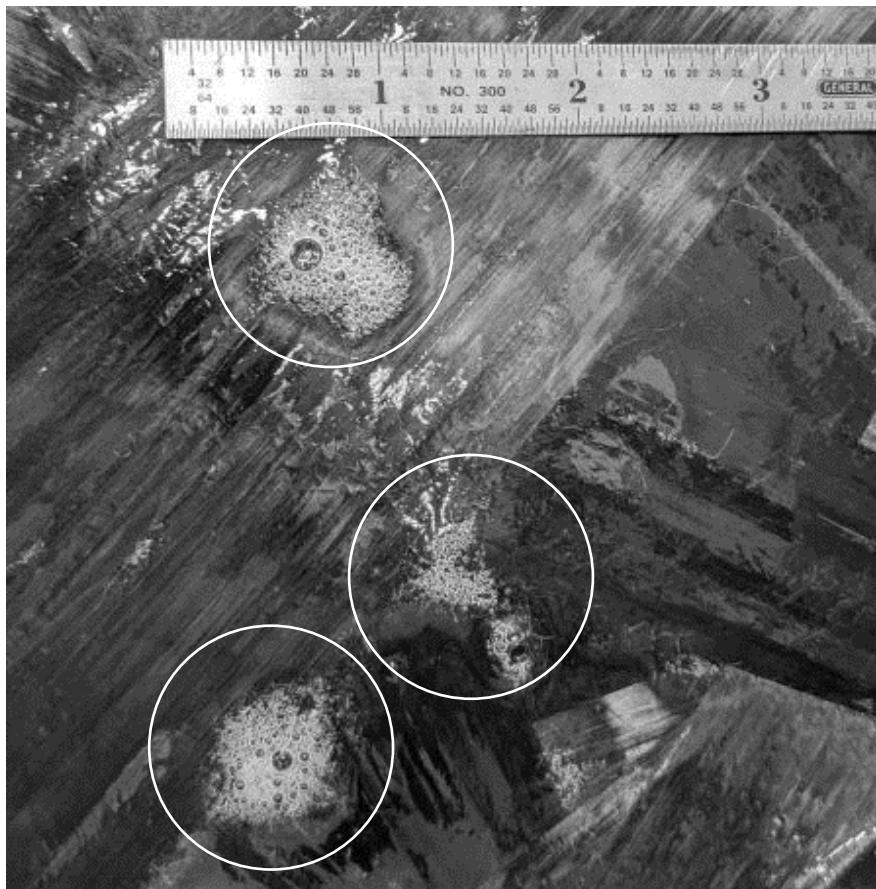
FIGURE 11. Solidified resin bubbles on the cylinder surface (*circled*).

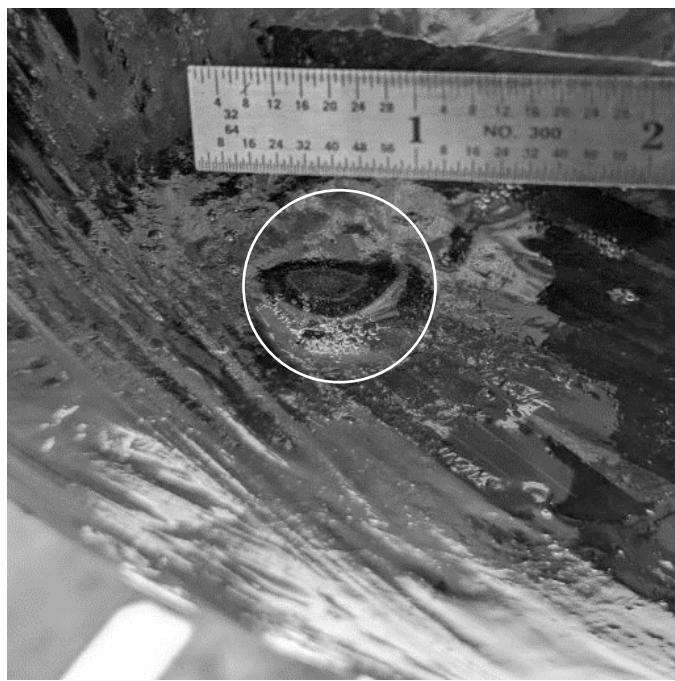
FIGURE 12. Resin run on the cylinder surface (*circled*).

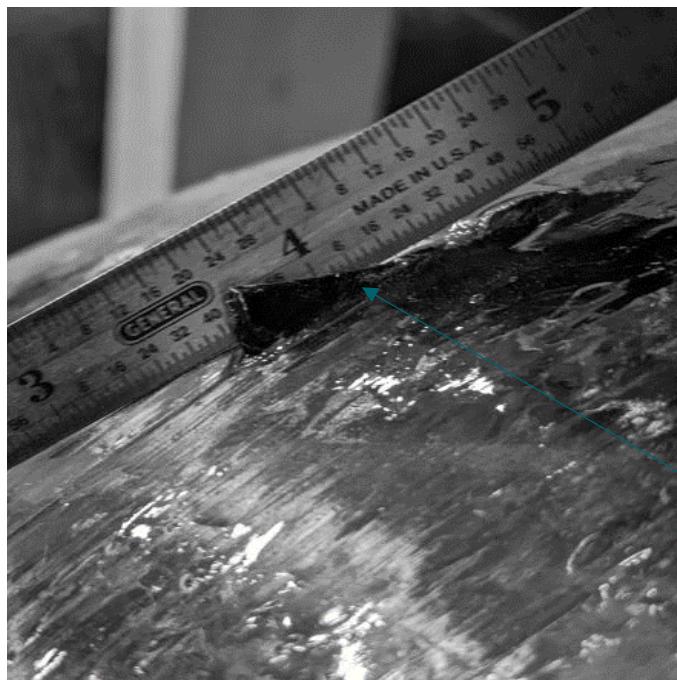
FIGURE 13. Raised fiber on the cylinder surface.

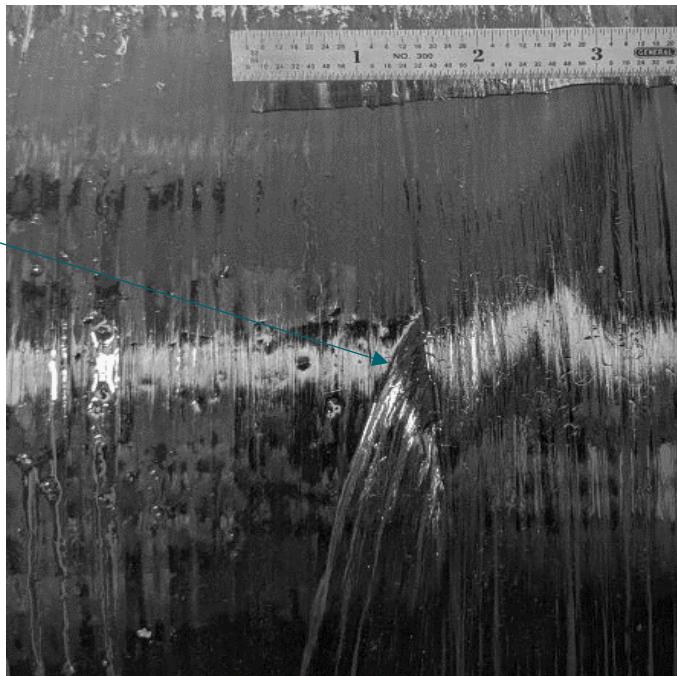
FIGURE 14. Fiber tuck on the cylinder surface.

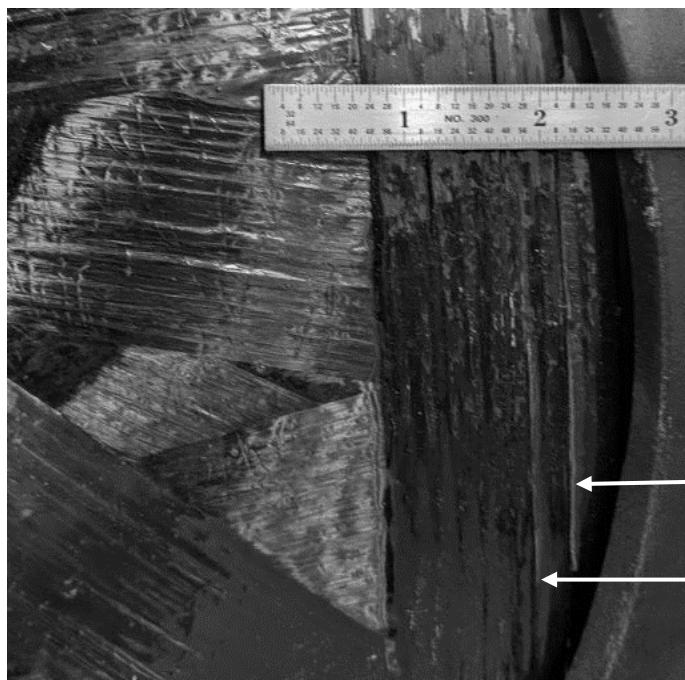
FIGURE 15. Dome end of cylinder displaying gaps in a fiber band (arrows) showing the band underneath.

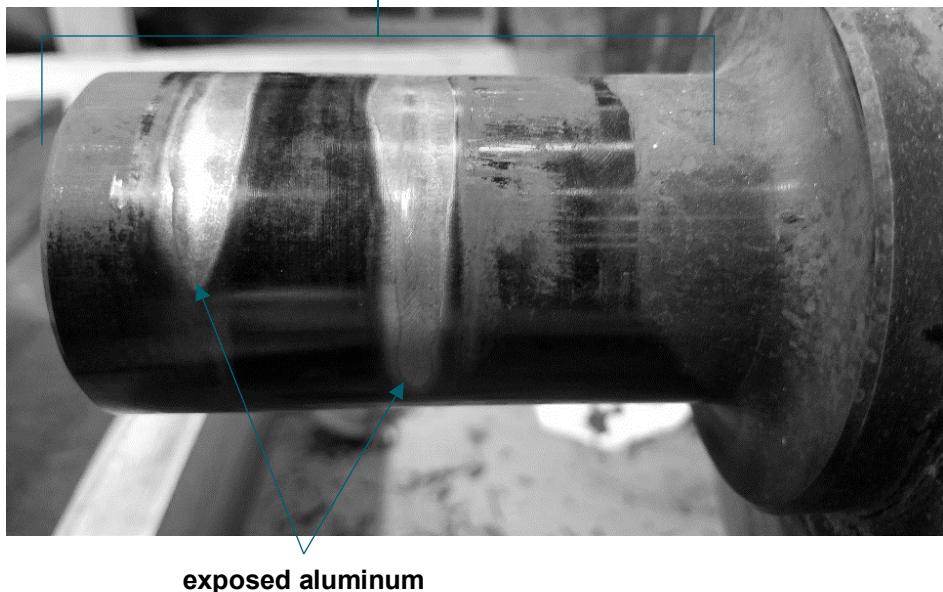
- exposed aluminum **FIGURE 16**
- variation in diameter along the length of the boss **FIGURE 16**
- plastic shavings
- contact between the boss and block.
- a gap between the bushing and boss **FIGURE 17**

check for variation in diameter across boss

FIGURE 16. Indicators of sliding end cylinder boss wear.
