Dealer Service Instructions for:

Revision 1 April 2022

Customer Satisfaction Notification Z09 Driver Side Seat Incorrect Fasteners

2021-2022 (DT) Ram 1500 Pickup

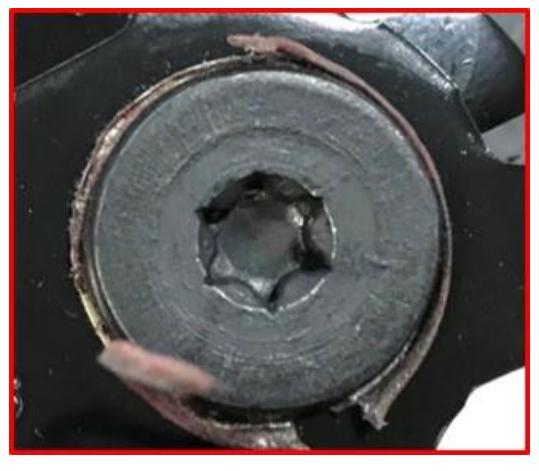
Figure 1 – Incorrect Bolt

- 1. Does the driver's seat side feel loose and/or make noises?
 - YES = Proceed to Step 2 of the Repair Procedure.
 - NO = This CSN has been completed. Claim the Inspect LOP to close the active CSN.
- 2. Adjust Driver's seat height full upwards and full rearward for best visual clearance.
- 3. Verify correct bolt in three locations on seat frame. The use of a flashlight, mirror and/or camera phone will help to inspect the front inboard bolt head due to obstruction from the center console (Figure 1 through Figure 4).

- 5. Raise seat fully.
 - For front outboard, remove seat lower side panel.
 - For rear inboard, access bolt from rear seat.
- 6. Remove incorrect track bolt with a T45 bit.
- 7. Remove threadlocker debris from incorrect bolt. The incorrect bolt can be used to remove debris within the threads by reinstalling and removing multiple times (Figure 5).

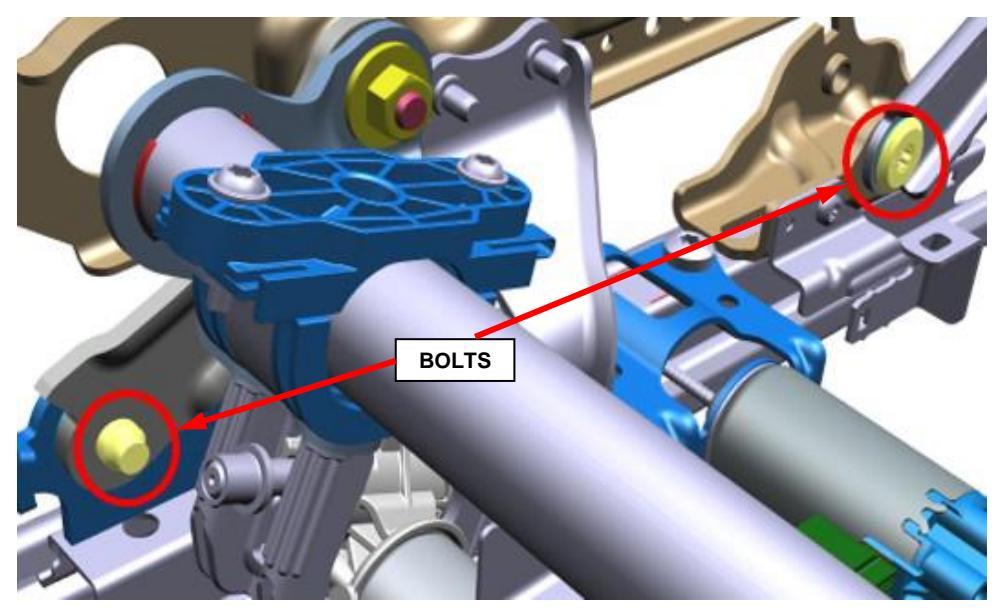
Figure 3 – Bolt Locations

- 4. Are any of these bolts incorrect?
 - YES = Incorrect front outboard or rear inboard bolt proceed to Step 5.
 - YES = Incorrect front inboard (Only) bolt proceed to Step 11.
 - NO = This CSN does not apply. Claim the Inspect LOP to close the CSN.

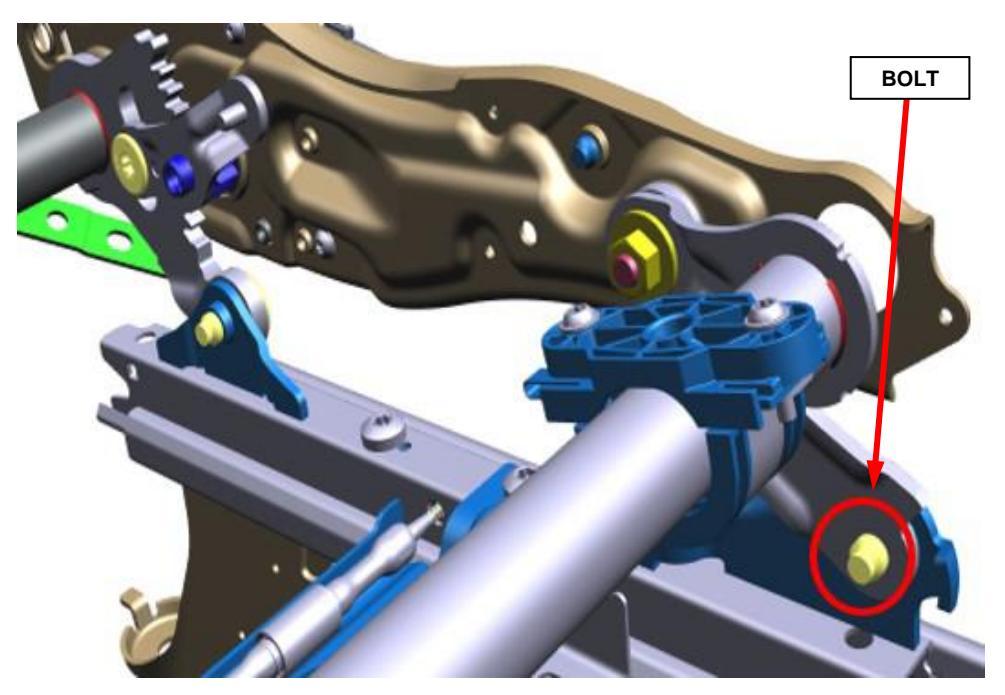
Figure 4 – Bolt Location

NOTE: Only the front outboard bolt may need replacing. The rear outboard bolt is not included in this CSN.
