NUMBER: 02-001-22 REV. A

GROUP: 02 - Front Suspension

Air Suspension Inoperable

2022 (WS) Grand Wagoneer/Wagoneer

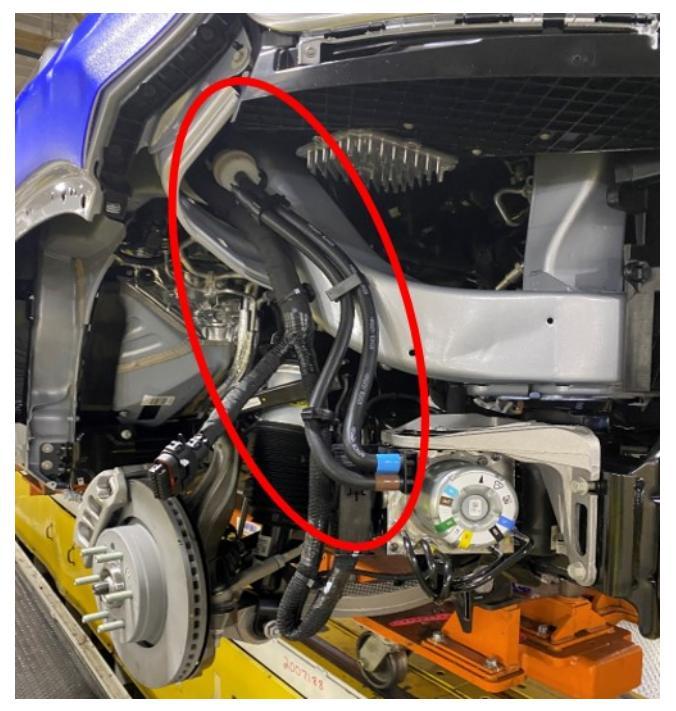
Fig. 1 Vent Hose and (ASCM) Connection

- Electrical connection for the Air Suspension Control Module (ASCM) is not fully seated.
- Vent hose inlet/outlet for air compressor for being properly connected (Fig. 1).

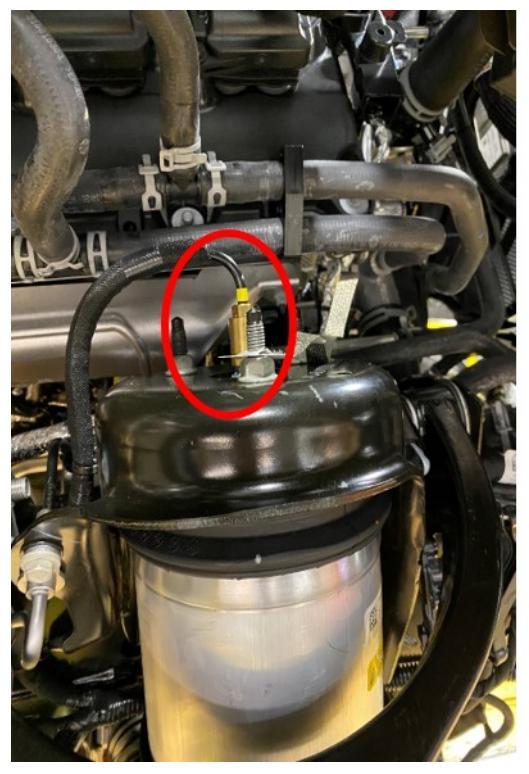
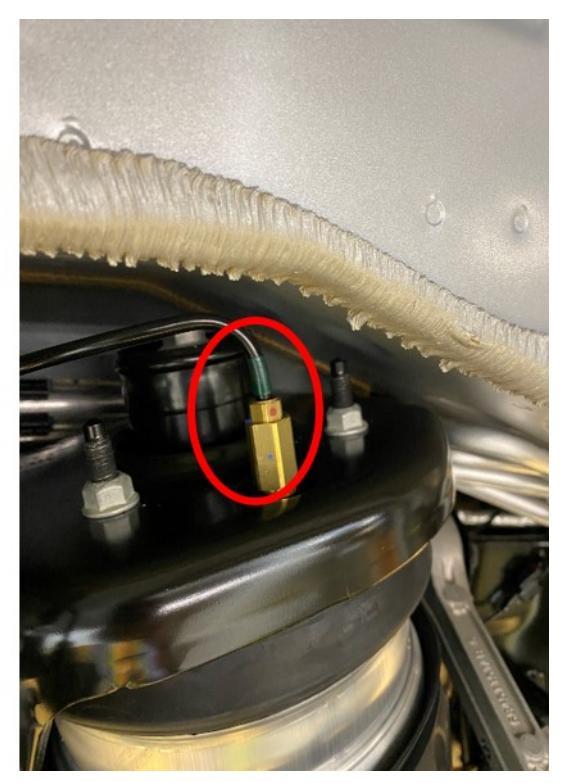
Fig. 2 Air Lines Not Fully Seated

• Air lines not fully seated either front or rear suspension (Fig. 2) .

- 8. Inspect and if necessary reconnect the front air suspension electrical connectors at the front ride height sensors (both sides) (Fig. 3).
- 9. Inspect and if necessary properly reconnect the front air suspension lines to the suspension air bag (both sides) (Fig. 2) .
- NOTE: Air line should be inserted up to the tape, allowable up to 1 mm clearance.
- 10. Inspect and if necessary reconnect the front air suspension linkage rods at the front ride height sensors (both sides).

NOTE: Air line should be inserted up to the tape, allowable up to 1 mm clearance.

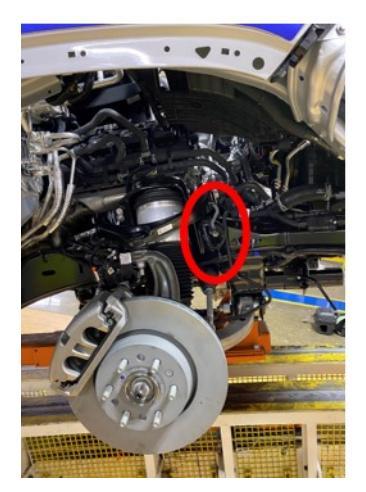
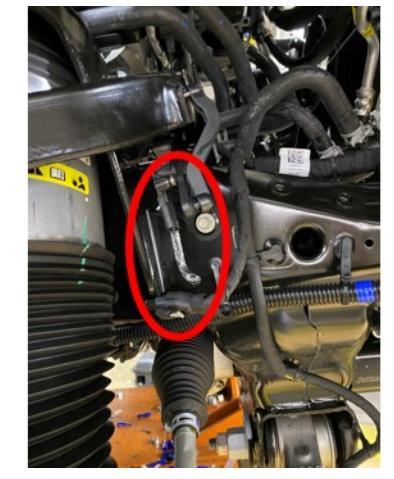
Fig. 3 Front Electrical Connector

• Front or rear ride height sensor not connected to the control arm (Fig. 3) or (Fig. 4).

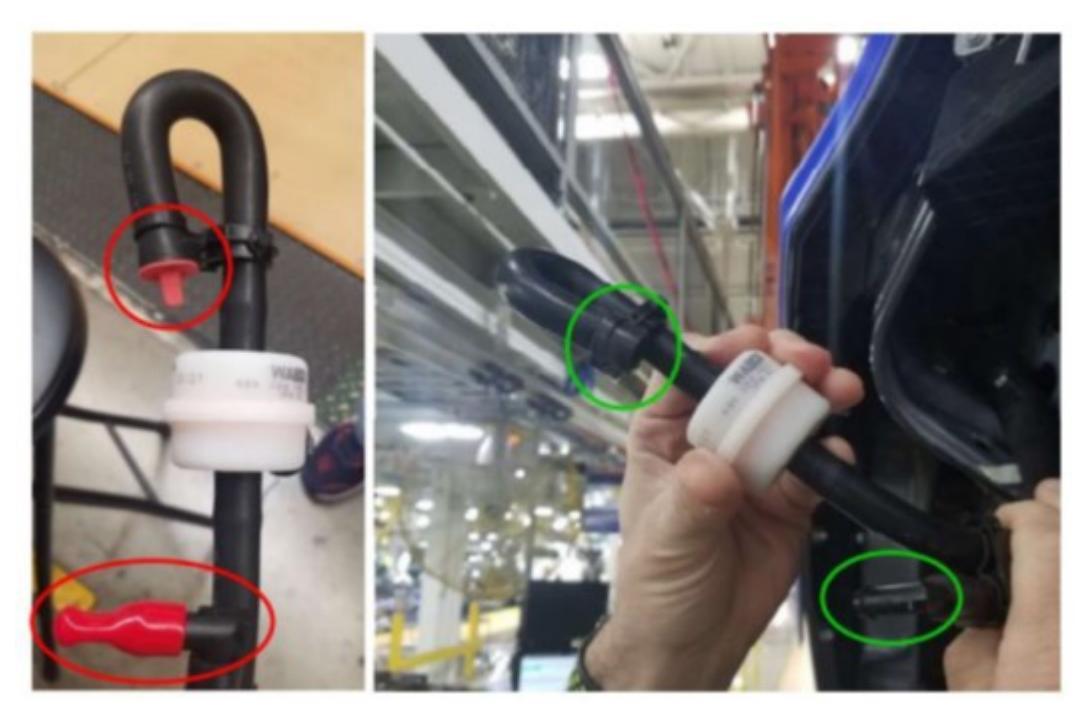
Fig. 5 Shipping Caps Left On Hose

• Shipping caps not removed from vent hose (Fig. 5) .

- 7. Inspect and if necessary remove the red caps (Fig. 5) from the hose and reconnect the front vent hose and electrical connector to the ASCM (Fig. 6).

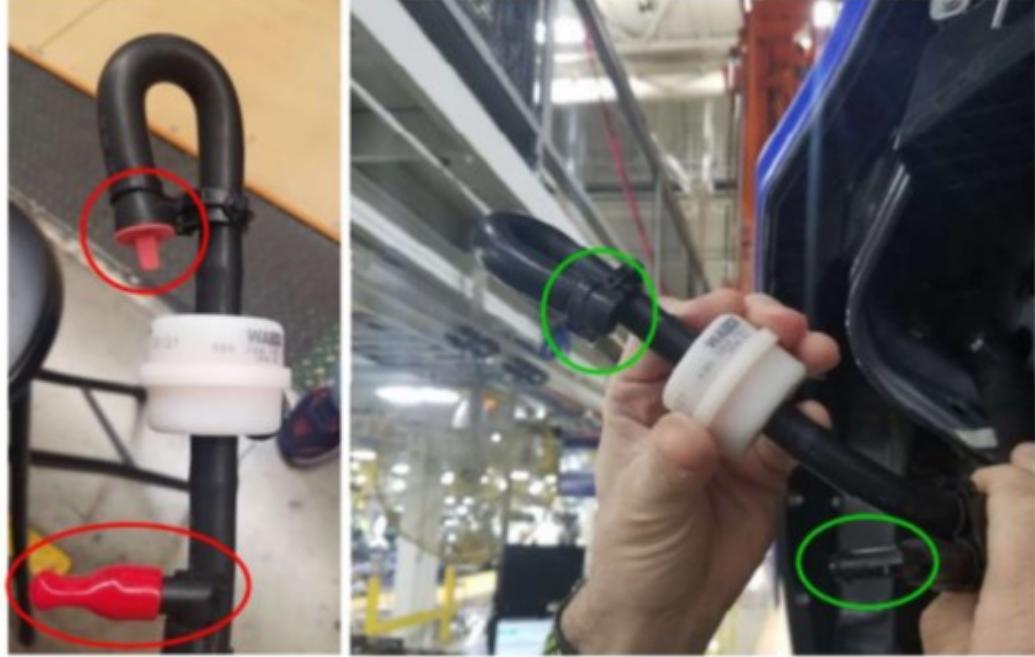
Fig. 7 Shipping Caps Left On Hose

*The customer may notice a "Service Air Suspension" message in the cluster or the air ride suspension is inoperable. Upon further investigation a technician may find the following DTC is set:

• C15AE-00 - Compressor Pressure Line Leak-.
