173/21 ENU 1950

# Warning Message "Coolant Temperature Too High": Checking Coolant Pump and Change-Over Valve (173/21)

Model Line: Panamera (971)

Concerns: Change-over valve for coolant pump

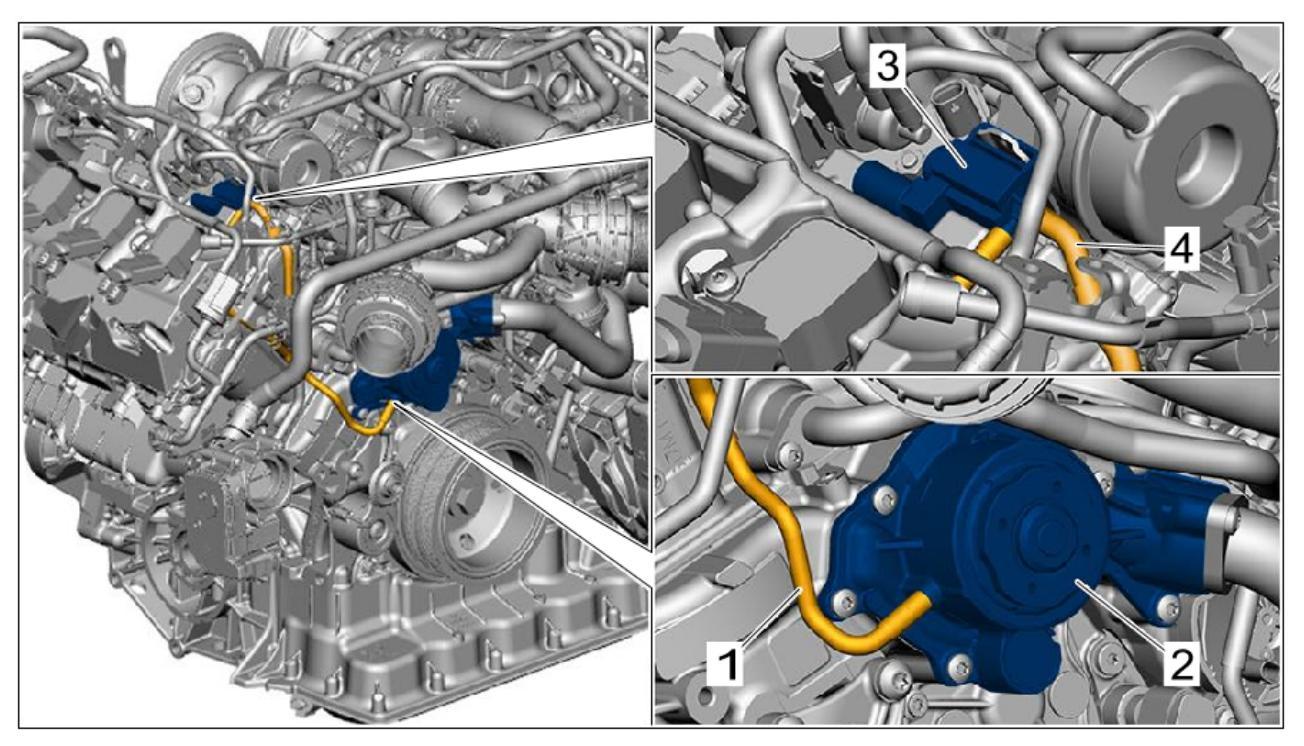
- 1 Pull vacuum hose  $\Rightarrow$  *Position of change-over valve and coolant pump*-**1** off the coolant pump  $\Rightarrow$  *Position of change-over valve and coolant pump*-**2**-.
- 2 Pull off vacuum hose  $\Rightarrow$  Position of change-over valve and coolant pump -4- from the control valve  $\Rightarrow$  Position of change-over valve and coolant pump -3-.
- 3 VAS 6213 Hand vacuum pump must be  $\Rightarrow$  Position of change-over value and coolant pump -3connected to the change-over value  $\Rightarrow$  Position of change-over value and coolant pump -4- on the vacuum hose connection. Then build up vacuum.

Stop the test procedure if a vacuum cannot be built up. In this case, the change-over valve is faulty and must be replaced. Continue with Step 5. If a vacuum can be built up, continue with Step 4.

- 4.2 Select the **Drive links/checks** menu.
- 4.3 Select **Drive links** and press F12<sup>"</sup> Next to confirm.
- 4.4 Select 'Activation of vacuum switchover valve for main coolant pump' and press•F8" to start.
  - If the vacuum in the vacuum pump display changes, the change-over valve ⇒ *Position* of change-over valve and coolant pump -3- is intact. Continue with Step 4. In this case, only ⇒ *Position of change-over valve and coolant pump* -2- replace the coolant pump if it is faulty.
  - If the vacuum in the vacuum pump display does not change, the change-over valve ⇒ Position of change-over valve and coolant pump -3- and the coolant pump ⇒ Position of change-over valve and coolant pump -2- must be replaced, if necessary, if the coolant pump is ⇒ Position of change-over valve and coolant pump -2- also faulty.

- 5 VAS 6213 Hand vacuum pump must now be disconnected from the vacuum hose ⇒ *Position of change-over valve and coolant pump* -1-.
- 6 Install vacuum hose  $\Rightarrow$  *Position of change-over valve and coolant pump*-1- on coolant pump  $\Rightarrow$  *Position of change-over valve and coolant pump*-2-.
