HYUNDAI Technical Service Bulletin

GROUP BODY	NUMBER 23-BD-002H
DATE JANUARY, 2023	MODEL(S) ALL

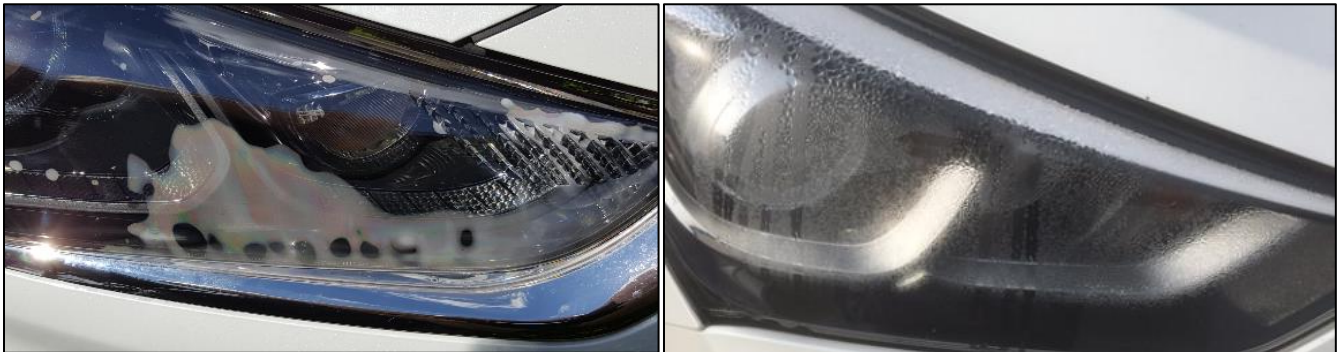
Applicable Vehicles: All

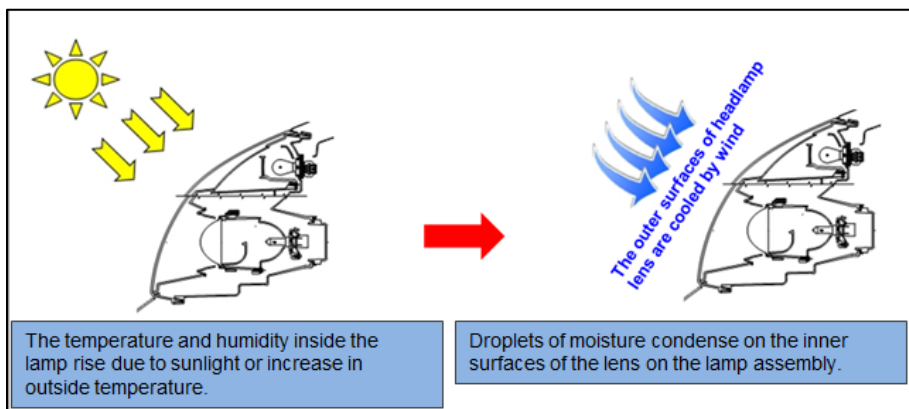
2. Condensation from Engine Startup

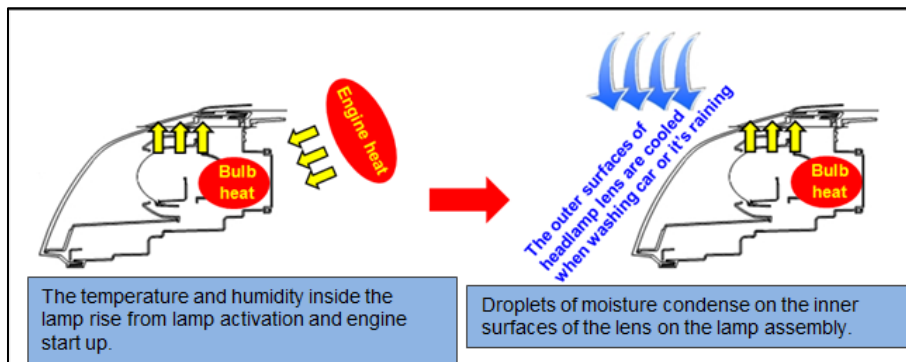
The amount and location of condensation will vary based on environmental factors and vehicle usage conditions (lamp usage, driving time and/or distance, etc.).

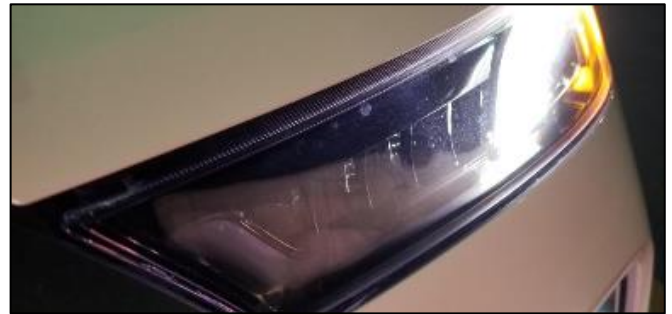
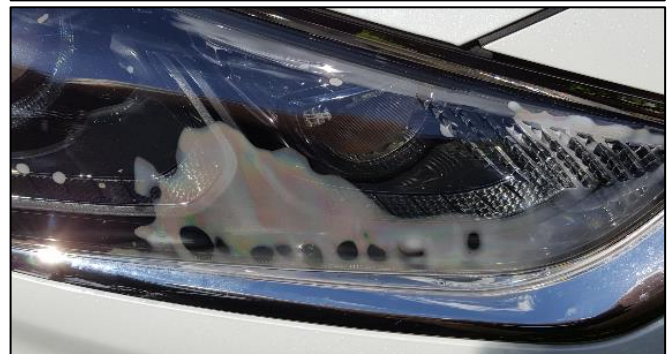
Normal condensation in the headlamp

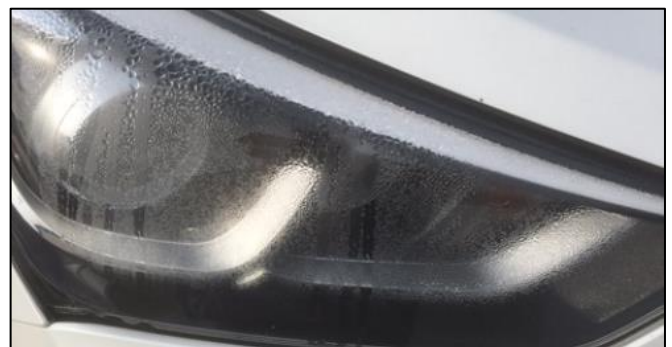
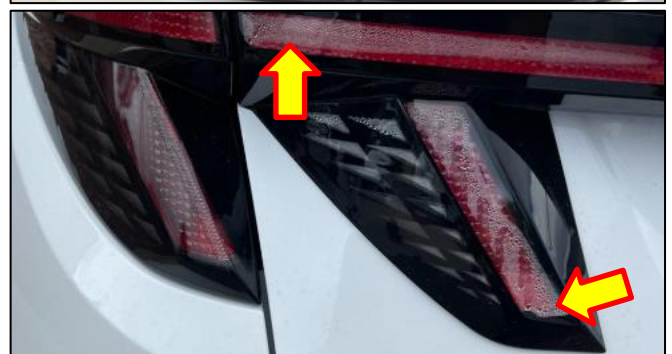
Water collecting inside the lamp assembly

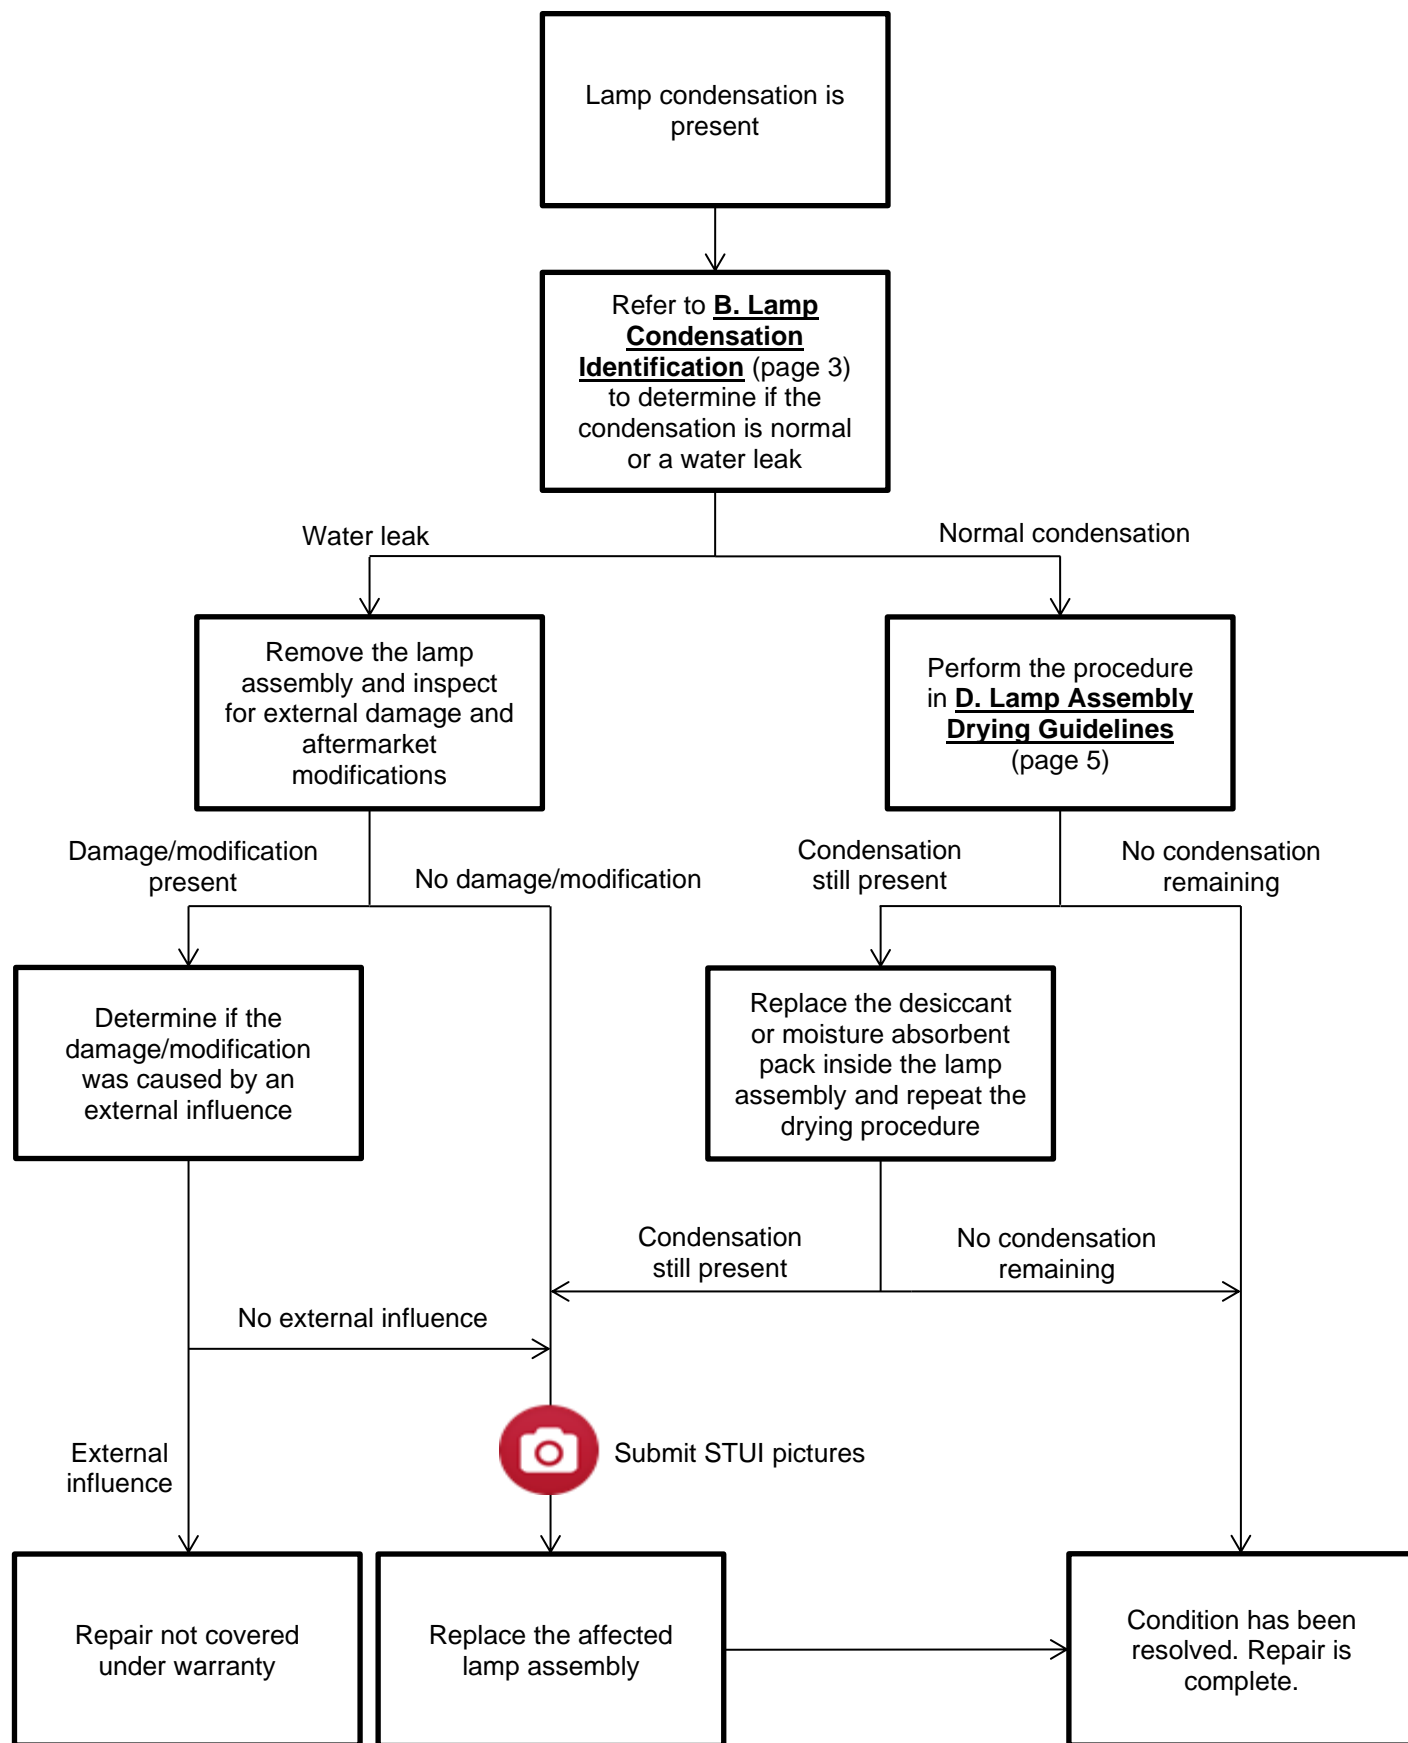
D. Lamp Assembly Drying Guidelines

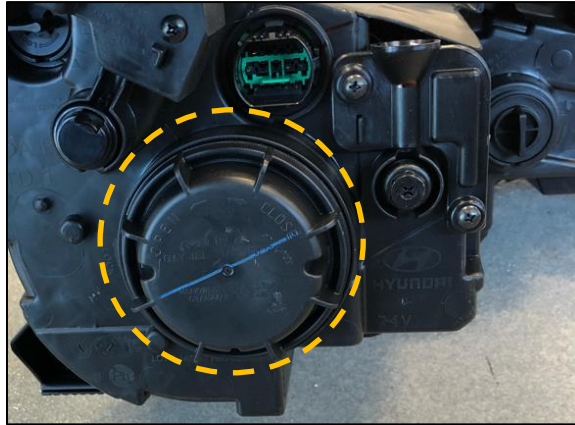
Example location of the dust cap
