Technical Service Bulletin

CVT BELT CHECK - SERVICE MANUAL REVISION

TSB-23-23-001

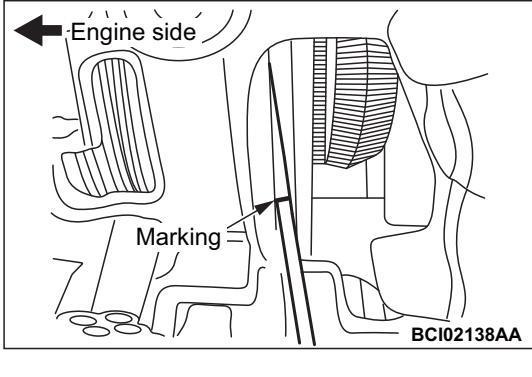
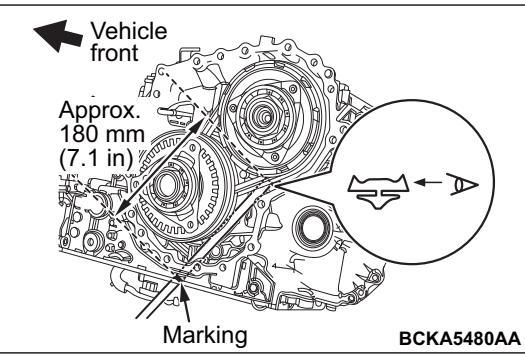
<ok samples>

No damage is observed on flanks (grooved surfaces) of belt elements.

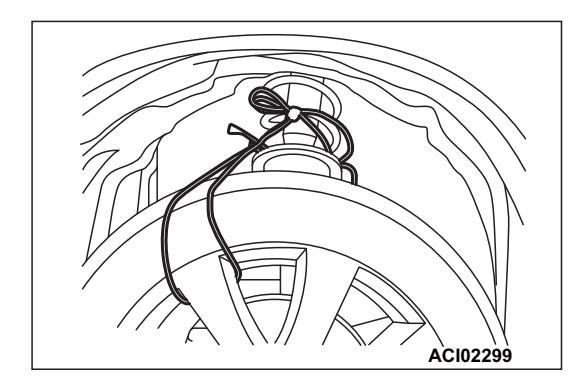
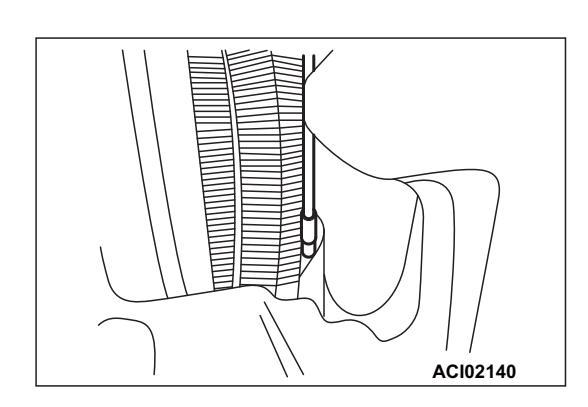
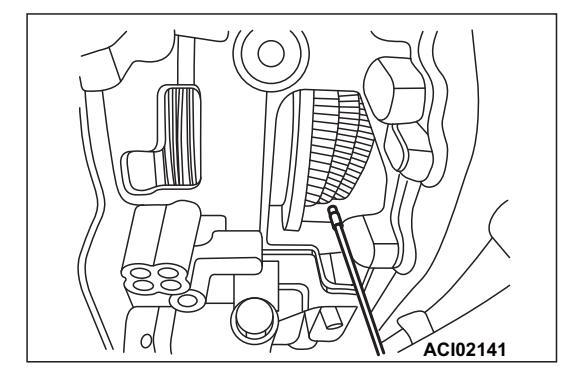
<DAMAGE SAMPLES>

Damages to grooves are observed on flanks of belt elements.

8. Refer to the OK samples and the damage samples below to determine the condition of the flanks (grooved surfaces) of belt elements. When a damage is found on the flanks of the belt elements, replace the CVT assembly (Refer to GROUP 23A - Transaxle assembly).
