QUALITY ACTION

CAMPAIGN BULLETIN

Front Bumper/Headlamp Dealer Inventory

Reference: P2A21 Date: January 31, 2023

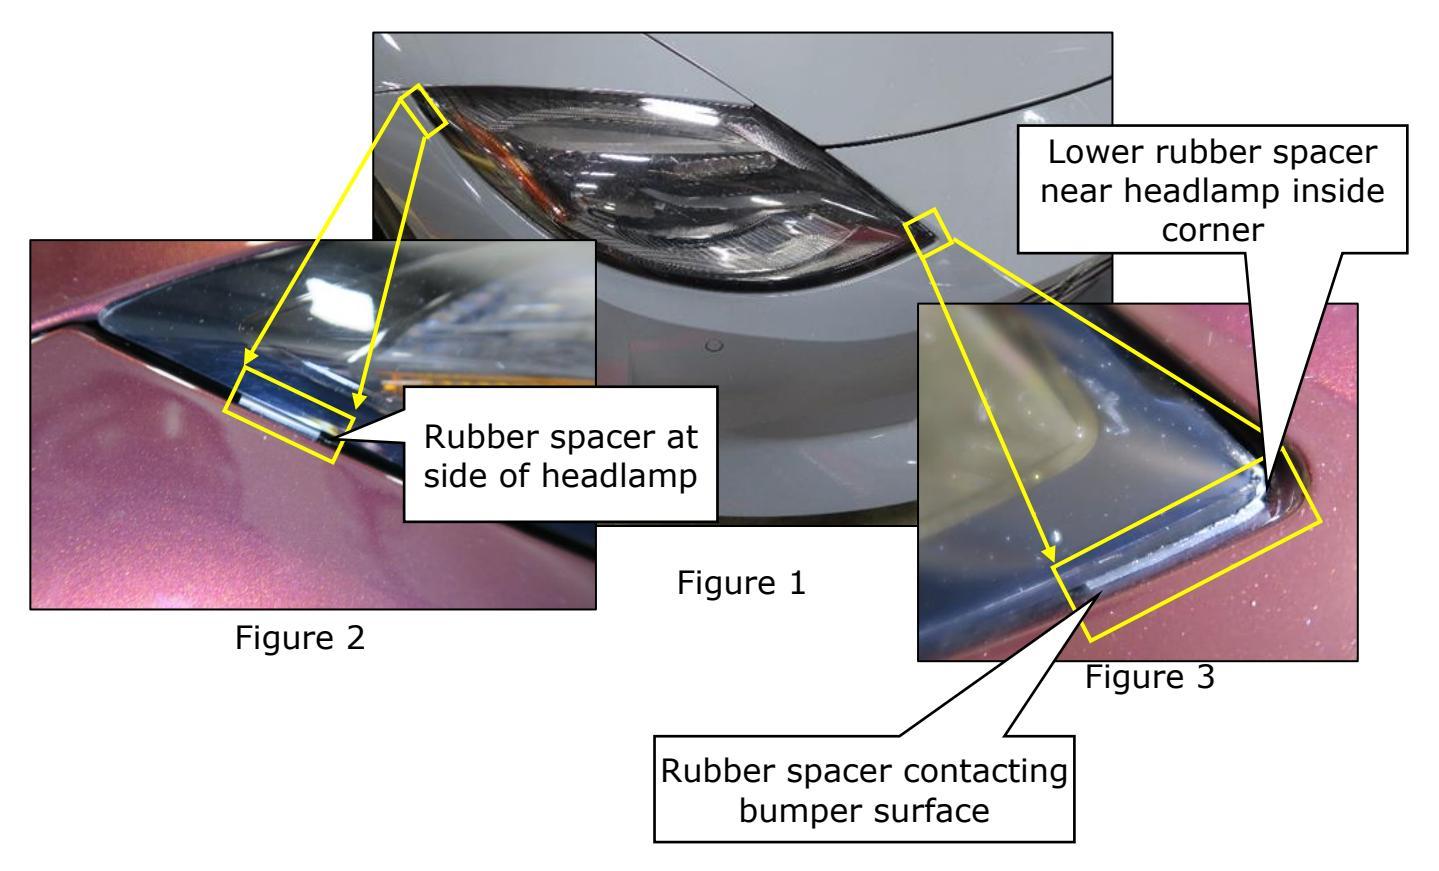
- 1. Inspect for the presence of the side rubber spacers and the position of the lower rubber spacers in the areas shown in Figure 1.
 - The side rubber spacer should be visible between the headlamp and front bumper in the area location shown in Figure 2
 - The lower rubber spacer should be positioned near the inside corner of the headlamp and MUST be contacting the front bumper surface as shown in Figure 3

- If Rubber spacers are present AND in the correct location, continue to Step 2 for clearance check.
- If the Rubber spacers are <u>NOT</u> present OR are in the incorrect location, skip to Step 3 for paint inspection, then continue to Step 4 for spacer installation.

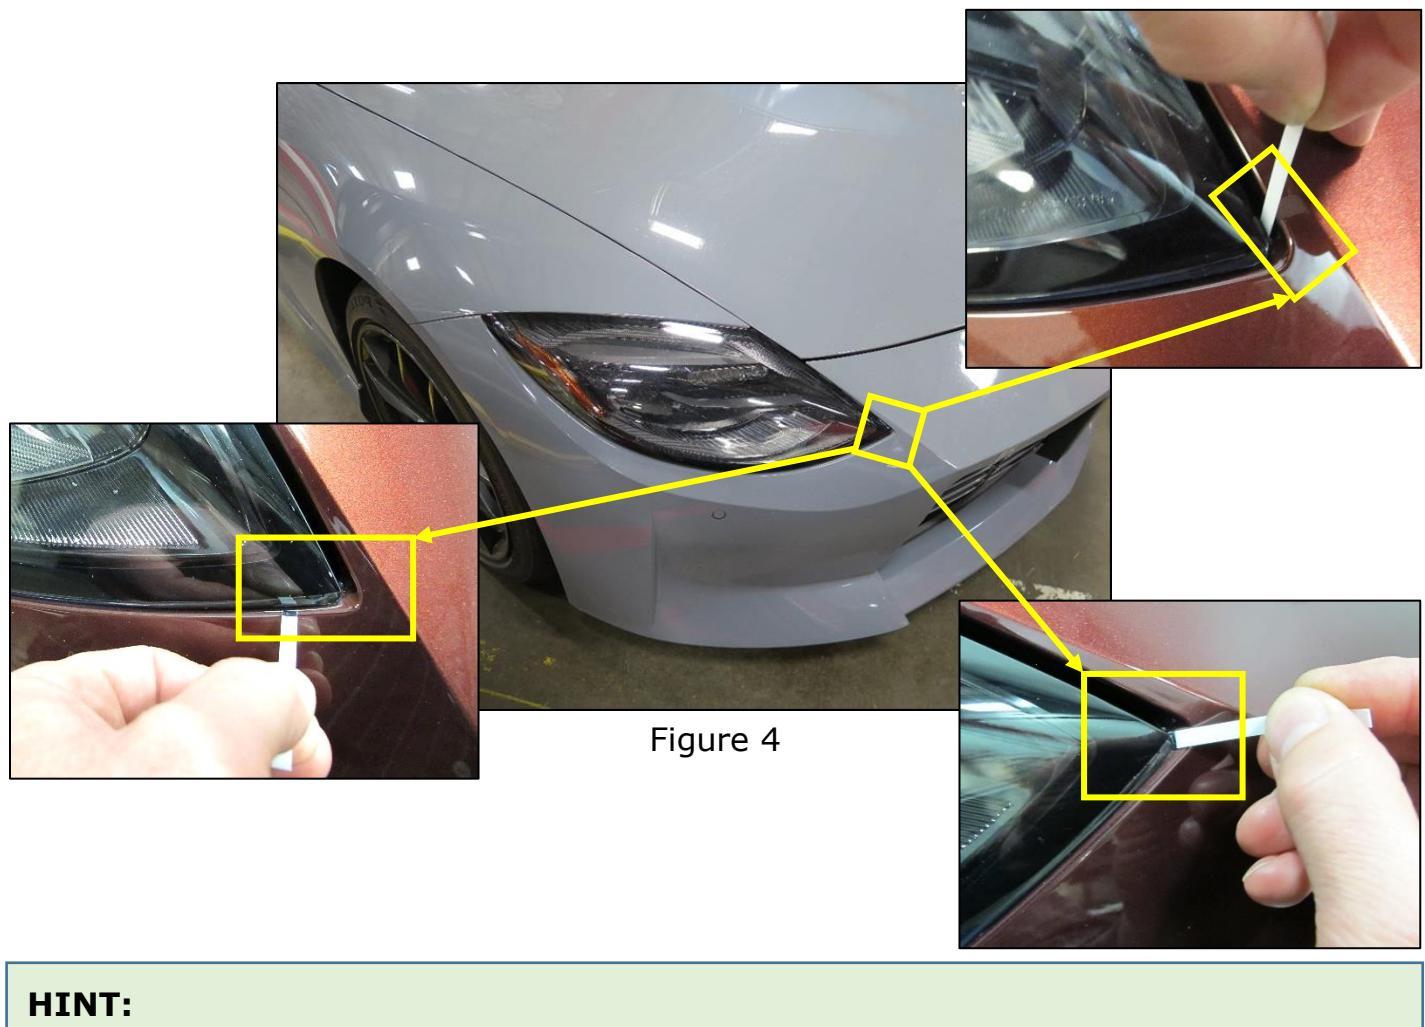
- 2. Using a 0.5mm (0.020") white plastic gap gauge from the parts kit, check the clearance between the headlamp and the front bumper in the areas shown in
 - Tool should easily slide between front bumper and headlamp

In some cases the rubber spacer may prevent the gap gauge from entering between the bumper and headlamp. This condition is normal and the spacer should **<u>NOT</u>** be replaced for this condition.

When checking the lower corner gaps, the gap tool should slide under the headlight far enough to no longer see the black edge.

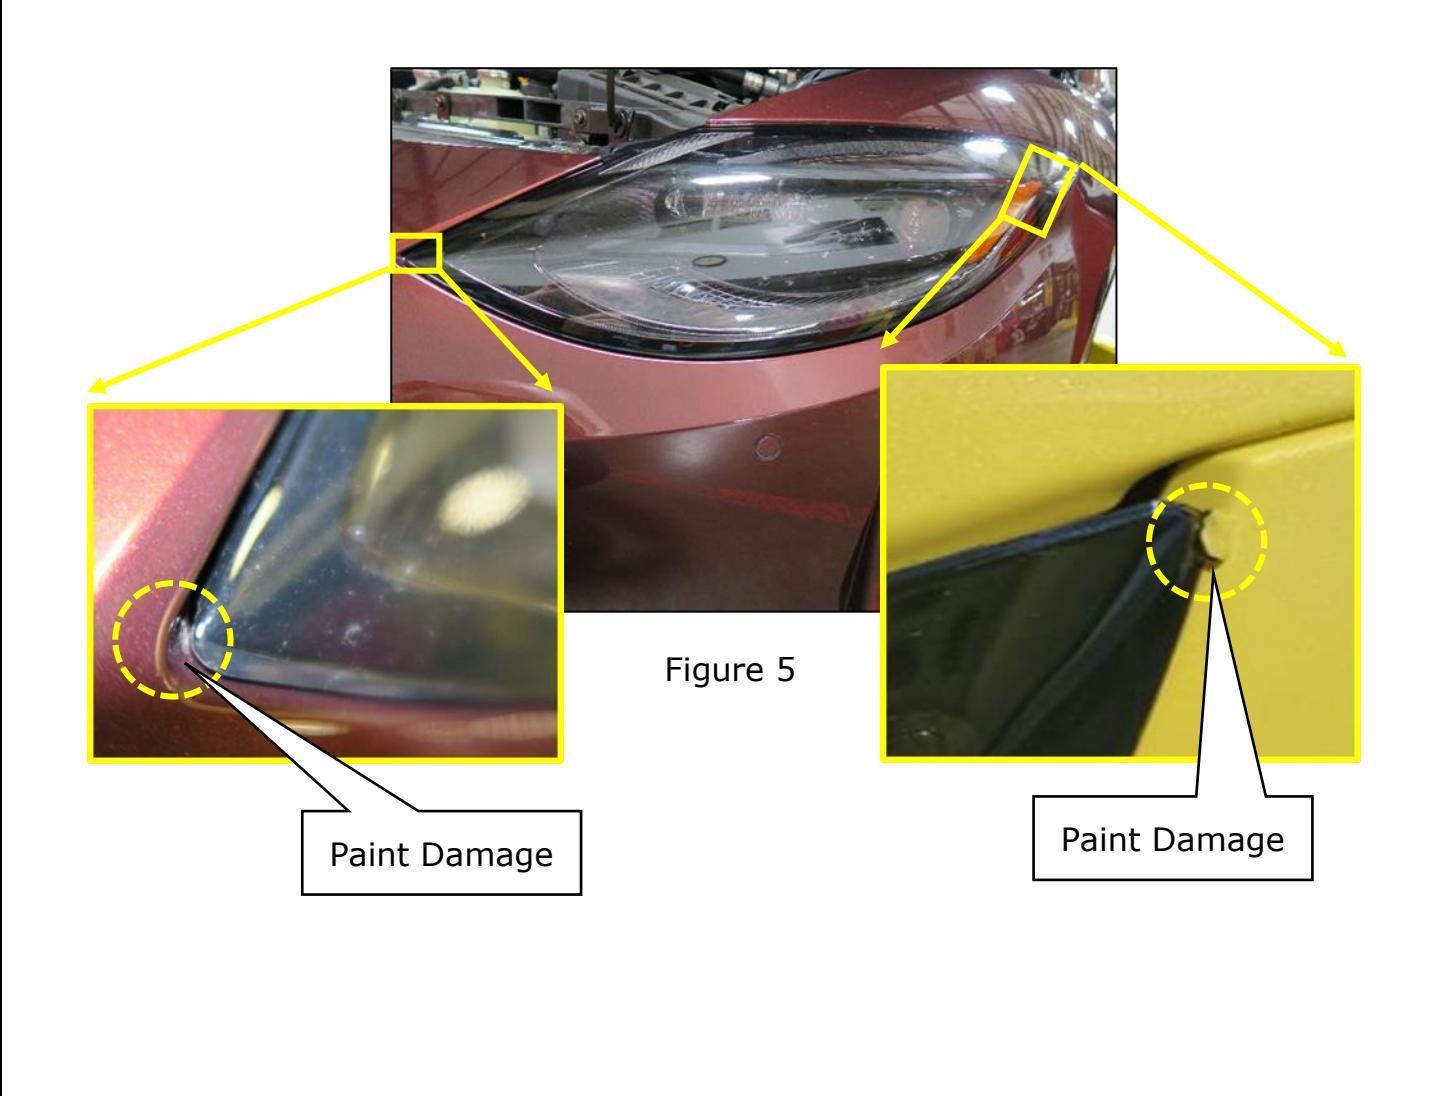
- 3. Visually inspect the corners of the front bumper for paint damage. (Examples of damage shown in Figure 5)
 - If Steps 1, 2 AND 3 inspections are OK, no further action is needed, the procedure is complete. Submit claim using OP Code P2A210.
 - If ANY of the inspections from Steps 1-3 are found NG, proceed to Step 4 for repairs.

YES - If the front bumper has paint damage in the area inspected in **Step 3**, perform the necessary paint repairs before continuing with **Step 24**.

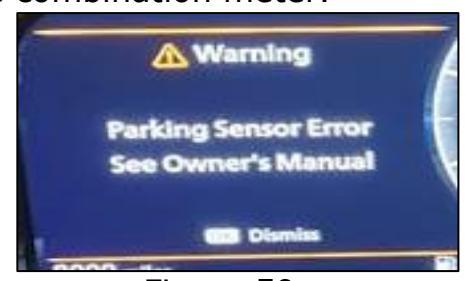
- Verify there are NO parking (sonar) sensor errors are present in the combination meter (gauge cluster)
 - If NO errors are present,
 - Turn the engine off
 - $\circ~$ If an error similar to the one shown in Figure 50 is present, verify the connectors behind the RH front fender liner are connected and locked
 - If both connectors are connected and locked, remove the front bumper and locate the sonar sensor connector that is not connected or not fully seated
