## Service Bulletin

## Subject: Radio Software Version Y167 – Multiple Updates for IOK

This Service Bulletin is replacing PIT5976. Please discard all previous copies of PIT5976.

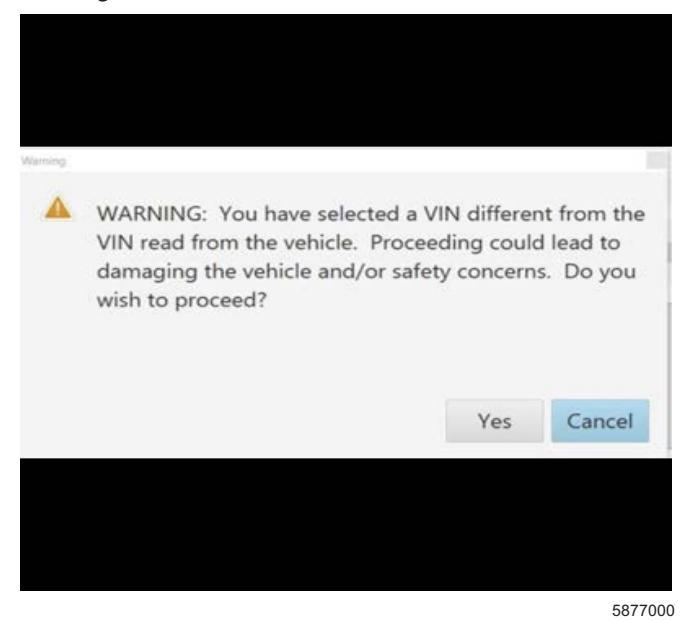
**Important:** If the vehicle VIN DOES NOT match, the message below will be shown
