Technical Service Bulletin

GROUP CAMPAIGN	NUMBER 23-01-019H
DATE MARCH 2023	MODEL(S) VENUE (QX)

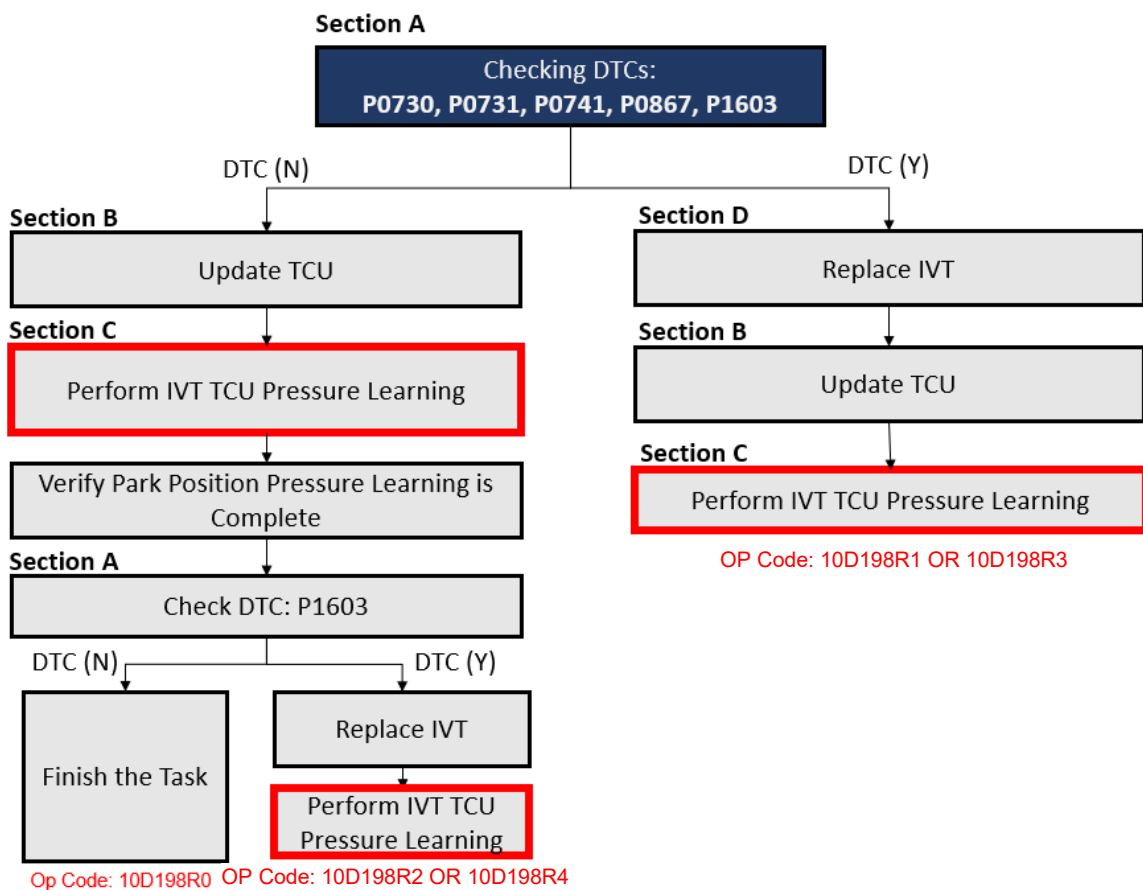
1. Refer to the flowchart below to update the procedure.

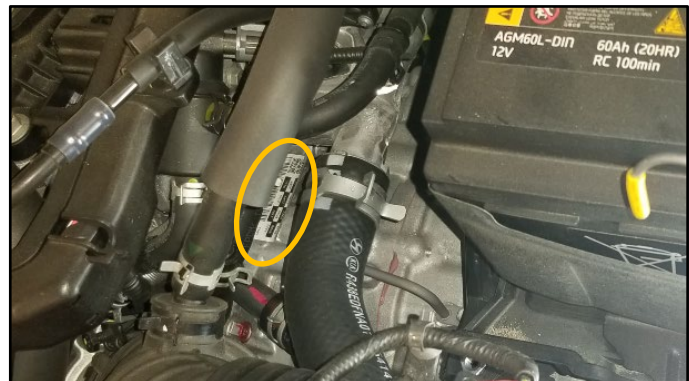
2. Perform the TCU adaptive values learning procedure.

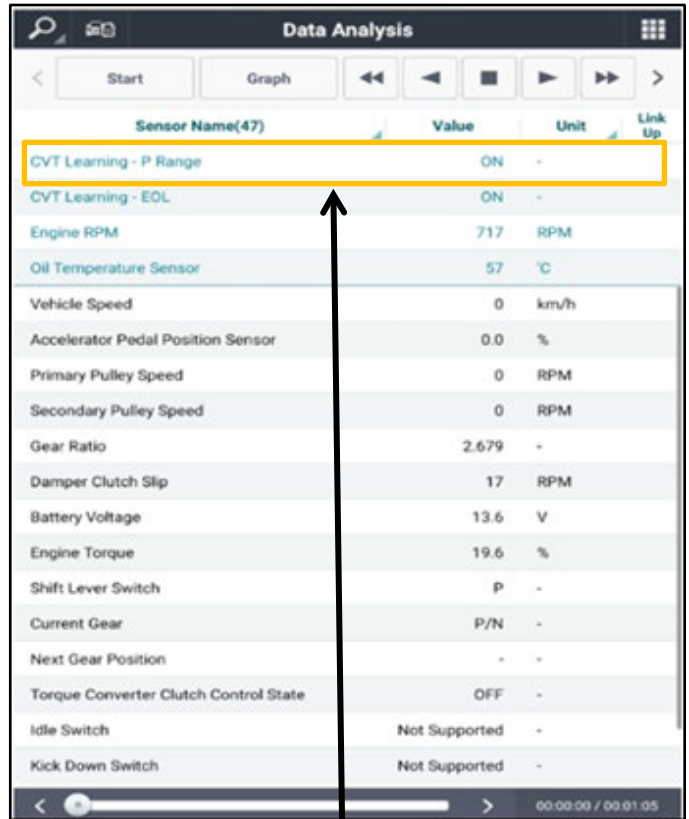
i Information
 Learning completion can be confirmed by using GDS-M to verify the IVT (“CVT”) P-Range learning value is “ON”. (“OFF” learning has not been completed)

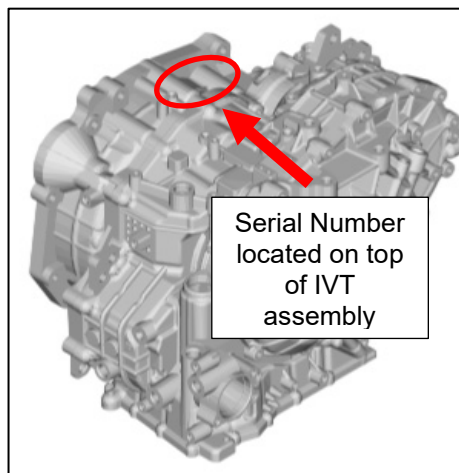
- If IVT replacement is performed, refer to **Section C** for IVT, TCU Learning.
