WRINKLES ON LEATHER SEAT SURFACE OF NEW (UNSOLD) VEHICLE

Bulletin No.: 09-007/23

Last Issued : 06/01/2023

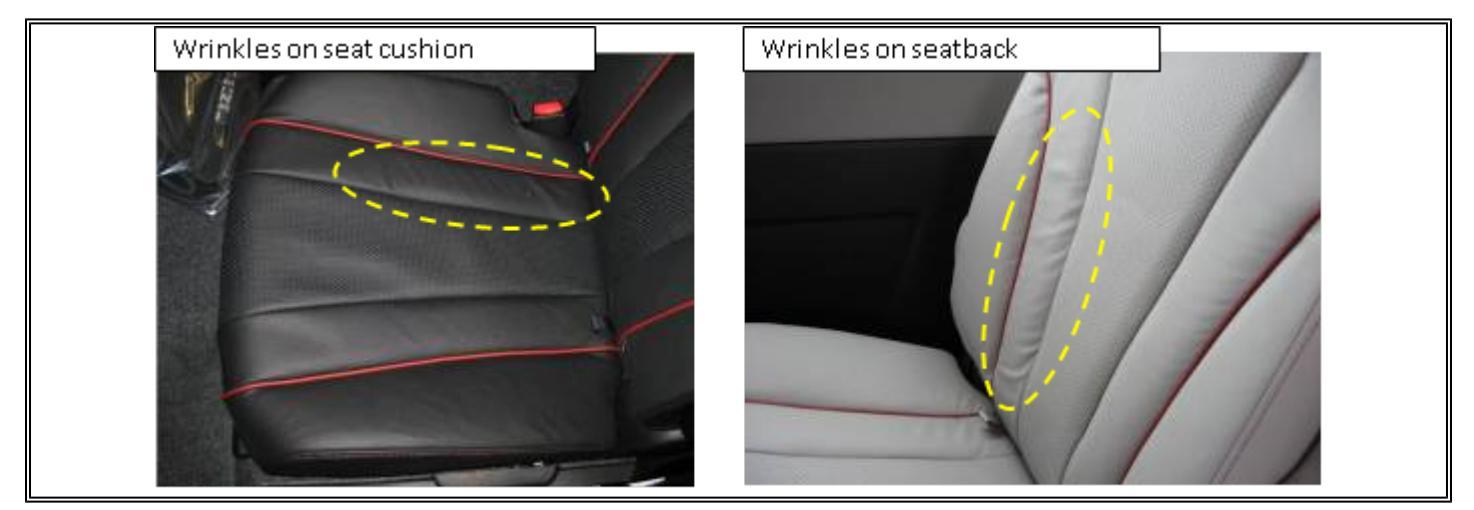
At PDI or when new vehicle is delivered, some customers may complain about wrinkles on the leather seat cushion and/or seat back surface.

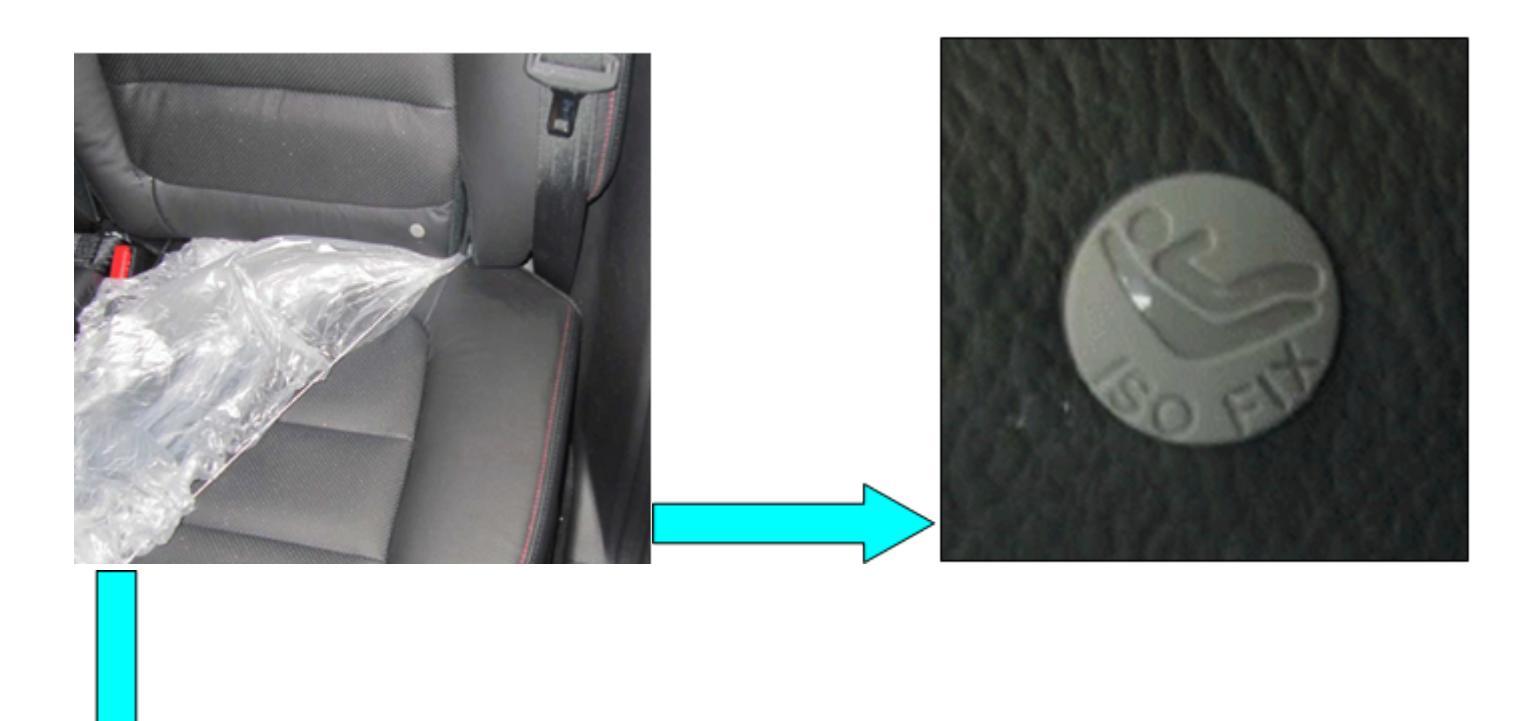
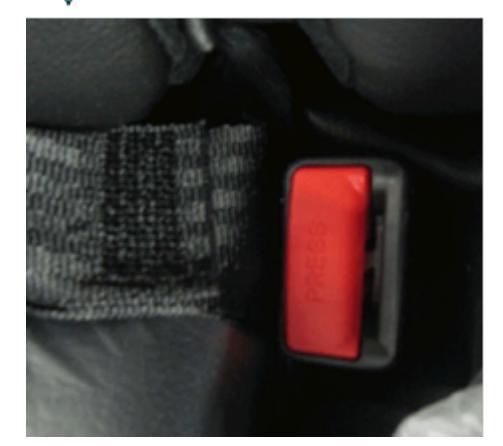
- Do not spray water on the ISO FIX button (shown below), seat belt and buckle.
- Do not run the iron on the ISO FIX button, seat belt & buckle.

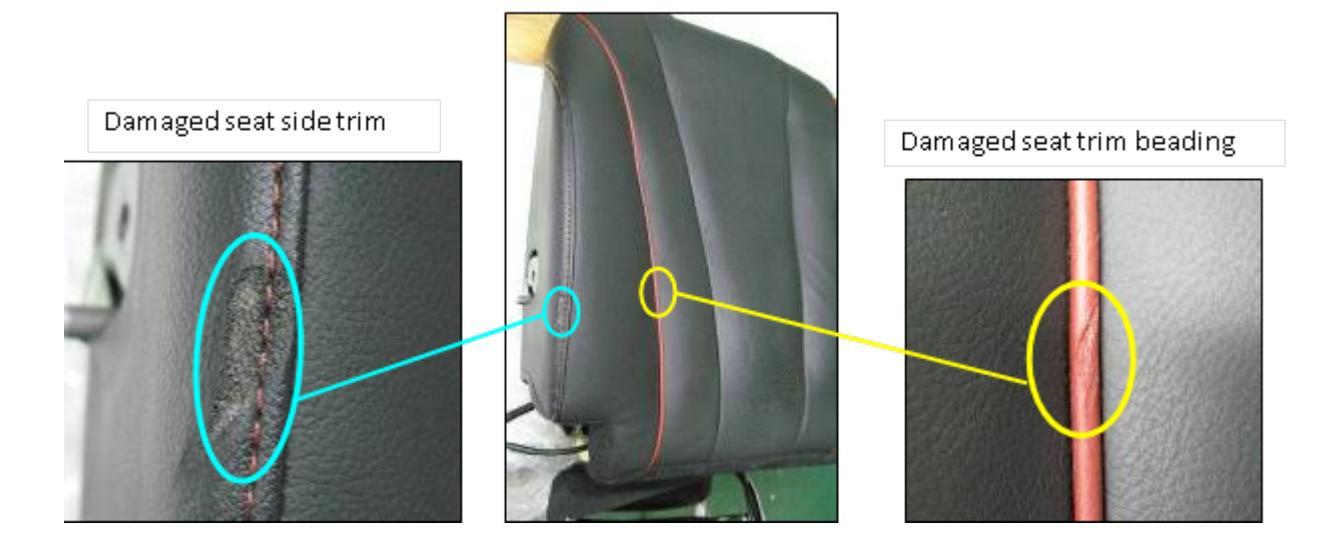
- **DO NOT** keep the iron in the same area for a long time. Doing so could damage the seat surface, as shown below.
- **DO NOT** run the iron without a water-soaked cloth, especially over the seat trim beading and seat side trim areas.
