SIB 32 04 20

## GROANING NOISE DURING HEIGHT ADJUSTMENT OF THE ELECTRIC STEERING COLUMN

This Service Information Bulletin (Revision 4) replaces SI B32 04 20 **dated March 2023**.

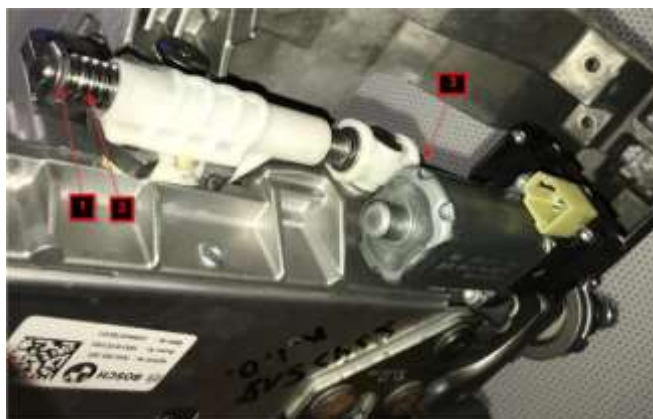
The spindle drive (2) is located on the right side of the steering column as viewed from the driver's seat.

The stop panel (1) of the spindle drive will need to be turned 90 degrees clockwise.

Before adjusting the stop spindle, the lock nut in the rear of the drive (3) must be secured in place.
