Case Number: S2318000006

Symptom/Vehicle Issue: Low Power, Transmission Will Not Upshift On Moderate To Heavy Accelerations.

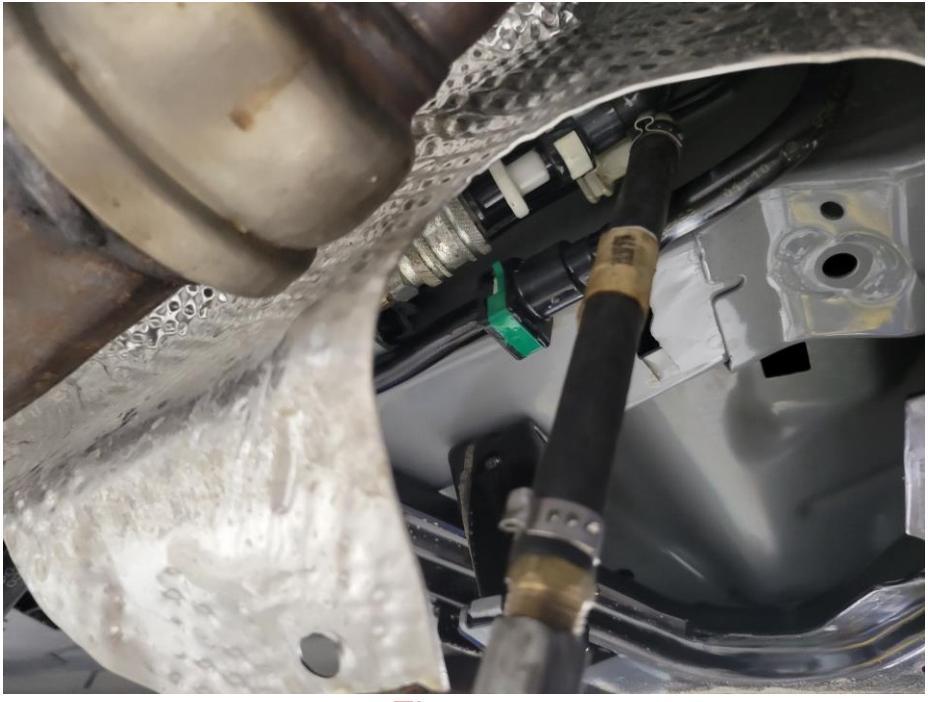
Figure 1.

1. Install the fuel pressure/decay tool (8978A) inline at the chassis fuel supply line connection towards the front of the vehicle. Please see (Figure 1).

- 2. Start the vehicle and raise the RPM by quickly applying over 50% throttle.
- 3. Compare the fuel pressure reading on the decay tester to the Fuel Pressure/Low Side Fuel Pressure reading in the wiTECH Powertrain Control Module (PCM) data tab. The readings should be equal between 50-60 psi. Did the fuel pressure reading on the decay tester drop while the wiTECH data remained near steady near 50-60 psi?
 - a. Yes>>> Replace the chassis fuel line bundle.
 - b. No>>> This document no longer applies. Please refer to normal published diagnostics.
