### APPLICABILITY: 2023MY BRZ

**SUBJECT:** Rushing Wind Sounds from Front Door(s)

NUMBER: 12-250-23 DATE: 07/10/23

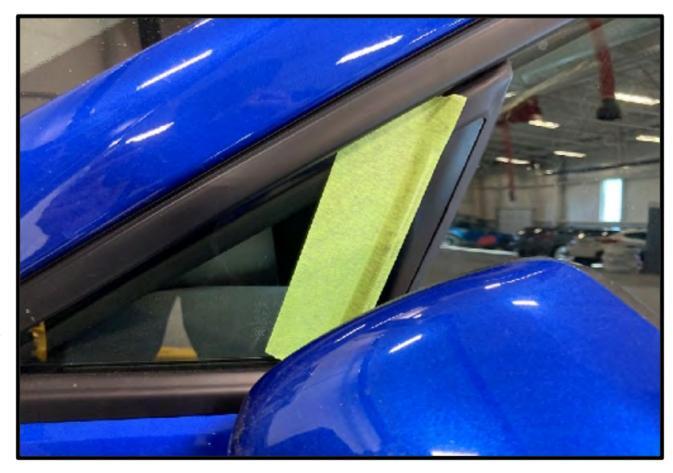
- 1. After verifying the customer concern, apply masking tape on the right or left run channel section of the front door partition glass as shown in the image to the right (one side at a time).
- 2. Road test and determine if any wind-type sounds can be duplicated. If duplicated, the front door partition glass is **NOT** the fault and further diagnosis will be required. If **NOT** duplicated, the affected front door partition glass will require replacement.

**IMPORTANT:** The front door partition glasses do not have to be replaced in pairs. **ONLY** the affected side(s) requires replacement.
