Advanced Technical Information

Bulletin #: 2317

Macan III – Check engine light with DME fault code P05A(0/3)00

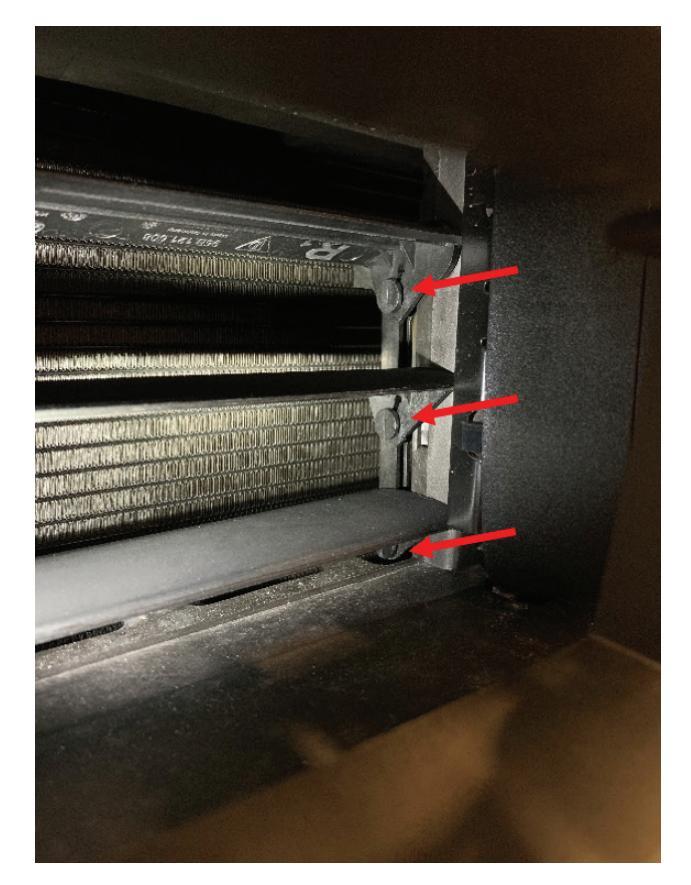
The customer states that the check engine light illuminates in the instrument cluster.

The workshop finds one or some of the following fault codes stored in the DME:

- DME P05A000 Cooling-air flap servo motor, top center mechanical fault (009D46)
- DME P05A000 Cooling-air flap servo motor, top center blocked (009D47)
- DME P05A300 Cooling-air flap servo motor, top center signal implausible (005D93)

1. Check for dirt or contamination at the friction points or the bearings for the motor and clean as needed.

- 2. Check for tension in the radiator shutters and the motor.
- 3. Delete the fault code(s) and operate the radiator shutters via the PIWIS Tester:
 - DME => Drive links/checks => Drive links => Activation of cooling-air flaps, upper coolant radiator
 - a. If the fault does not return, no further diagnosis is necessary.
 - b. If the fault returns, please replace the motor for the front radiator shutters as instructed in WM 193219 Removing and installing motor for cooling-air flaps
