Service Bulletin

Bulletin No.: 18-NA-073

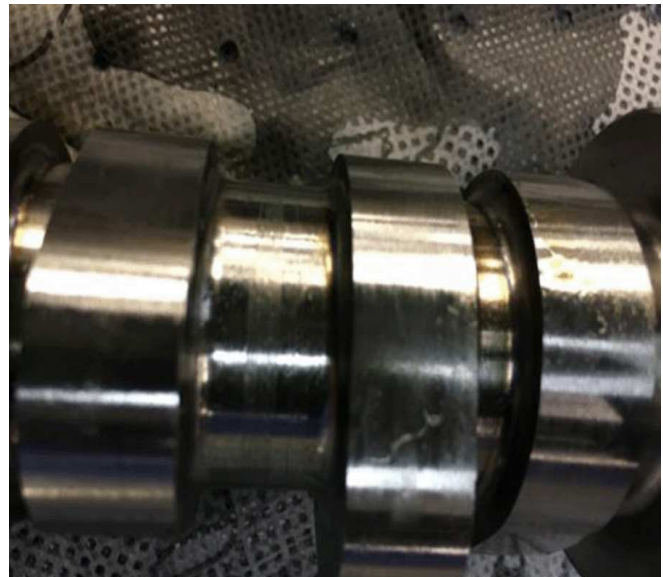
Review the following:

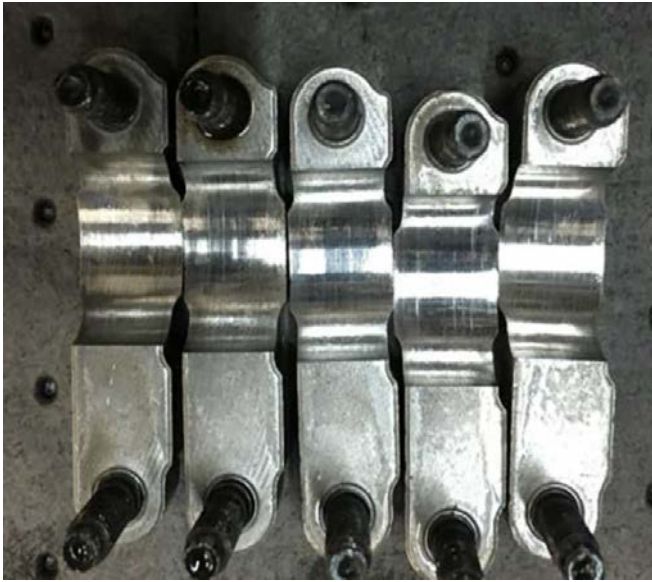
Review the following:

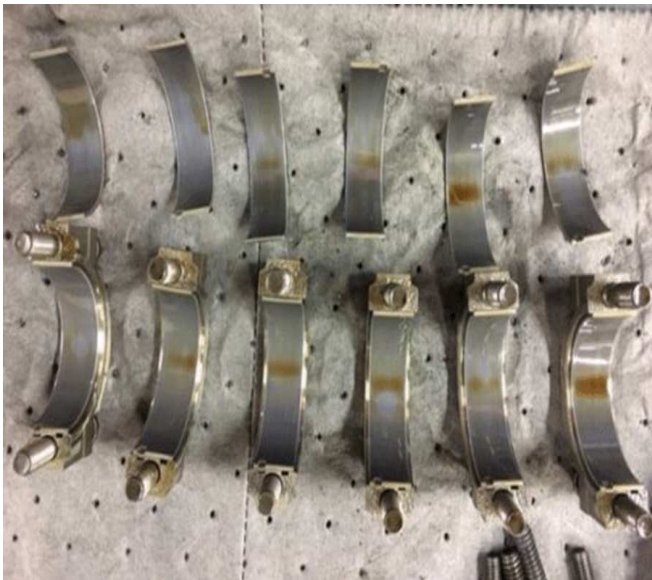
Review the following:

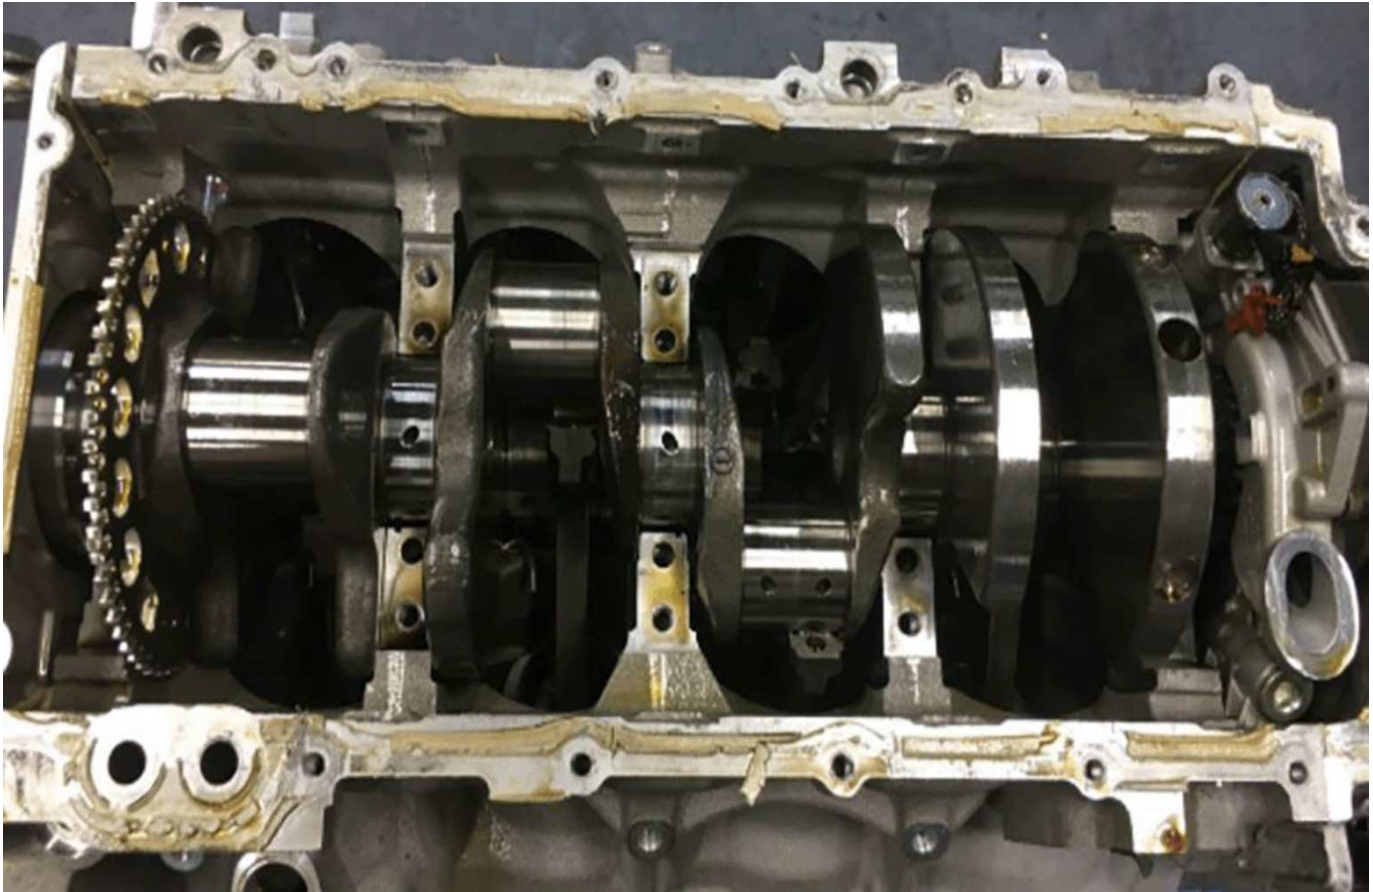
Review the following:

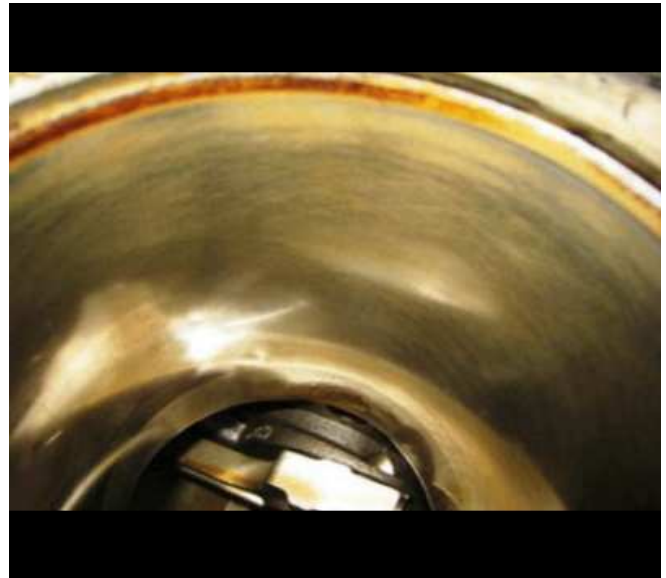
Note: The peak to valley suspecting an engine block of possible cylinder bore damage, scoring or out of round as the possible cause of engine oil consumption, misfire, cylinder leakage or blow by. spec for crosshatch is .65-2.8 microns. Any deviation and the crosshatch will be gone even if a cylinder is suspected of being oversize, we can only confirm that by checking with an air gauge at the engine plant.

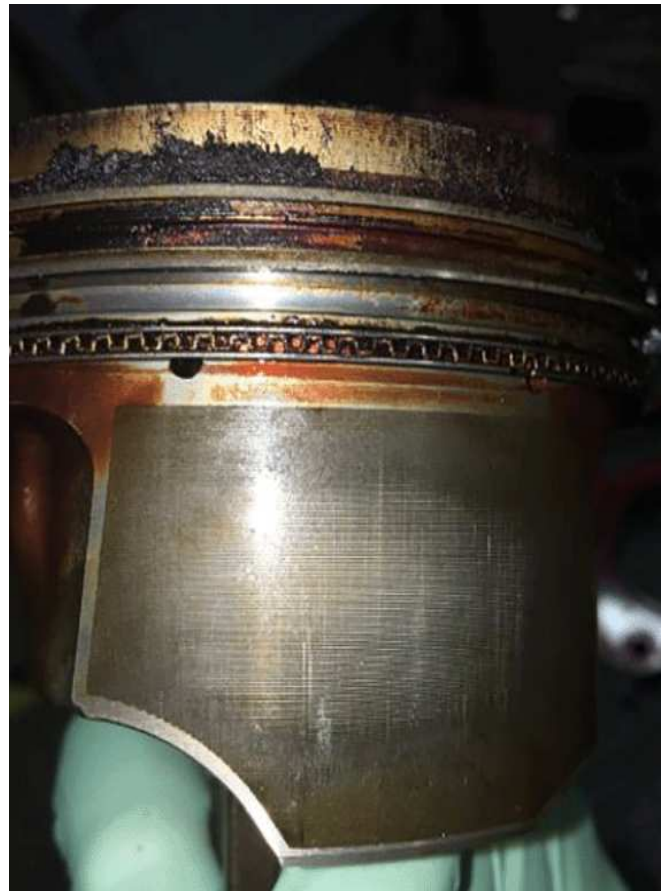
Review the following:

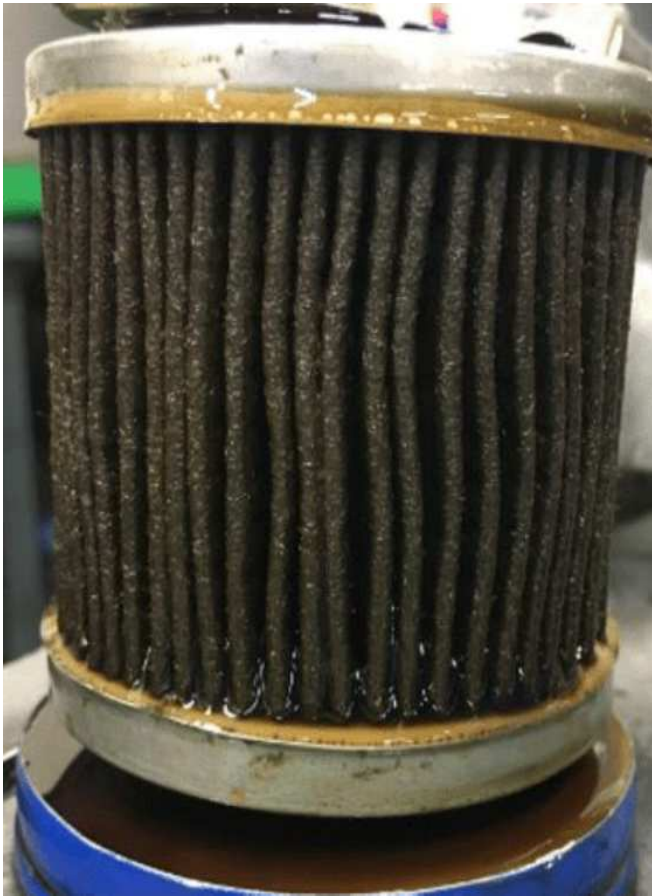
Review the following:
