# Technical Service Bulletin (TSB)

Third Row Sunshade Tab Stuck Between Door Panel

REFERENCE:	TSB: 23-085-23 GROUP 23 - Body	Date:	July 27, 2023	<b>REVISION</b> :	-
VEHICLES AFFECTED:	2023 (RU) Chrysler Pacifica This bulletin applies to vehicles built or 0517XX) and on or before May 18, 2023 2ND & 3RD Row Window Shades (Sales	6 (MDH 0518XX) equipped with		MARKET AP ⊠NA ⊡SA ⊡EE	PLICABILITY: MEA IAP CH
CUSTOMER SYMPTOM: CAUSE:	Customers may comment on the follow • The third row window shade is stu Incorrect installation of the interior pan	ck.

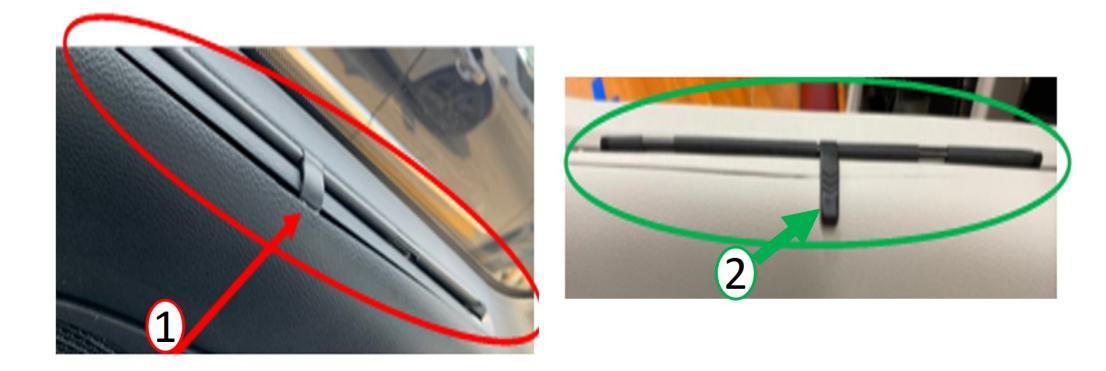
Fig. 1 Sunshade Tab

1. Verify the third row sunshade tab is not stuck between the trim panel on both the left side and right sides (Fig. 1).

- 1 Stuck Tab
- 2 OK
- 2. If the tab is stuck between the trim panel, use a trim stick to pry the sunshade tab out (Fig. 2).
