Technical Service Bulletin (TSB)

Radio Over The Air Update from S24.6, S26.15 and T25.43 to T25.48 Software Version

REFERENCE:	TSB : 08-209-23 GROUP 08 - Electrical	Date:	August 31, 2023	REVISION:	_
VEHICLES AFFECTED:	 2022 - 2023 (DT) Ram 1500 Pickup 2022 - 2023 (D2) RAM 3500 Pickup 2022 - 2023 (D2) RAM 3500 Cab Chassis 2022 - 2023 (DF) RAM 3500 10K Lb. Cab Chassis 2022 - 2023 (DF) RAM 3500 10K Lb. Cab Chassis 2022 - 2023 (DP) RAM 4500/5500 Cab Chassis 2022 - 2023 (DP) RAM 4500/5500 Cab Chassis This bulletin applies to 2022 model year vehicles equipped with either: Uconnect 5 NAV W 8.4" Display (Sales Codes UBL and UEL) Without Surround View Camera (Sales Code XAK). Uconnect 5 NAV W 12.0" Display (Sales Codes UBQ and UEQ) Without Surround View Camera (Sales Code XAK). This bulletin applies to 2023 model year vehicles built on and before December 23, 2022 (MDH1223XX) equipped with either: Uconnect 5 NAV W 8.4" Display (Sales Codes UBL and UEL) With Surround View Camera (Sales Code XAK). 			MARKET APPLI	CABILITY: MEA IAP CH

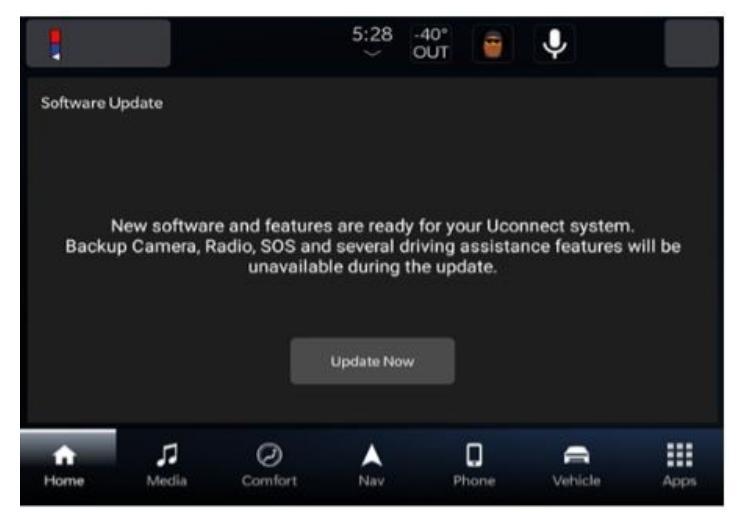
Fig. 1 Software Acceptance Screen

Customers will see a notification on their radio screen when new software is available for their radio (Fig. 1). The owner will have the option to update the radio or schedule the update for later. There is not an option to decline the update indefinitely, the update must be performed.

- 1. The vehicle needs to be in 'Park'. The ignition needs to be in the off position.
- 2. If the customer selects "Update Now" they can shut off the vehicle and leave. The update will be completed automatically.

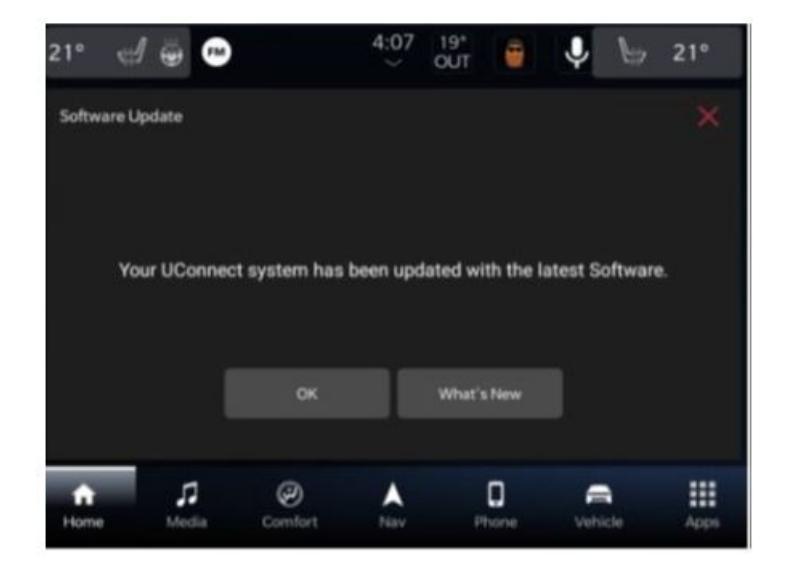
Fig. 2 Software Update Confirmation Screen

3. Upon completion of update, the radio will display a confirmation message (Fig. 2).
