87 Air conditioning does not cool

87 23 57 2071619/1 October 9, 2023.

Model(s)	Year	VIN Range	Vehicle-Specific Equipment	
A4, and A4 allroad	2017 – 2018		Not Applicable	
S4, A5, A5 Cabriolet, A5 Sportback, S5, S5 Cabriolet, S5 Sportback, and RS 5	2018	All

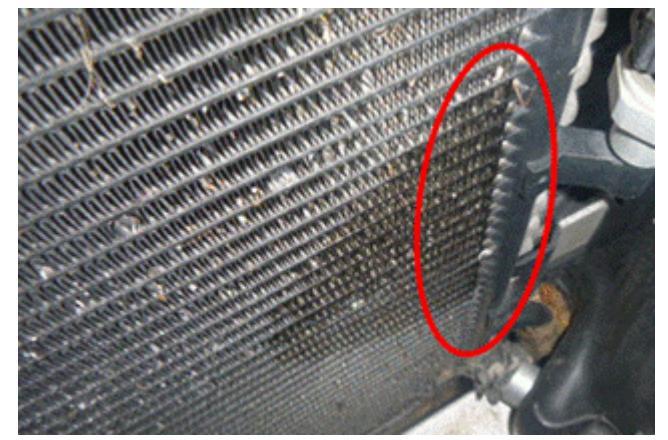
A refrigerant leak may be found at the air conditioning condenser, specifically where the cross tubes meet the collector tank. This is caused by a weakening of the brazed cross tube to collector connections.

Figure 1. Evidence of a refrigerant leak at the condenser.

4. Should the vehicle present with the condenser refrigerant leak as described in this TSB replace the air conditioning condenser.

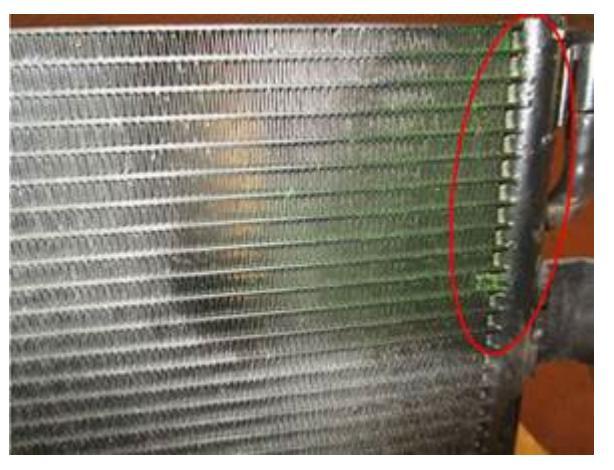
2. If contrast agent is used figure 2 shows dye residue in the area of the condenser at issue.

Figure 2. Evidence of a refrigerant leak at the condenser using contrast agent as the diagnostic medium.

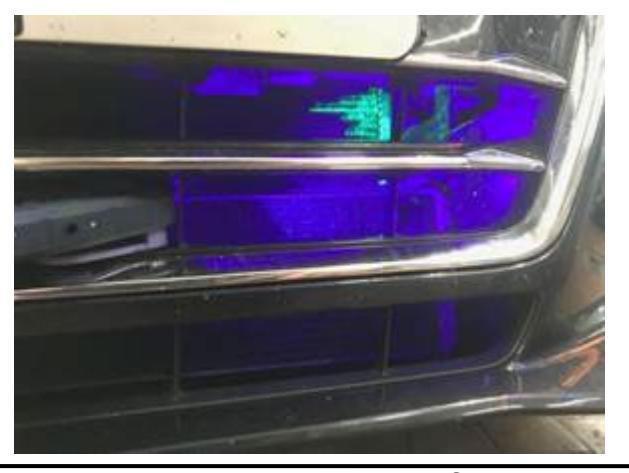
3. Figure 3 shows evidence of refrigerant escape from the area of the condenser at issue as viewed using contrast agent illuminated with UV lighting.

Figure 3. Evidence of a refrigerant leak at the condenser using contrast agent and UV lighting.
