Release date: 10/17/2023

Applicable Vehicles						
Model(s) Year		Eng. Code Trans. Code		VIN Range From	VIN Range To	
Golf R, GTI	2022 - 2024	All	All	All	All

94-23-01 - Headlamp: Rubber lip-seal (between headlight and 10/17/2023 Release date: fender) loose

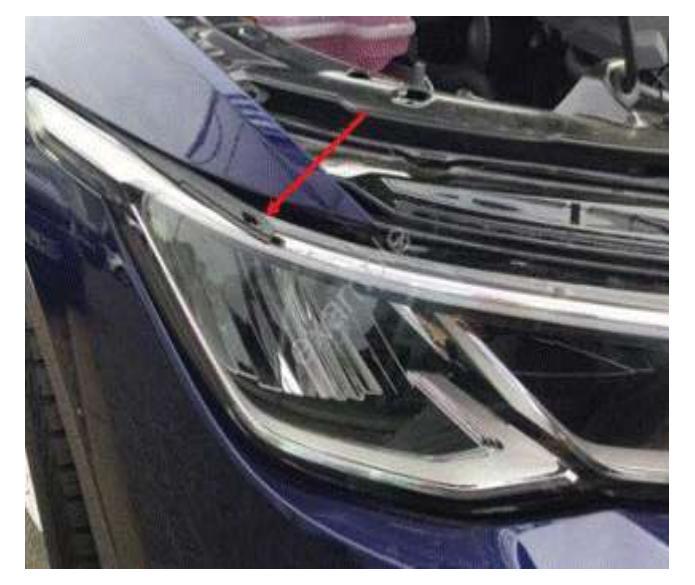
Figure 1.

Incorrect assembly of the rubber lip/seal in the assembly process. This can result in damage to the locking lug. As a result of the damage to the locking lug, the rubber lip/seal comes loose or protrudes.

The rubber lip/seal (see Figure 1, red arrow) between the headlamp and the fender (left/right) is loose/detaching/is off.

#### Procedure for gluing the rubber lip/seal:

Remove headlamp assembly. See repair manual Group 94 in Elsa.
