TSB #:	TSB40082301	Release Date:	9/12/2023
Main Group:	40 - Interior		
Subject:	Instrument Panel (IP) Vents – Malfunction and Replacement		
Vehicle:	FM29 OCEAN	<b>Production Range:</b>	SORP
Model Year(s):	2023	Region(s):	Global
Mobile Service:	NO

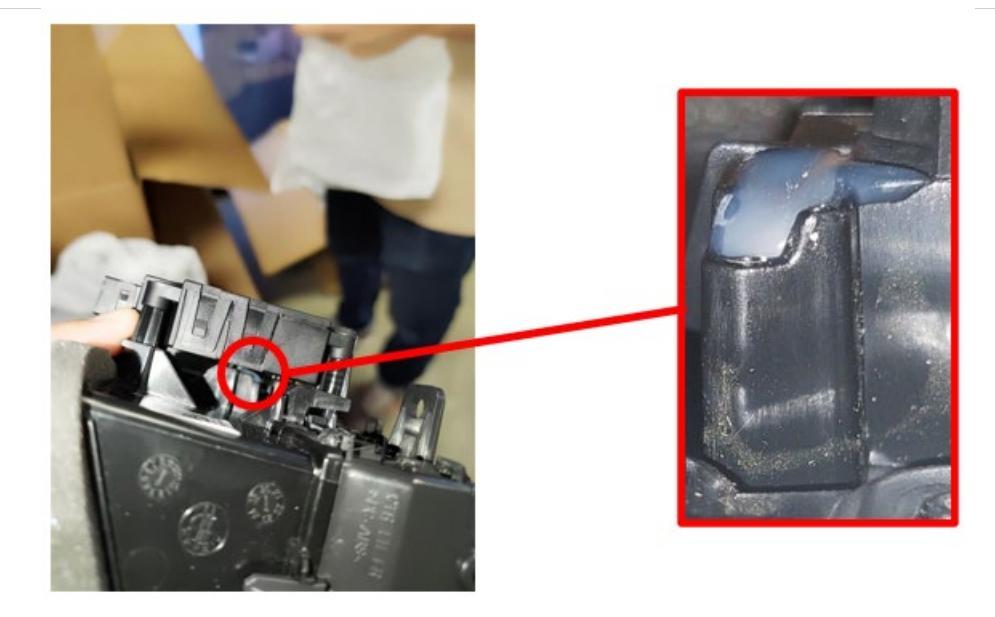
1. FM29 DEV SP 0442 AIR VENT: Identify an extra white hot melt component on the end stop area.

Figure 2. Air vent with hot melt rework

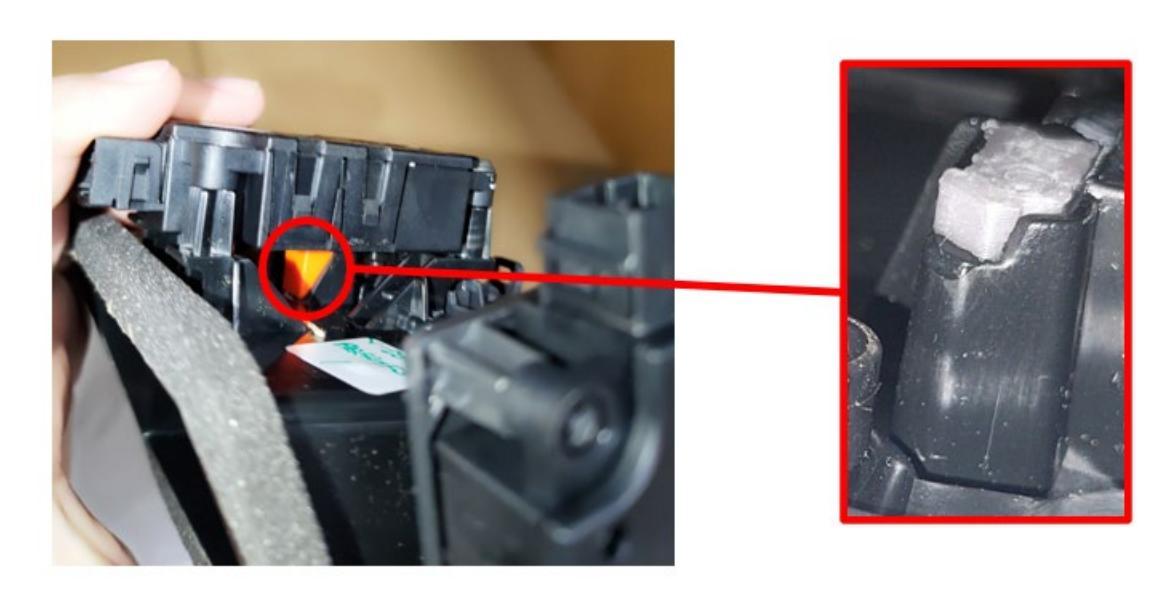
2. FM29\_DEV\_SP\_0451 AIR VENT: Identify a 3D printed insert on the end stop area can be orange, red or white color.

Figure 3. Air vent with 3D insert
