Mazda North American Operations Irvine, CA 92618-2922

WATER PUMP COOLANT LEAK

Service Alert No.: SA-081/23

Last Issued : 12/05/2023

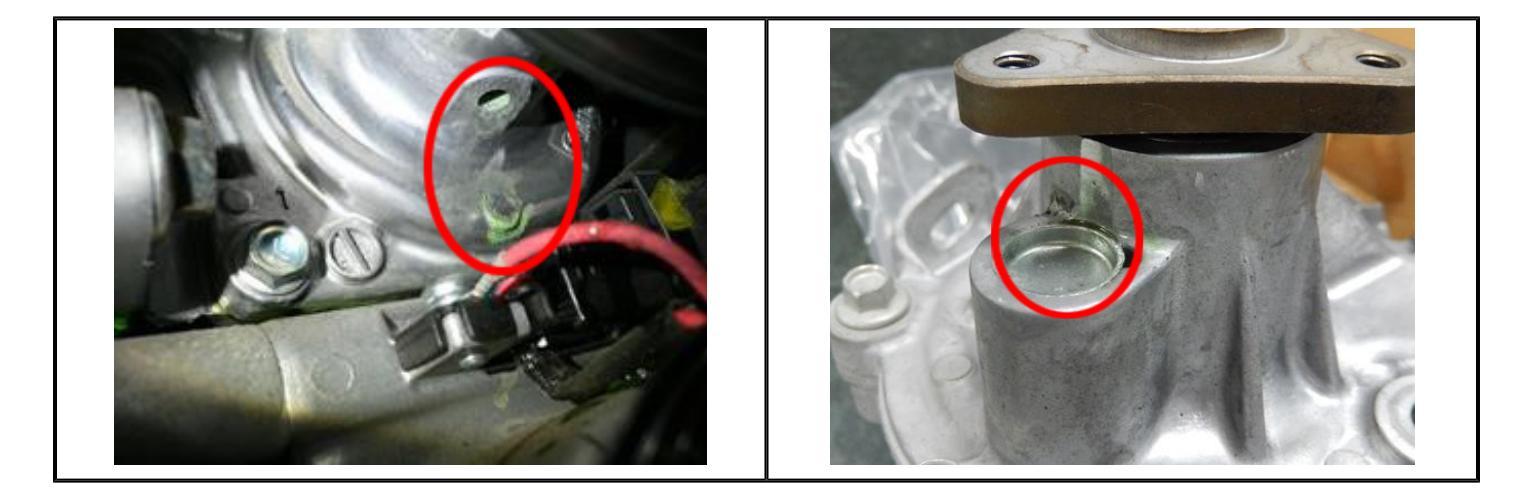
Normal Water Pump Coolant Seepage

A mechanical seal (A) is used for the water pump. This mechanical seal can seal coolant (B) by sliding a mating ring (C) against a seal ring (D). When the sliding surface temperature of the mechanical seal is more than 248 °F (120 °C) while driving, a small amount of steam (E) is leaked and bleeds through the bleeding hole (F). After drying, the steam leaves a green coolant deposit near the water pump bleed hole (F). This is a normal condition and does not require water pump replacement. The water pump should only be replaced if there is an accumulation of crystallized coolant near the bleed hole.

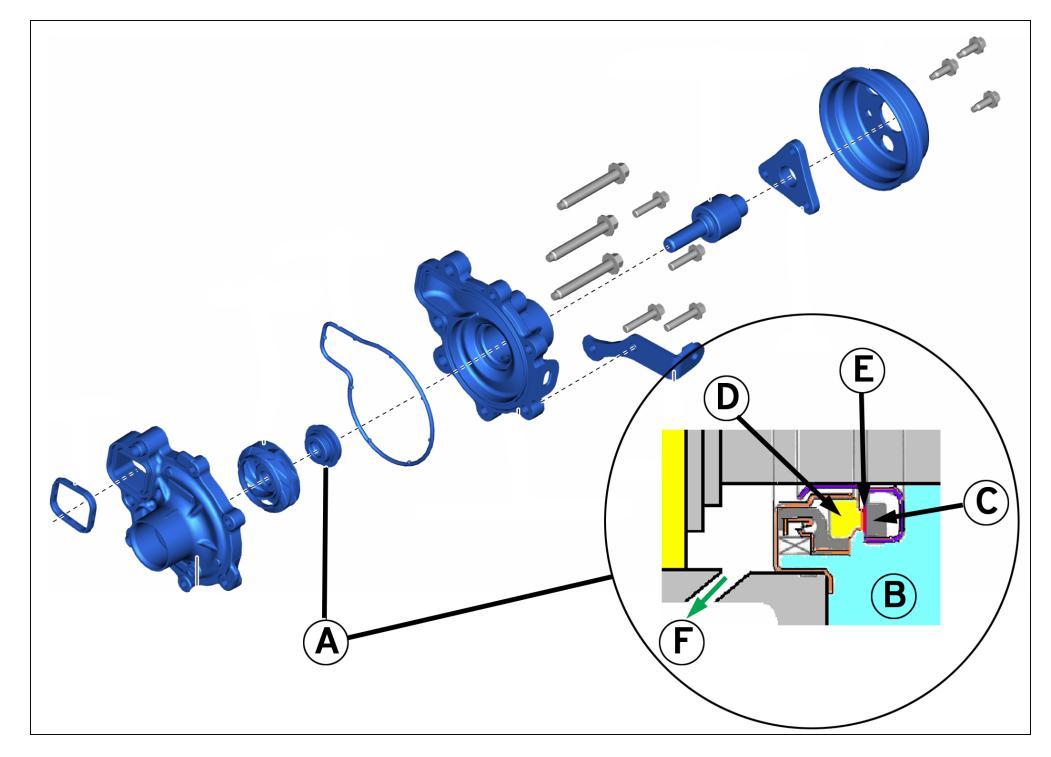
Bleed hole (F) is located under water pump

Dried coolant steam shows as green-color deposit at bleed

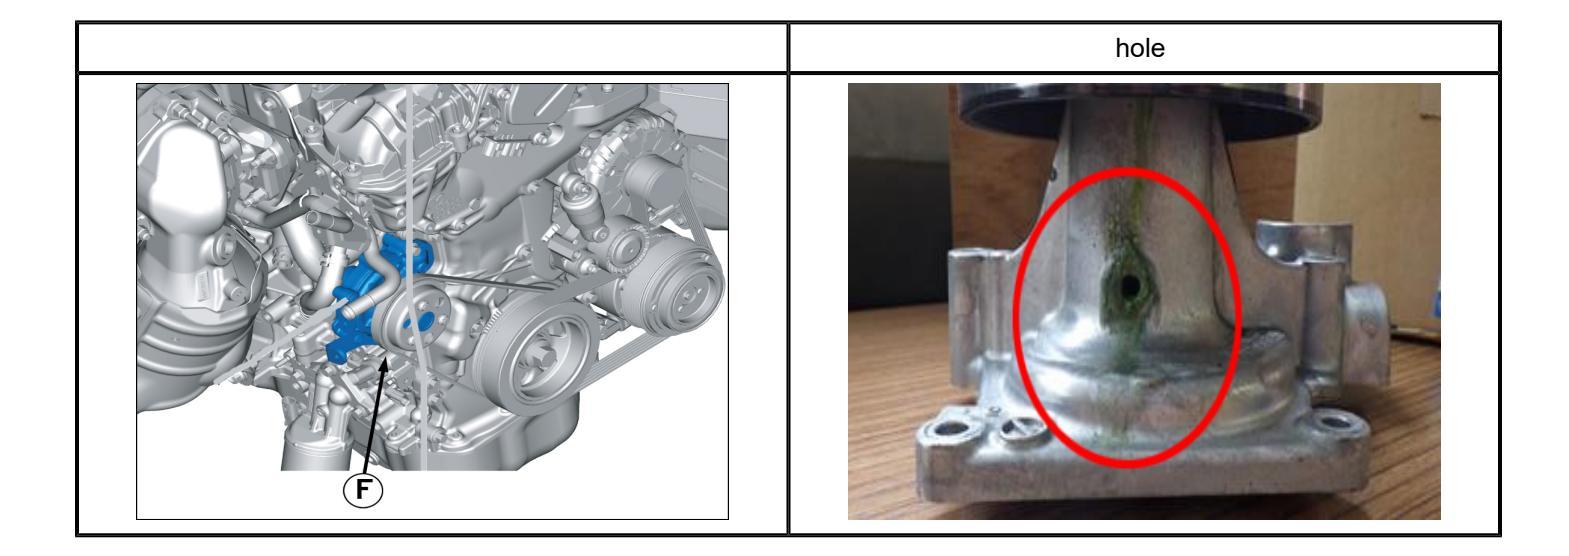
Water Pump Samples:	
GOOD	NO GOOD
No accumulation of crystallized coolant near the bleed hole (F).	Accumulation of crystallized coolant near the bleed hole (F)
DO NOT replace the water pump.	REPLACE the water pump.
	F

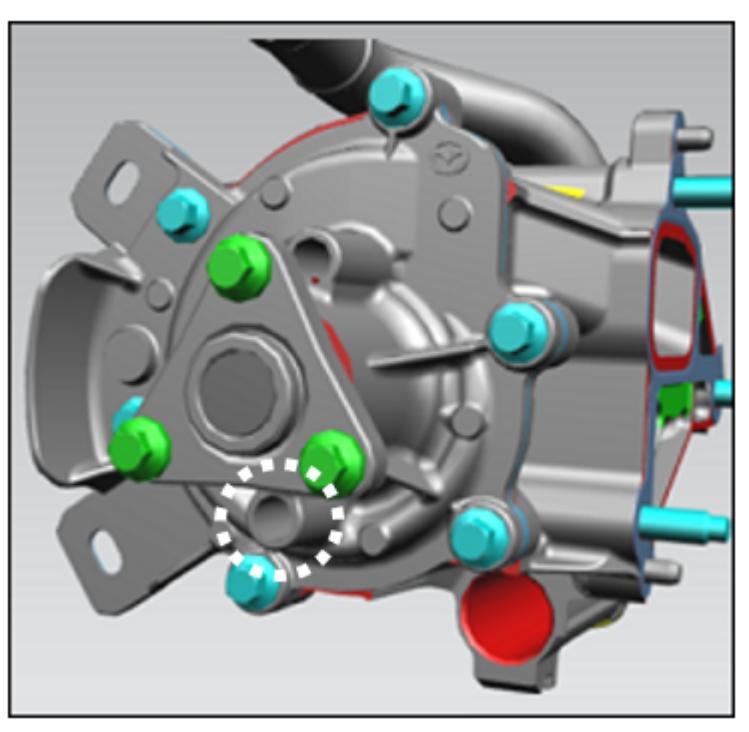
SKYACTIV-G 2.5 (PYUL)

- Regarding the following engines, diagnose whether the water pump requires replacement as with the other engines in this service information.
- Refer to the following images regarding the location of the bleeding hole (white dotted circle).
