68 Electric luggage compartment roll cover inoperative

68 24 44 2072897/1 February 6, 2024.

Model(s)	Year	VIN Range	Vehicle-Specific Equipment
A4 allroad	2017	000001 – 169491	Not Applicable

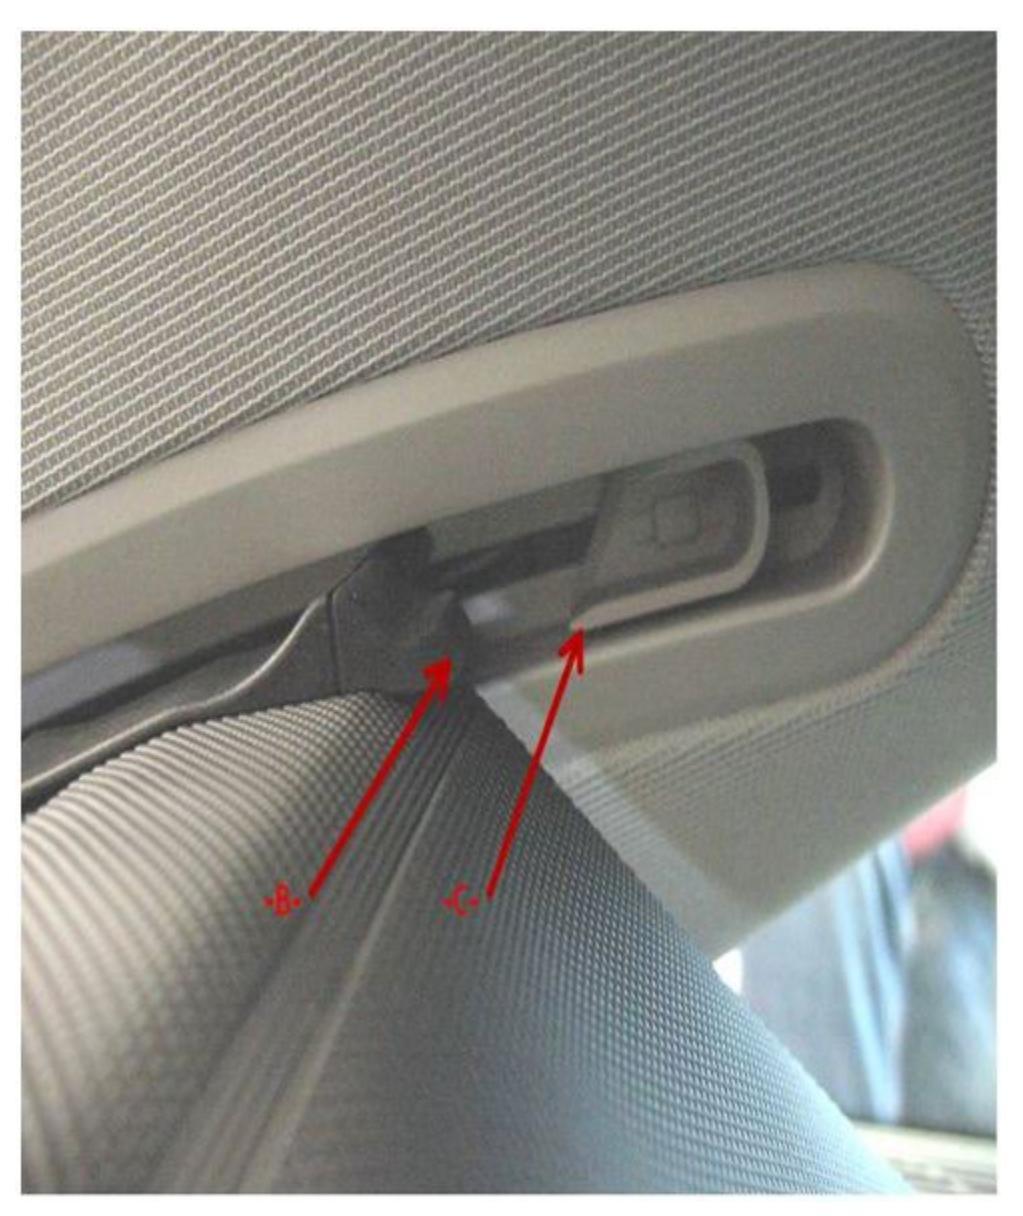
1. When the luggage compartment roll cover is mounted in its guide rails, the electric drive can get blocked. This can occur if the cover locking pins (Figure 1, position "B") are slowly moved upwards inside the guide rail and then positioned shortly before the electric drive catches (Figure 1, position "C"). In this position, the locking pins do not engage in the catches of the electric drive. The electric drive reverses and the catches remain at the top of the rail.

Figure 1. Luggage compartment roll cover locking pin not engaged in catch of electric drive.

1. Check if the luggage compartment roll cover locking pins (Figure 1, position "B") are engaged in the catches (Figure 1, position "C") of the electric drive. If necessary, insert the locking pins into the catches.
