Service Bulletin

Subject: Whine Noise from Transmission Area

Brand:	Model:	Model Year:		VIN:		Engino	Transmission:
Branu.		from	to	from	to	Engine:	fransmission.
Chevrolet	Colorado	2023	2024			L3B	8L45, 8L80 (N8R, MFC)
GMC	Canyon					LJD

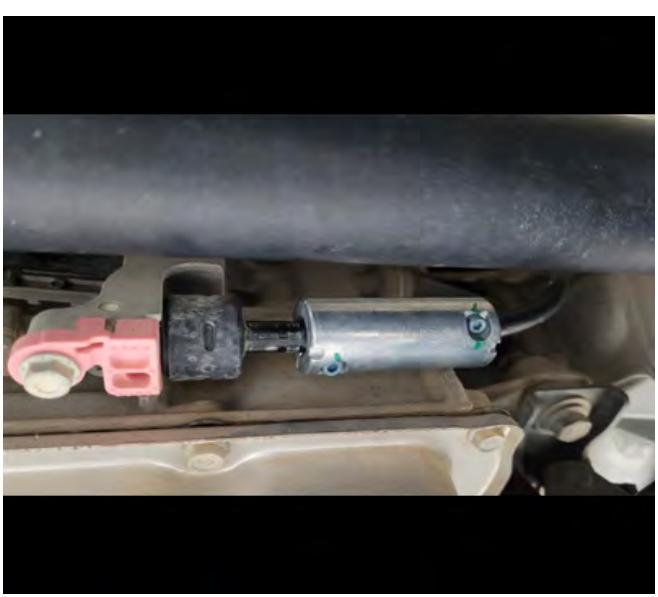
6515875

Involved Region or Country	North America	
Condition	Some customers may comment that a noise can be heard around 25-50 MPH (40–80 KPH) in "D" (drive) under light acceleration and/or coast conditions.	
Cause	This condition may be caused by cable isolation in 4th and 5th gear causing a whine noise approximately 42 MPH (68 KPH) with slight acceleration.	
Correction	Refer to the Service Procedure.

If the conditions above match, **DO NOT** replace the transmission for this concern. Install a transmission cable mass/weight.
