CAUSE:	Headlamp condensation.

DISCUSSION:

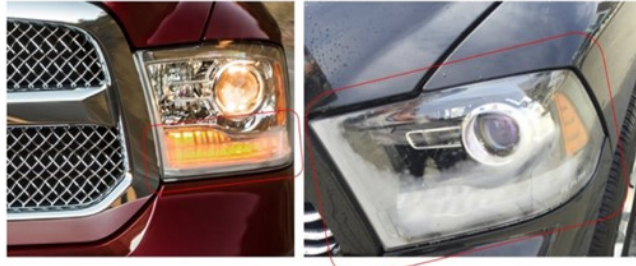
**Fig. 1****Fogged Headlamp Examples**

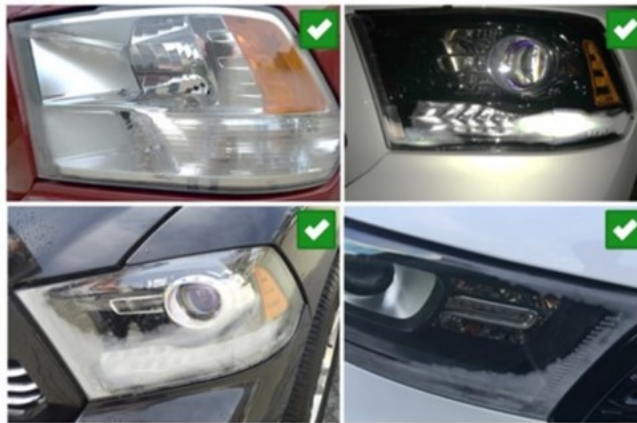
**Fig. 2****Condensation/Fogging Beginning To Clear Examples**

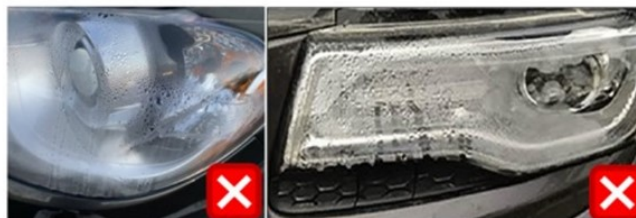
**Fig. 3****Condensation/Fogging Not Beginning To Clear Examples**

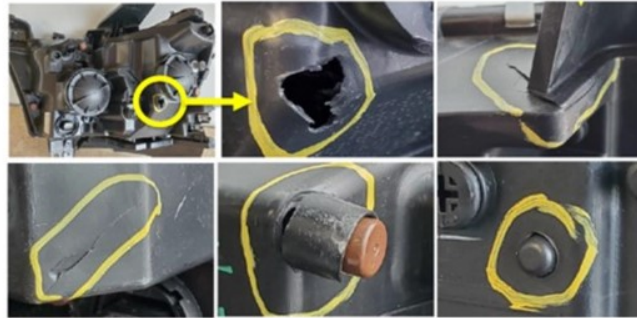
- **Damage:** Breakage on the headlamp housing will allow moisture/water to enter to the headlamp (damage, cracks, holes, etc.) Fig. 4. If this is noticed, the Failure Code must be recorded accordingly: **11/BROKEN OR CRACKED**.

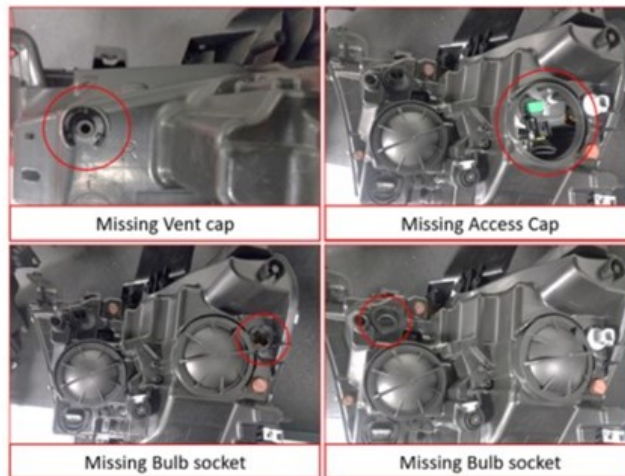
- **Missing Sealing Components:** Missing vent caps, access caps or bulb sockets will allow moisture/ water to enter to the head lamp Fig. 5. If this is noticed, the Failure Code must be recorded accordingly: **1C / CONNECTOR LOOSE NOT ATTACHED**.

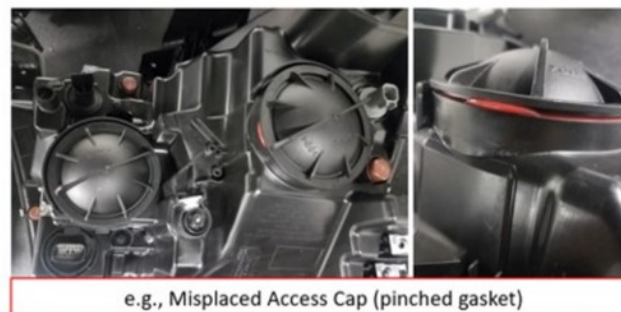
- **Sealing Components:** Missing/damaged vent caps, incorrectly installed access caps and bulb sockets, will allow moisture/water to enter to the head lamp Fig. 6. If this is noticed, the Failure Code must be recorded accordingly: **1C / CONNECTOR LOOSE NOT ATTACHED**.
