Technical Service Bulletin

SUBJECT:			No:	TSB-20-23-001REV3
POTENTIAL TR	ANSMISSION SH		DATE:	March 2024
WITH POSSI	BLE DTC (CVT-8)) – REVISED	MODEL	See below
CIRCULATE TO:	[] GENERAL MANAGER	[X] PARTS MANAGER		[X] TECHNICIAN
[X] SERVICE ADVISOR	[X] SERVICE MANAGER	[X] WARRANTY PROCESSOR		[] SALES MANAGER

Certain vehicles with F1CJC/W1CJC (CVT-8) transmissions may exhibit a shudder or surge condition possibly caused by poor reaction of the hydraulic pressure circuit. With continued driving under these conditions, the CVT belt may slip repeatedly when accelerating, and abrasion powder may enter the hydraulic pressure circuit, causing a warning light to turn on with one of the following DTCs: P0776, P0730, P0741, P084A, P0969, P2719. The shudder/ surge condition may also be described as engine flare, lack of acceleration, and/or car shake.

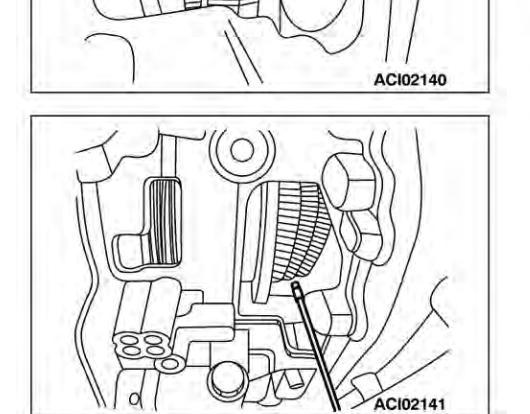
Refer to below damage sample illustrations.

- If damage is found on either side of mating surfaces of the belt, CVT assembly replacement is required.
- If no damage is found on mating surfaces of the belt, a new valve body Installation is required. Follow next steps.

NOTE: Be sure to replace the filter screen and external filter element. Refer to ASA CAPS for correct part numbers for the vehicle.
