Nissan Group of the Americas  
Copyright ©

# TECHNICAL SERVICE BULLETIN

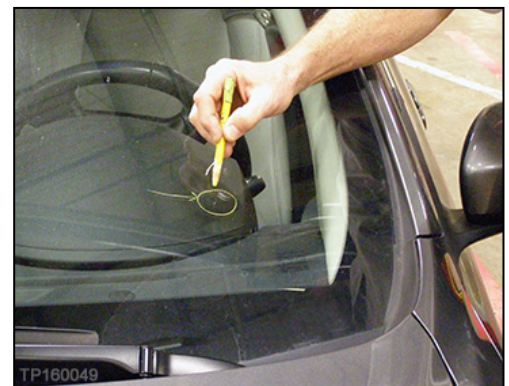
Infiniti Bulletins are intended for use by qualified technicians, not 'do-it-yourselfers'. Qualified technicians are properly trained individuals who have the equipment, tools, safety instruction, and know-how to do a job properly and safely. NOTE: If you believe that a described condition may apply to a particular vehicle, DO NOT assume that it does. See your Infiniti retailer to determine if this applies to your vehicle.

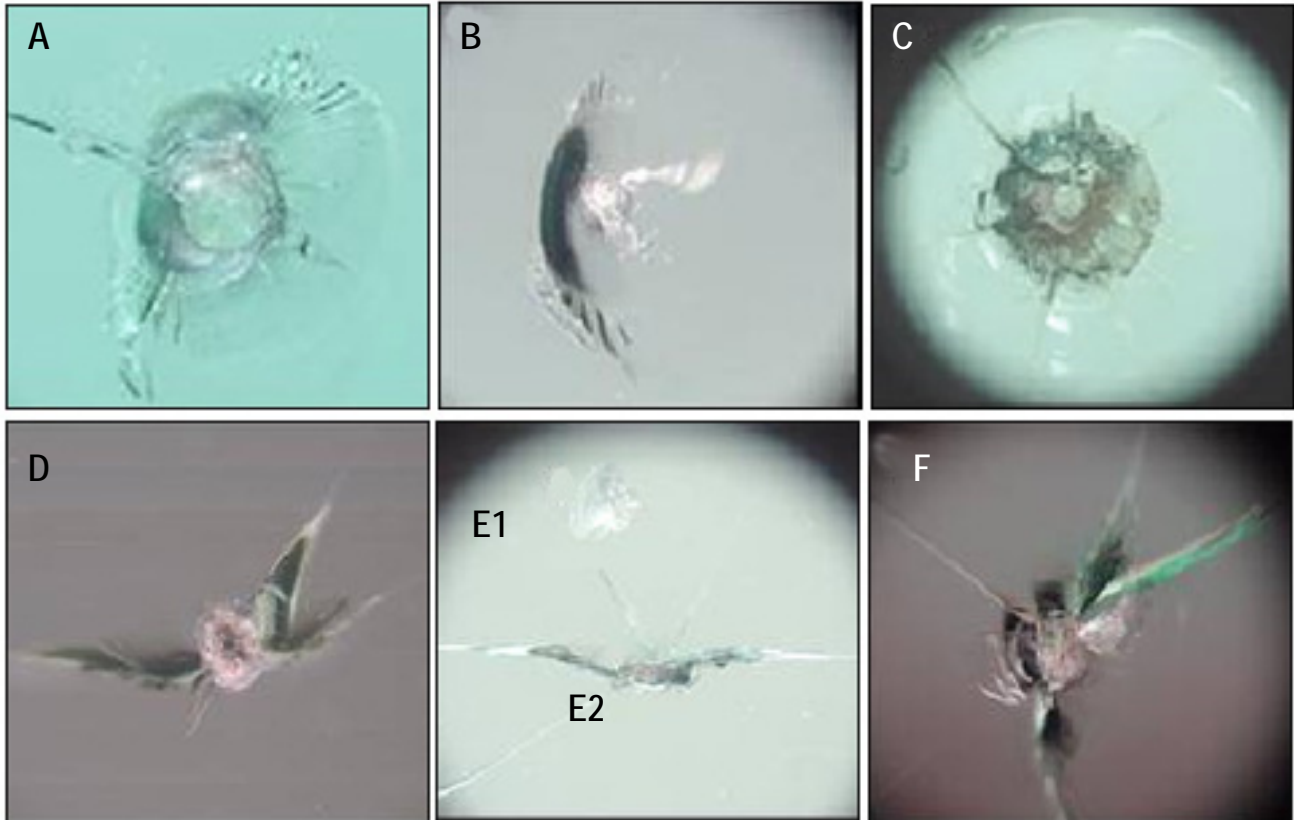
Cracks can spread and become larger from the original strike point or crush mark due to:

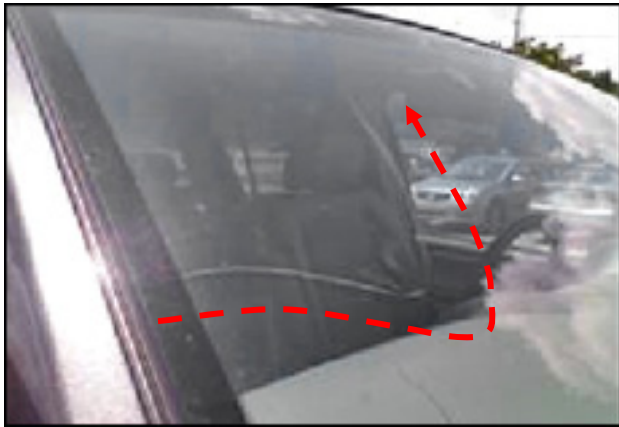
Single crack with **no** impact mark:  
**Warranty**

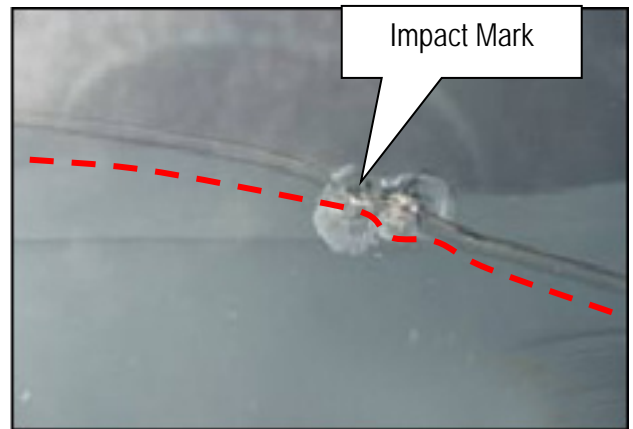
Single crack with impact mark:  
**Not Warranty**

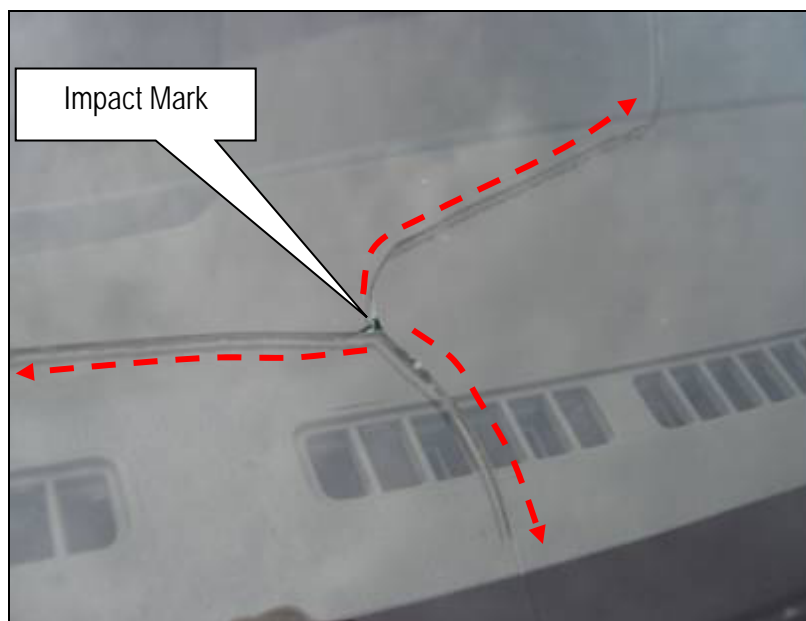
Compound crack: **Not Warranty**

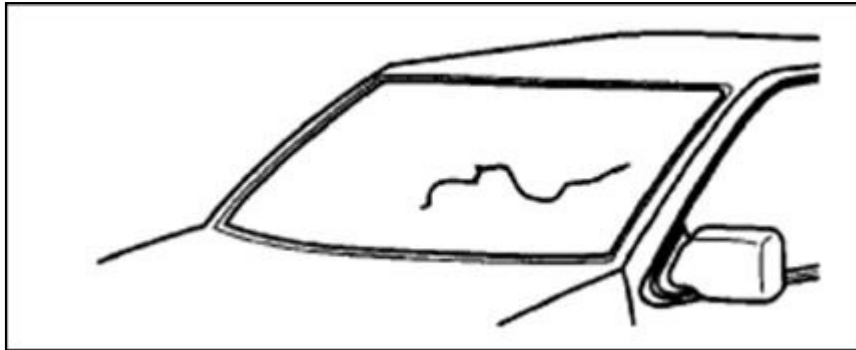
Cracks not reaching edge: **Not Warranty**

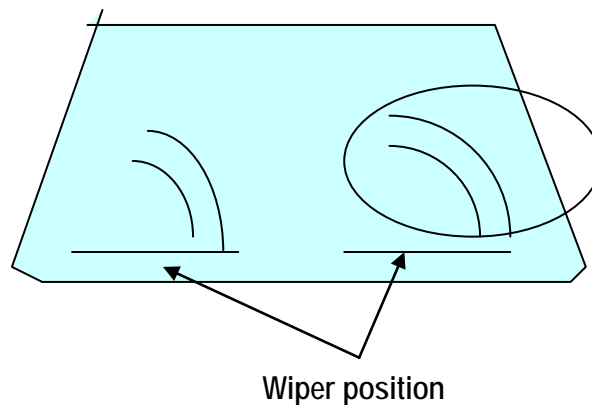
Scratch from sand/stone: **Not Warranty**

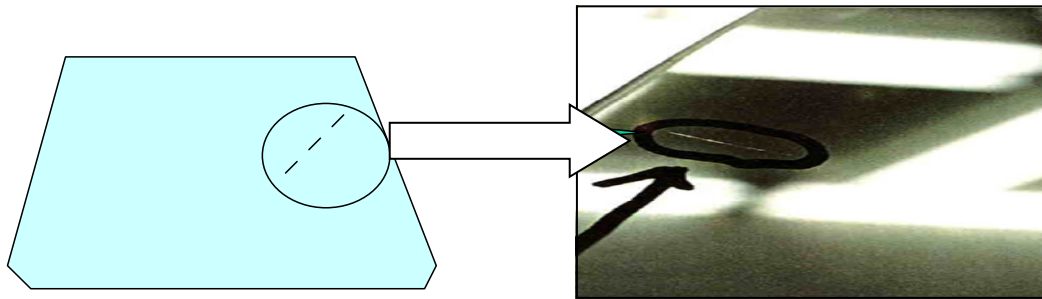
Scratch from metal objects: **Not Warranty**

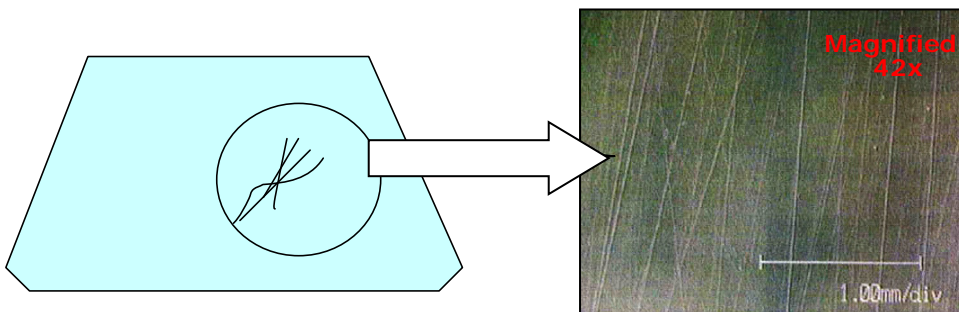
Scratch from dirty towel/cloth: **Not Warranty**

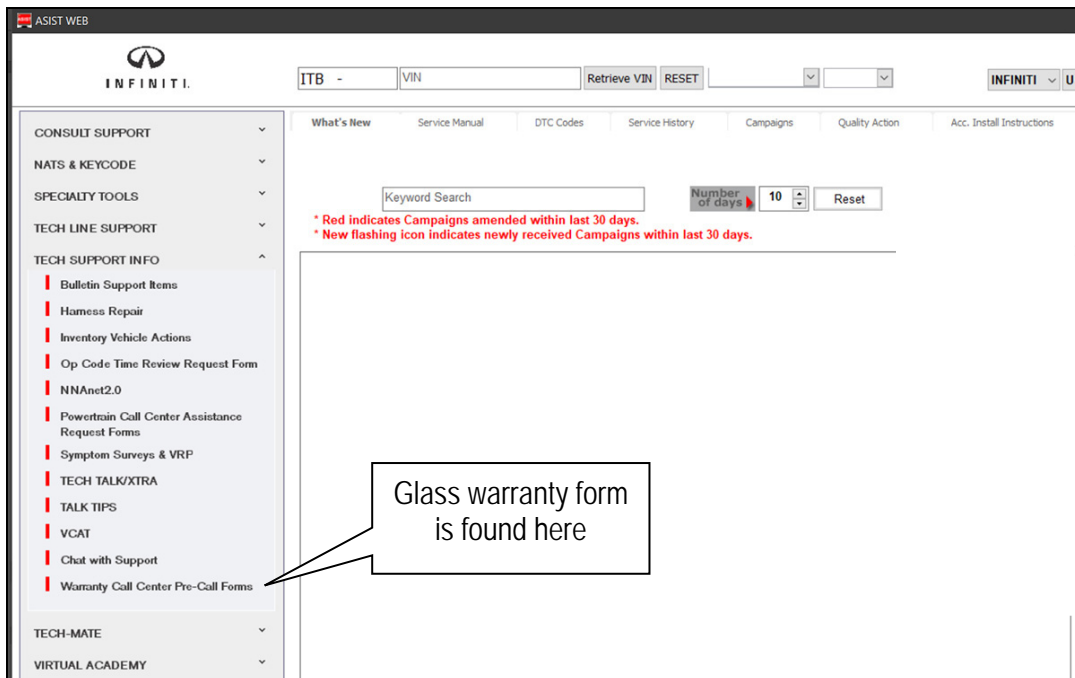
## AMENDMENT HISTORY
