Bulletin No.: PIP5932C

PIP5932C Information on Malfunction Indicator Lamp (MIL) Illuminated with Any Combination of DTCs P0521, P06DD or P06DE Setting

Brand:	Model:	Model Years:	VIN:		Engine:	Transmissions:
			from	to		
Buick	Envista	2024	All	All	1.2L LIH	All
Chevrolet	Trax	2024	All	All	1.2L LIH	All

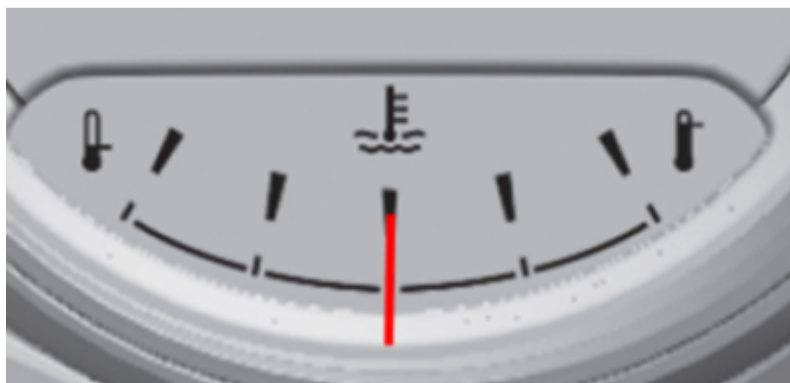
Module Diagnostics => [K20] Engine Control Module => Data Display => Engine Mechanical Data

Start and run engine for minimum 15 minutes until the coolant temperature gauge needle is centered in the gauge.

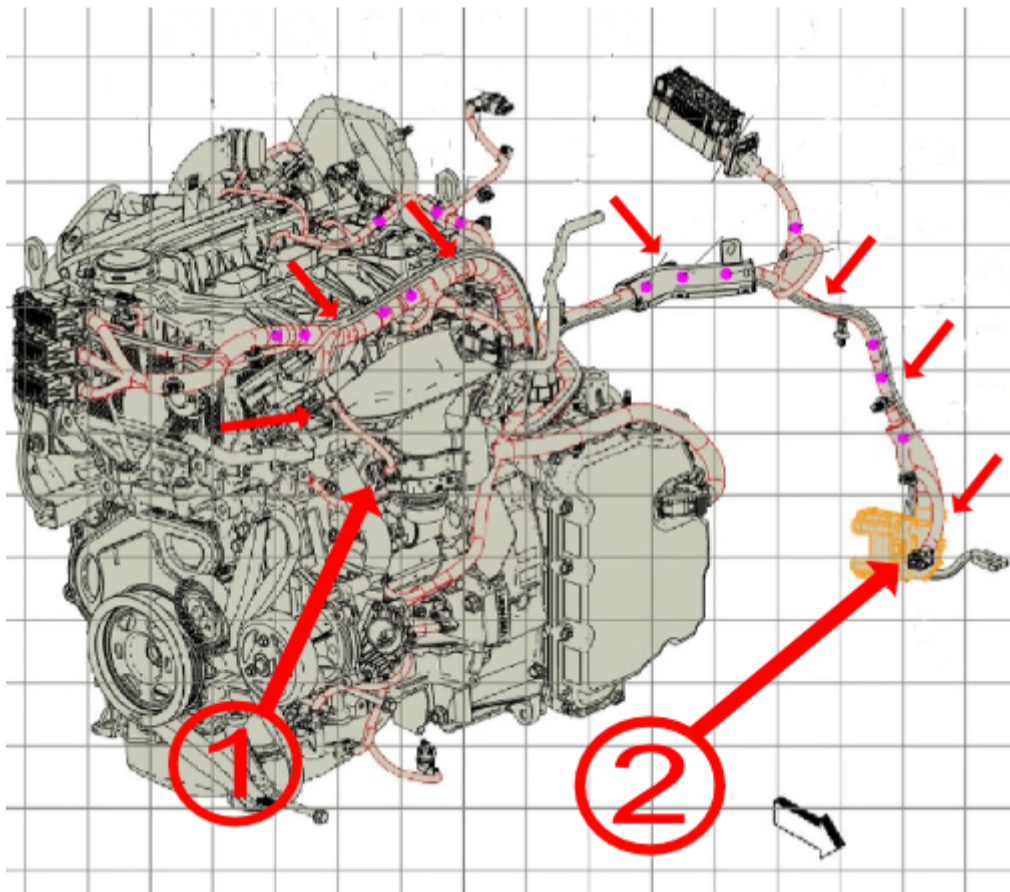
If the resistance is within range, tap and manipulate the engine wiring harness between the oil pressure sensor (1) and X125 (2) shown below, while monitoring for a change in the resistance reading.

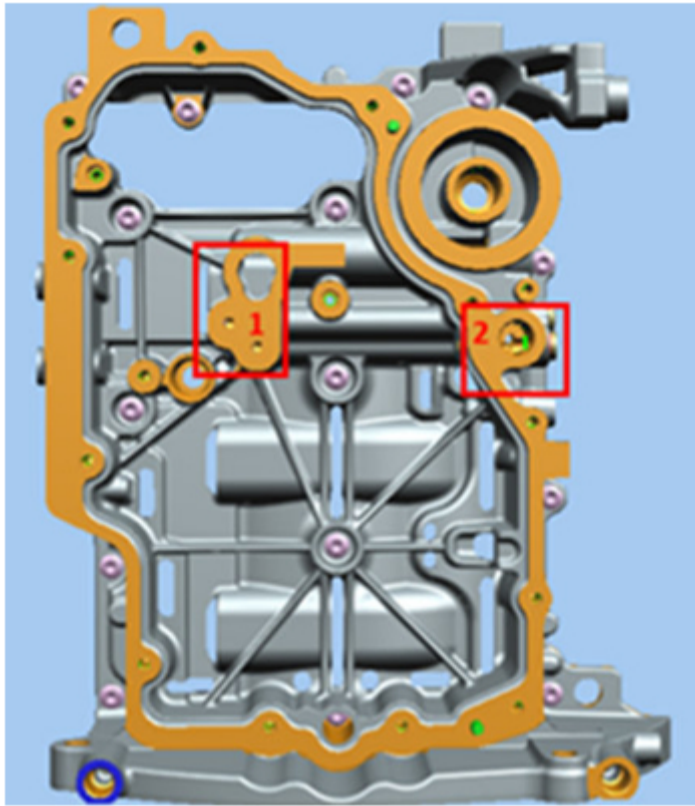
Caution: If oil pump replacement is needed, ensure the three oil pump oil holes (Area 1) and OCV mounting hole (Area 2) are free of debris BEFORE installing the oil pump and OCV. If debris is found, remove with a lint-free cloth or brush that will not scratch the surface.
