#### FRESH TANK SENSOR / GREY TANK SENSOR RESET TOFNO

#### HOW TO ACCESS FRESH TANK SENSOR / GREY TANK SENSOR TOFNO

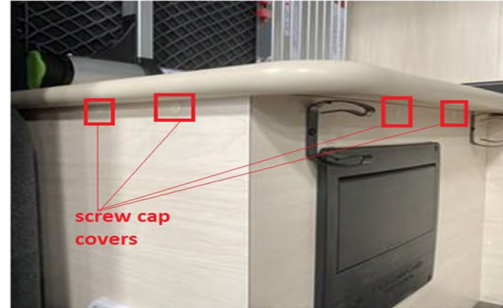
If you need to access tank sensors, it will be at the back driver side rear (see picture below) There will be screw cap covers just under the top panel. You need to remove the table leg for you to see it. There will be screw cap covers on the other side as well. Once all screws are removed, you can pull up that partition. It will be on the inside right side.

You will see 2 sensors with wires (1 for each tank). Top sensor if for fresh tank and bottom sensor is for grey tank.

Remove the driver's rear ledge and you will see rear of tank with the spider tank level sensor inboard of the wheel well. This is easy to get at and change. The wood panel may need to be trimmed a bit to be able to pull out sensor. Tank stays where it is.

1. replace sensor if bad . takes 0.5 hour to R/R Sensor. **Please contact Spyder Controls if you need to buy the tank sensors.**
