Service Bulletin

Bulletin No.: 05-03-08-002J

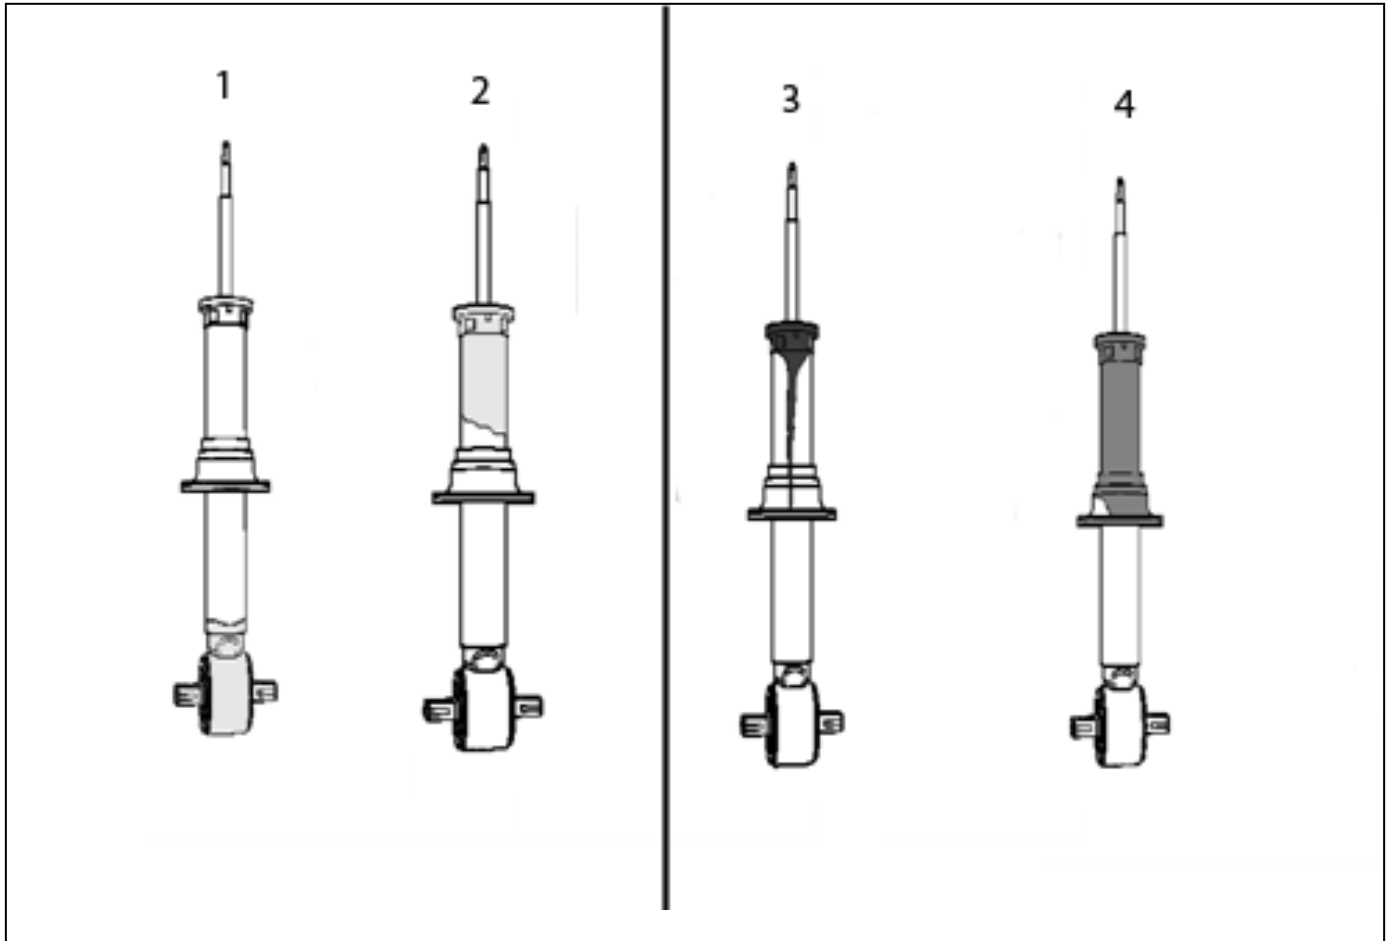
Coil-over Shock Absorber
