Pre-Authorization Requirements for Warranty Goodwill Grid Requests

MY 2023 and 2024 ProMaster (VF) - All Models With Power Folding Mirrors

Generic Procedure for Wheel Speed Sensor (WSS) Trouble Codes - All Models and Variants

DTC B22A9-42 ECU Internal Performance, General Memory Failure Issue - MY 2024 Grand Cherokee (WL) PHEV IDCM - All Models and Variants

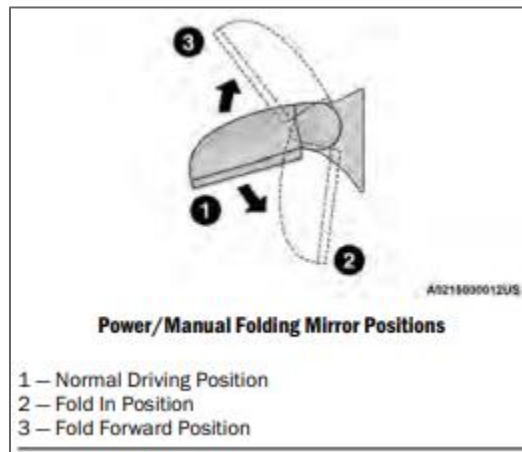
Figure 1

Please note that in the event of a power folding outside mirror malfunction, the condition may be due to the following possible causes:

1. Folded forward manually.
2. Folded by accidental impact.

The issue can be addressed by following the service procedure. Not following the service procedure can result in a continuous failure. Leaving the mirror in a non-powered position, accidental impact, or manual fold, can cause

permanent damage to the mirror. Electrically restore the mirror to its normal position, as soon as practical.

Mirrors can be manually folded in forward position, it is required to manually fold back to the normal position before trying to use the mirror switch, otherwise the mirrors may not move with the switch, and be misdiagnosed as a failed mirror.

For visual reference, **Figure 1** represents the three different folding mirror positions can reach by folding it, even if it is by power, manual, or accidental.

If the mirror head or pivot exhibits a slight amount of play in the normal position, the mirror should be power folded closed, then power folded open, this may require multiple button pushes to restore proper power mirror operation.

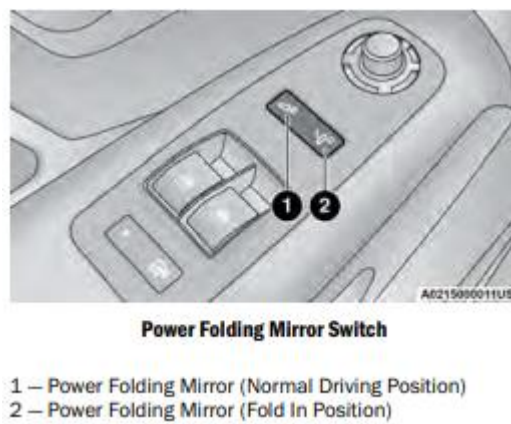
Figure 2

The switch for the power folding mirrors is located on the driver's door panel, below the power mirror controls. Push the switch on the

right and the mirrors will fold in, push the switch on the left and the mirrors will return to the normal driving position.

Please refer to **Figure 2** below or go to page 27 of the ProMaster Owner's Manual for the Power Folding Mirror Switch controls.

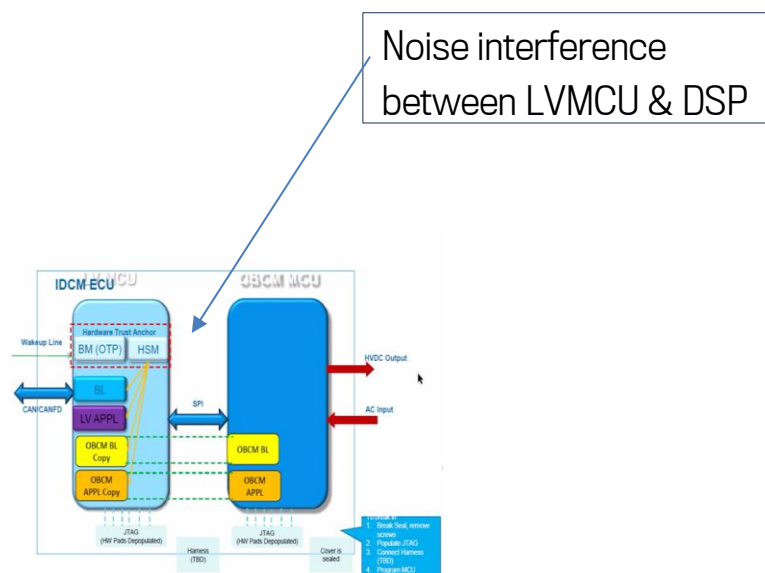
Symptom/Vehicle Issue: High Voltage (HV) Battery Will not Take a Charge, Diagnostic Trouble Code B22A9-42-ECU Internal Performance-General Memory Failure Integrated Dual Charge (IDCM)

Please note that in the event of a DTC B22A9-42 present, the condition may be due to the following possible cause:

24MY IDCM has integrity check feature enabled as a part of cyber security requirement. During this integrity check monitoring, any noise/interference in Serial Programming Interface (SPI) communication between Low Voltage Micro-controller Unit (LV MCU) and Digital Signal Processor (DSP) would set this DTC. Disabling integrity-check feature will avoid triggering this DTC (approved from Cybersecurity team).

The issue will be eliminated with following the service procedure. Not following the updated service procedure will result in an IDCM failure, which will induce and IDCM replacement. (see TSB - 08-192-24)

1. Disable HV Battery Contactors using wiTECH - Go to the Misc Functions tab --> Select Disable HV Battery Contactors -> then follow the wiTECH prompts.
2. Use wiTECH to confirm that the contactors are open and waiting five minutes. If the contactors do not open turn the ignition on then off. Once successful a note will appear on the wiTECH screen indicating the contactors are open.
3. Reprogram the IDCM with the latest software. Detailed instructions for flashing control modules using the

wiTECH Diagnostic Application are available by selecting the application "HELP" tab

4. Clear all DTCs that may have been set in any module due to reprogramming. The wiTECH application will automatically present all DTCs after the flash and allow them to be cleared.
5. Enable HV Battery Contactors using wiTECH - Go to the Misc Functions tab --> Select Enable HV Battery Contactors For Service--> then follow the wiTECH prompts.
6. Verify the vehicle will charge.
