# FCA CARIBBEAN WARRANTY OPERATIONS NEWSLETTER

## VOLUME 10, ISSUE 9

## MY 2023 and 2024 ProMaster (VF) - All Models With Power Folding Mirrors

## DTC B22A9-42 ECU Internal Performance, General Memory Failure Issue - MY 2024 Grand Cherokee (WL) PHEV IDCM - All Models and Variants

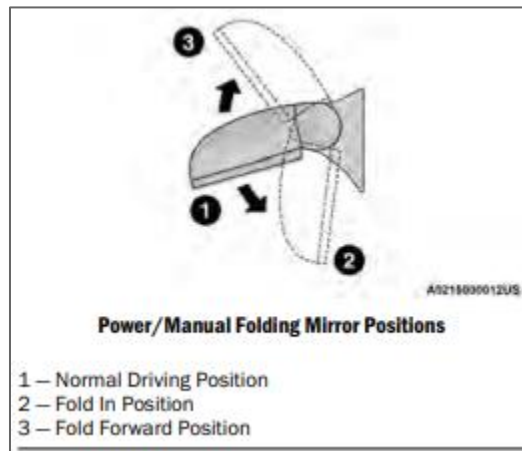
Figure 1

Please note that in the event of a power folding outside mirror malfunction, the condition may be due to the following possible causes:

1. Folded forward manually.
2. Folded by accidental impact.

The issue can be addressed by following the service procedure. Not following the service procedure can result in a continuous failure. Leaving the mirror in a non-powered position, accidental impact, or manual fold, can cause

For visual reference, **Figure 1** represents the three different folding mirror positions can reach by folding it, even if it is by power, manual, or accidental.

If the mirror head or pivot exhibits a slight amount of play in the normal position, the mirror should be power folded closed, then power folded open, this may require multiple button pushes to restore proper power mirror operation.

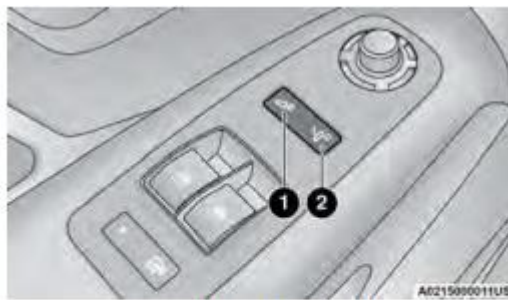
Please refer to **Figure 2** on the right or go to page 27 of the ProMaster Owner's Manual for the Power Folding Mirror Switch controls.

- 1 – Power Folding Mirror (Normal Driving Position)
- 2 – Power Folding Mirror (Fold In Position)

The switch for the power folding mirrors is located on the driver's door panel, below the power mirror controls. Push the switch on the right and the mirrors will fold in, push the switch on the left and the mirrors will return to the normal driving position.

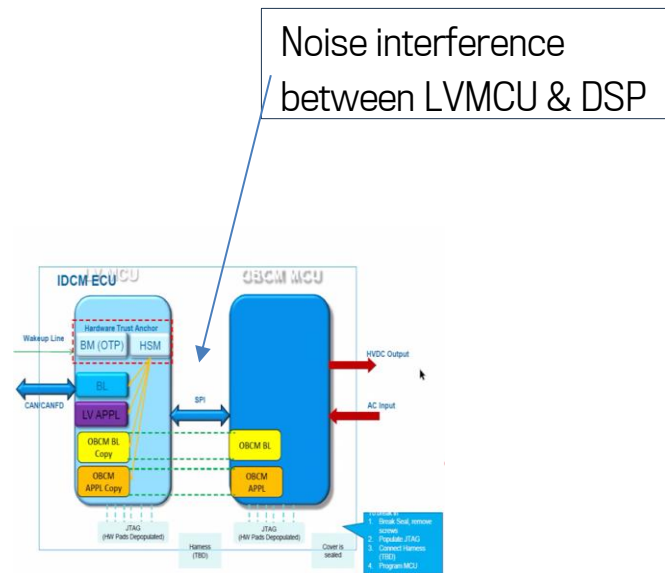
Symptom/Vehicle Issue: High Voltage (HV) Battery Will not Take a Charge, Diagnostic Trouble Code B22A9-42-ECU Internal Performance-General Memory Failure Integrated Dual Charge (IDCM)

Please note that in the event of a DTC B22A9-42 present, the condition may be due to the following possible cause:

24MY IDCM has integrity check feature enabled as a part of cyber security requirement. During this integrity check monitoring, any noise/interference in Serial Programming Interface (SPI) communication between Low Voltage Micro-controller Unit (LV MCU) and Digital Signal Processor (DSP) would set this DTC. Disabling integrity-check feature will avoid triggering this DTC (approved from Cybersecurity team).

The issue will be eliminated with following the service procedure. Not following the updated service procedure will result in an IDCM failure, which will induce and IDCM replacement. (see TSB - 08-192-24)

1. Disable HV Battery Contactors using wiTECH - Go to the Misc Functions tab --> Select Disable HV Battery Contactors --> then follow the wiTECH prompts.
2. Use wiTECH to confirm that the contactors are open and waiting five minutes. If the contactors do not open turn the ignition on then off. Once successful a note will appear on the wiTECH screen indicating the contactors are open.
3. Reprogram the IDCM with the latest software. Detailed instructions for flashing control modules using the wiTECH

4. Clear all DTCs that may have been set in any module due to reprogramming. The wiTECH application will automatically present all DTCs after the flash and allow them to be cleared.
5. Enable HV Battery Contactors using wiTECH - Go to the Misc Functions tab --> Select Enable HV Battery Contactors For Service--> then follow the wiTECH prompts.
6. Verify the vehicle will charge.

Please follow the (TSB - 08-192-24) Standard Procedure, present in the Link-E-Entry system/ Service Library
