McLaren Artura HVAC TXV Block Inspection and Troubleshooting Guide

Topic: Troubleshooting guide supporting diagnosis of potential leaks from the HVAC TXV block

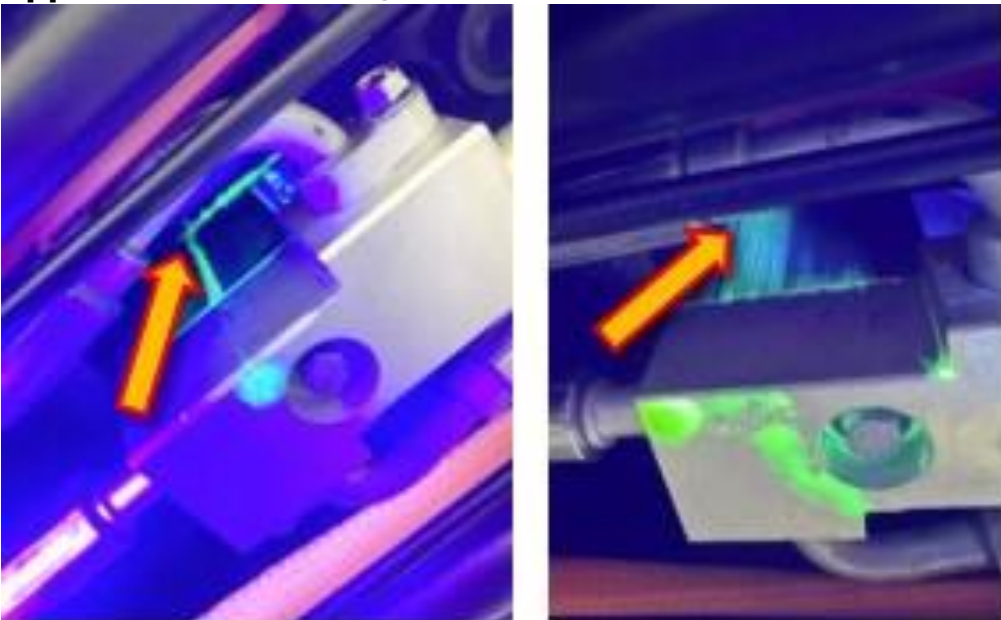
Upper TXV leak - Leaking from above the TXV between HVAC and TXV interface.

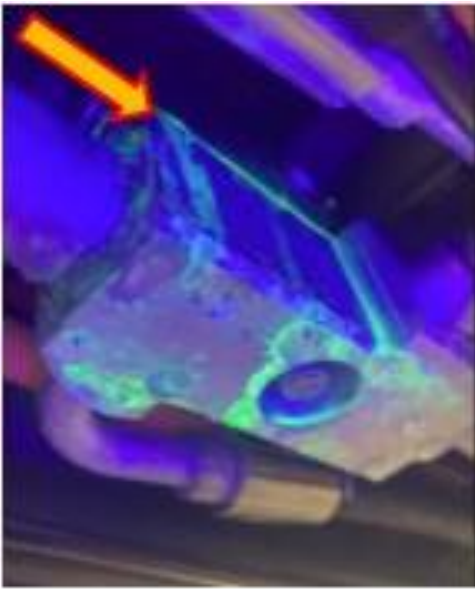
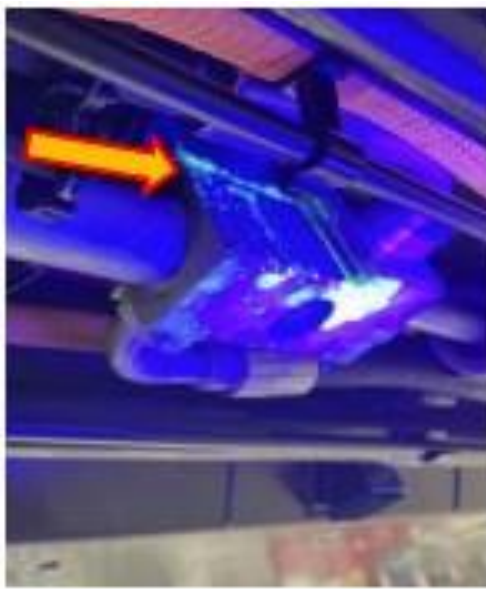
Lower TXV/Block Interface Leak - Leaking from in between TXV and pipe block.

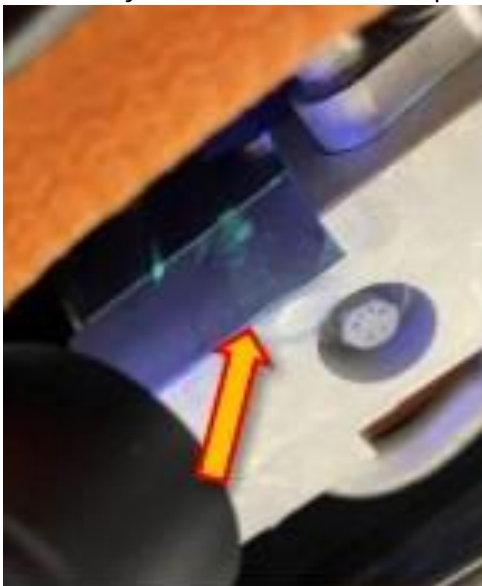
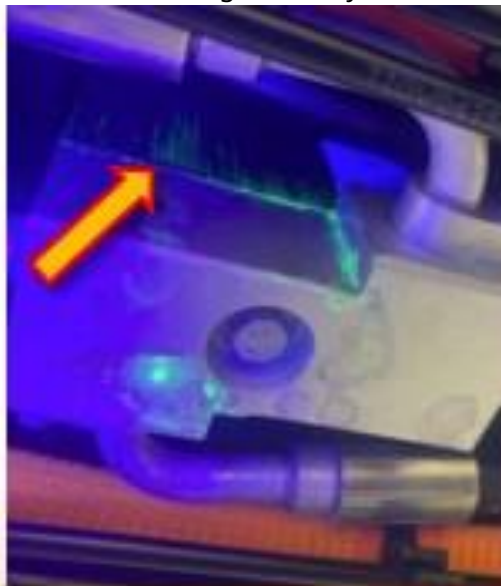
Residual Dye Marks / Not Cleaned - Faint residual marks, smudges, or condensate water carrying residual dye into channels. Due to poor cleanliness during assembly or after rework.

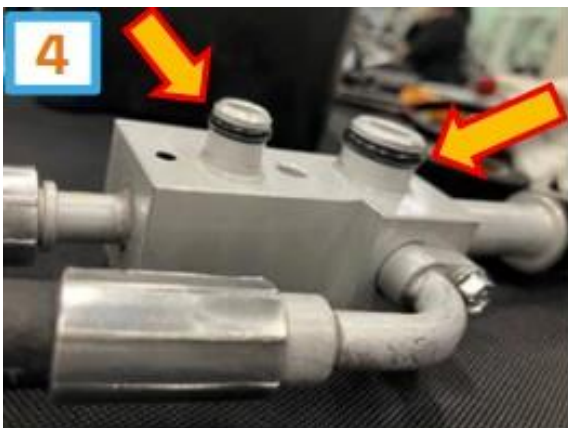
4. Inspect the black o-rings for damage and replace with new

16LA716CP: Larger Spigot: 12.5mm ID x 3mm CSD, Material: CR

16LA717CP: Smaller Spigot: 8.92mm ID x 1.83mm CSD, Material: CR

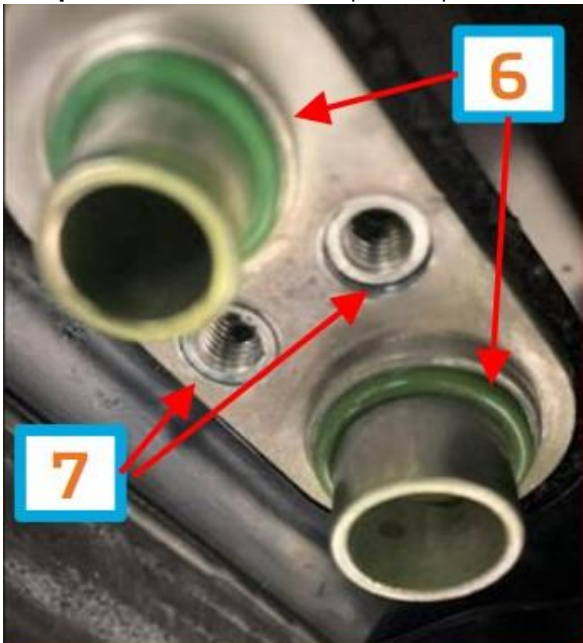
7. Check the underside of the HVAC distribution box for the presence of inserts

Care point: If the inserts are not present, please submit a Technical Request and await further guidance.

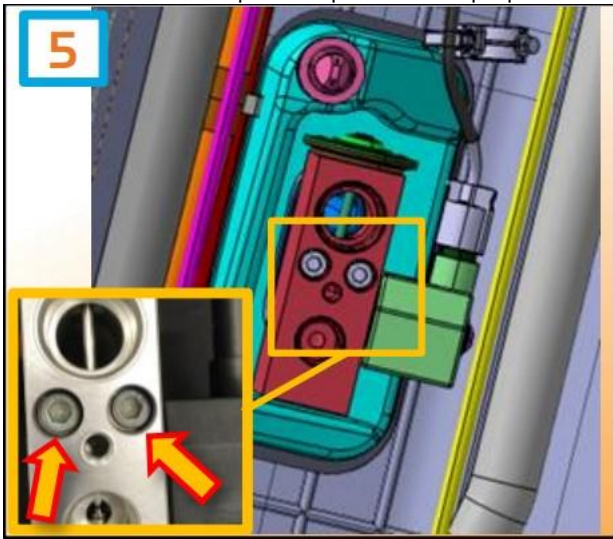
5. Prior to removal, check TXV bolts torque value of 6Nm is achieved

Care point: If bolts do not torque up to the nominal value, then it suggests an issue with the HVAC distribution box inserts. If the inserts are not present, please submit a Technical Request and await further guidance.

If the inserts are present, replacement of the HVAC distribution box will be required with part number **16LA709CP** or newer. Please submit a Technical Request for parts release purposes.

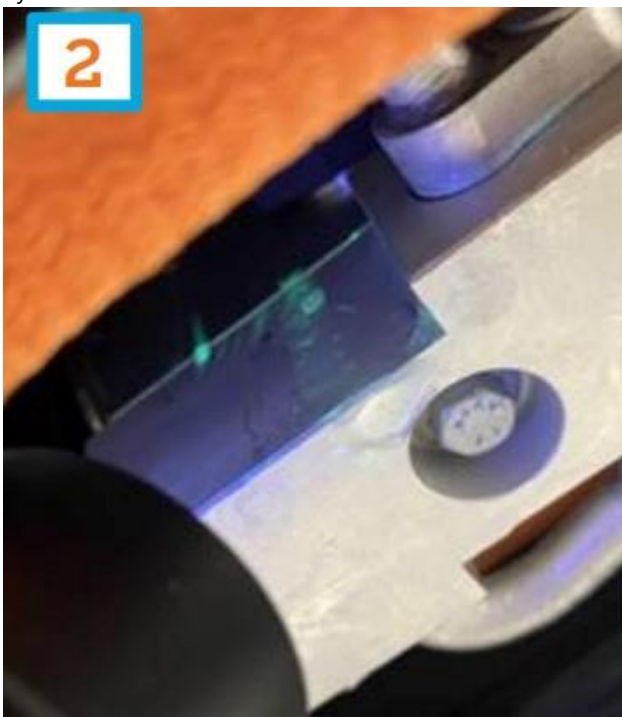
1. Inspect thoroughly with UV torch for any potential leak paths

2. If faint marks, smudges or witness lines are visible, this suggests condensate water could have carried residual dye down the TXVblock

Thoroughly clean the block assembly and surrounding areas with solvent cleaner. Inspect again with UV light to ensure no residual dye is left
