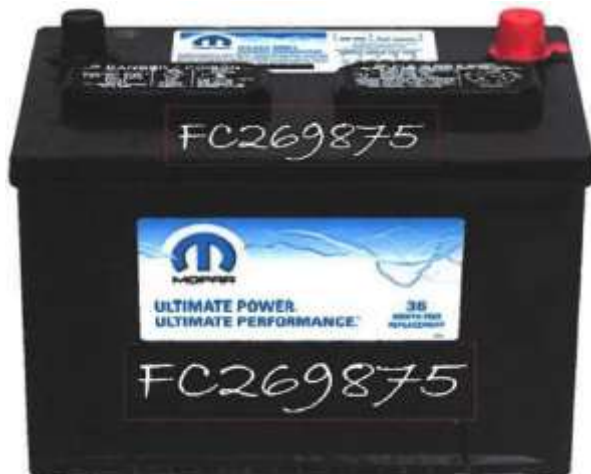
Using a white paint pen, clearly write out the last eight of VIN

**How:** Using a paint pen on the outside of the battery, write the last 8 of the VIN of the vehicle that the battery came from. The rest is up to , as they will pick up the labeled batteries, along with all other cores, during their normal delivery and pick up schedule.

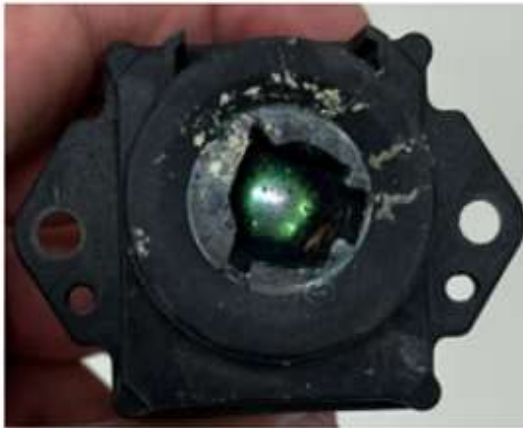
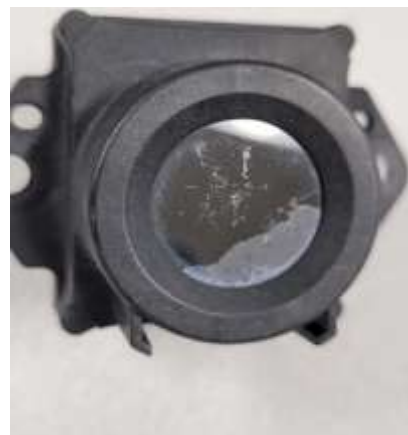
We have found during supplier analysis, the night vision camera lens is found to be cracked, potentially caused by an external force such as road debris. Symptoms for this issue are found in Service Library. If the Night Vision Camera lens is cracked, or delaminated, it is not considered a defect in material or workmanship yet could be considered for

If that is not obtained, then this is considered an Insurance claim with the vehicle car insurance. In any event, it is not supported for a warranty reimbursement.

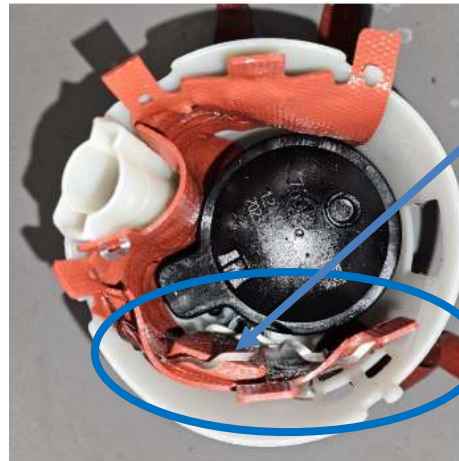
### Bad Part

For Diesel Exhaust Systems, if an owner has added any form of hydrocarbon, such as diesel fuel, fuel system additives, gasoline or any other petroleum-based product, the whole DEF system is contaminated. A quantity less than 100 parts per million or less than 1 oz. per 78 gallons (295 liters) of any form of hydrocarbon will contaminate the entire DEF System. It will

require the replacement of the DEF Pump, DEF Lines, DEF Injector and DEF Tank.

Early sign of Hydrocarbon contamination.

Deformed Heater Mat

Please inform the owner that only DEF Fluid from a dedicated DEF container, funnel or nozzle should be used for refilling the DEF Tank.
