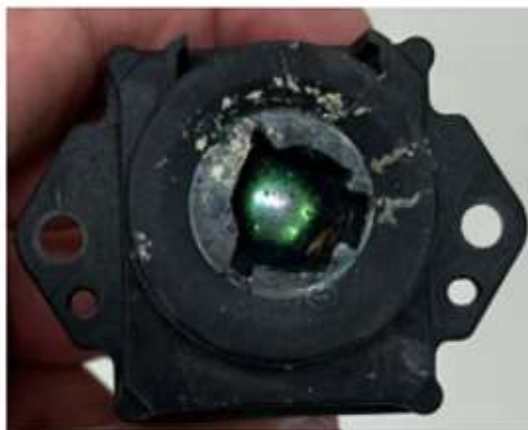
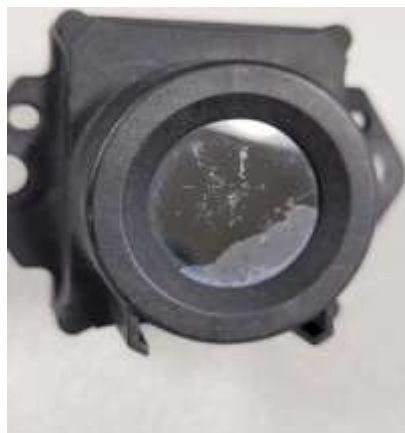
We have found during supplier analysis, the night vision camera lens is found to be cracked, potentially caused by an external force such as road debris. Symptoms for this issue are found in Service Library. If the Night Vision Camera lens is cracked, or delaminated, it is not considered a defect in material or workmanship yet could be considered for

If that is not obtained, then this is considered an Insurance claim with the vehicle car insurance. In any event, it is not supported for a warranty reimbursement.

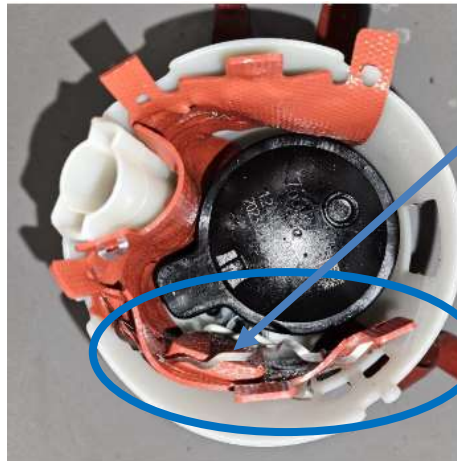
Bad Part

For Diesel Exhaust Systems, if an owner has added any form of hydrocarbon, such as diesel fuel, fuel system additives, gasoline or any other petroleum-based product, the whole DEF system is contaminated. A quantity less than 100 parts per million or less than 1 oz. per 78 gallons (295 liters) of any form of hydrocarbon will contaminate the entire DEF System. It will

Early sign of Hydrocarbon contamination.

Deformed Heater Mat

require the replacement of the DEF Pump, DEF Lines, DEF Injector and DEF Tank.

Please inform the owner that only DEF Fluid from a dedicated DEF container, funnel or nozzle should be used for refilling the DEF Tank.
