# Service Bulletin

Bulletin No.: 01-08-42-001Q

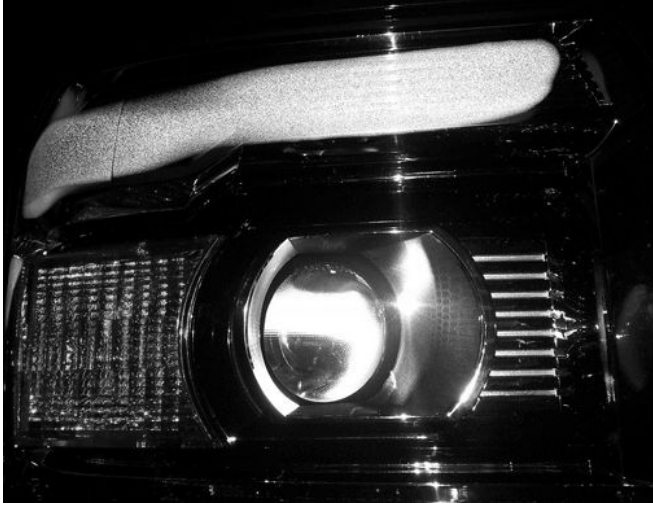
Condensation Examples (Do Not Replace Lamp Assembly Under Warranty)

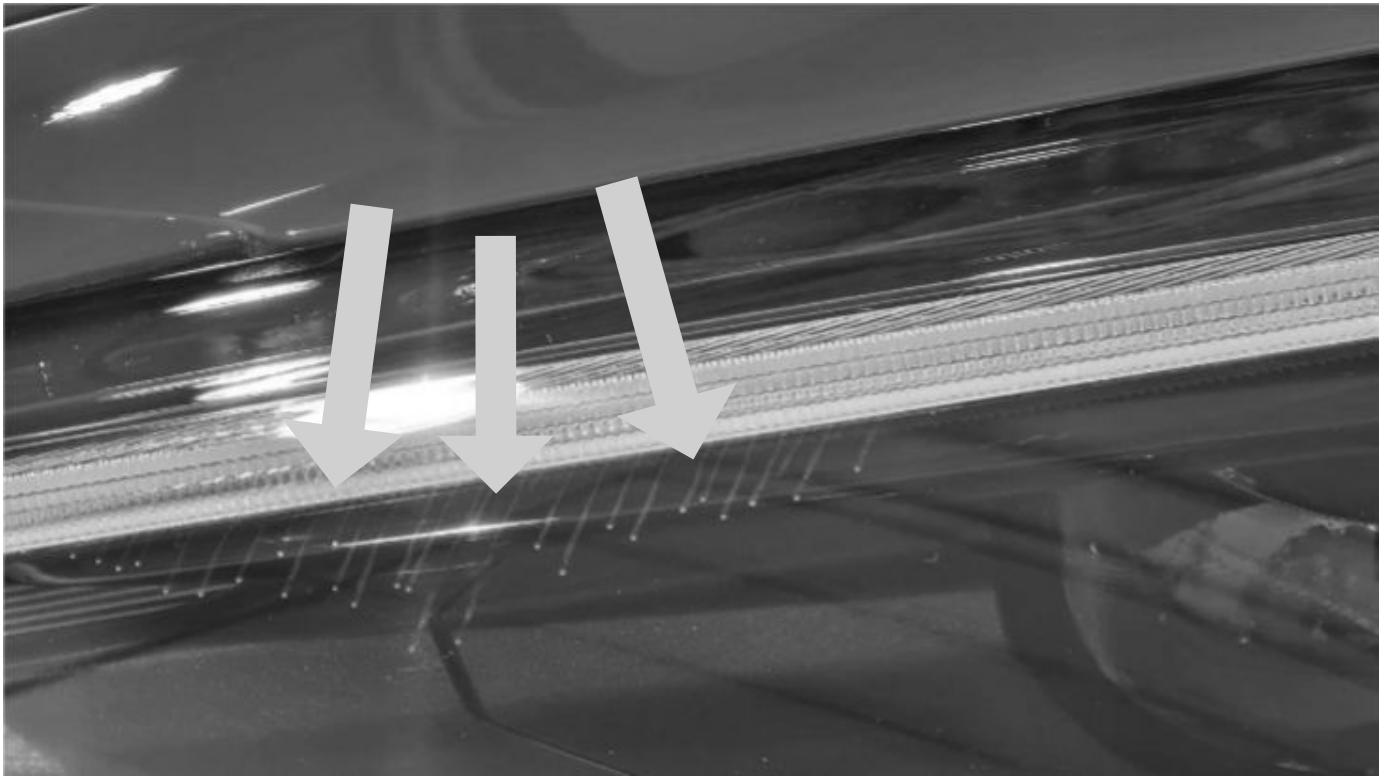
Internal Coating Issues Examples

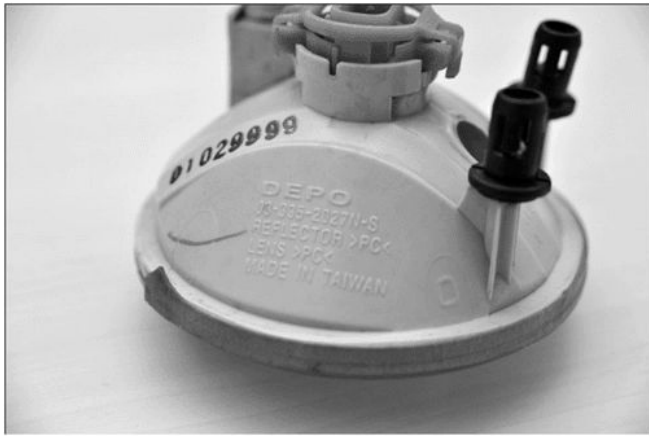
Many companies outside of General Motors are manufacturing lamp assemblies that look very similar to original equipment. They target high volume programs. These lamps are most often presented by customers as holding moisture or for inoperative functions due to corroded electrical connections. It appears these non OE lamps get installed on vehicles as part of a collision repair. Most likely the customer has no idea they are not original equipment, as the initial appearance is generally good. Obviously, these parts are not covered by warranty. Some of the common company names seen on these lamps are Eagle Eyes, Srumto, and Depo.
